Seismic Design of Anchored Brick Veneer

D. Reneckis, PE

Thornton Tomasetti, London, UK

SUMMARY:

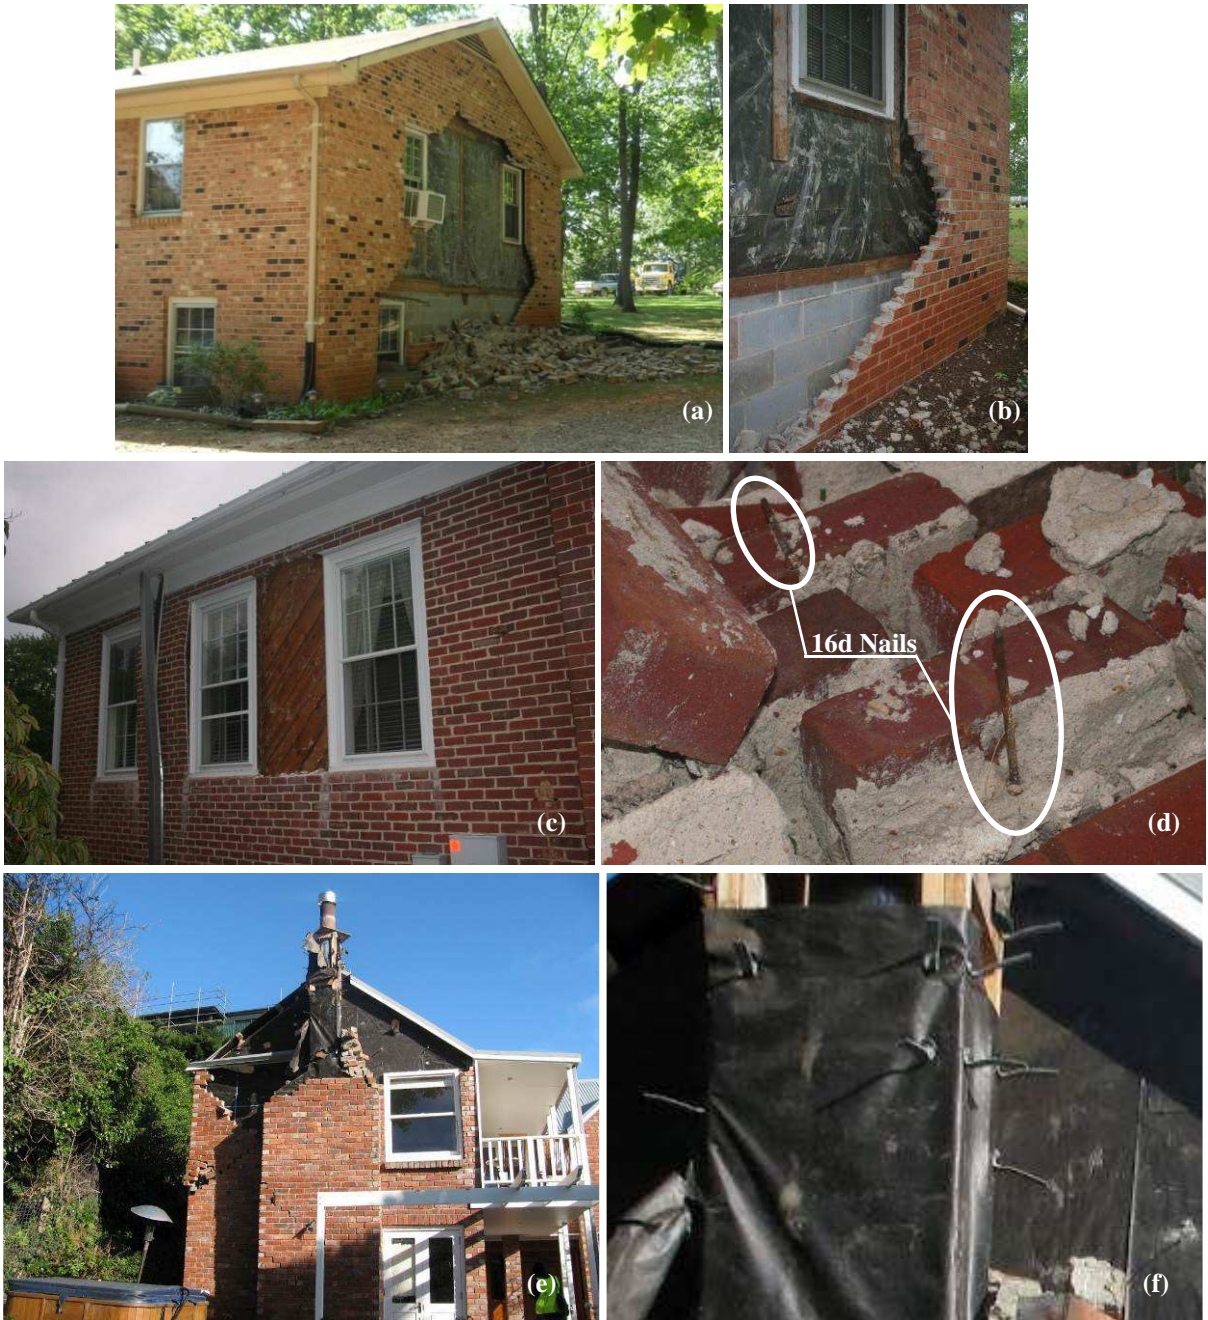
Figure 1. Brick veneer wall damage and collapse following earthquakes in (a-d) August 2011, Mineral, Virginia (photos by Matthew Eatherton, Virginia Tech), and (e,f) February 2011, Christchurch, New Zealand (photos by Kevin Jackson, Thornton Tomasetti).

After the weak to moderate earthquakes in the U.S., collapsed brick veneer walls generally exposed inadequate or lack of anchorage for the brick masonry to the wood frame backup. For example, after the event in Virginia, several residential homes with brick veneer revealed that tie connections were

completely ignored, and therefore the brick veneer was built as a free-standing masonry wall around the wood frame home exterior, as shown in Figure 1(a,b). In older residential construction present in Virginia, as shown in Figure 1(c,d), collapsed brick masonry revealed that anchorage was only provided by driving 16d nails into the wood backup, and then setting the head of the nail into the mortar joints. This type of connection typically provides very little pullout resistance from the wood frame backup because the nail is generally driven a short distance into the wood frame backup. On the other hand, following the strong shaking in Christchurch, New Zealand, homes with collapsed brick veneer generally revealed an adequate number of tie connections, as shown in Figure (e,f); however, as a result of the strong shaking, the masonry itself was the weak component, and anchorage to the backup was lost due to tie connections failing at the mortar joints. The desktop study presented in Section 3.3 on the alternative strength design methodology was carried out for the four U.S. locations where recent seismic events resulted in brick veneer wall damage and/or collapse.

Residential wood frame home structures with exterior brick masonry veneer are typically built in one or two story configurations, as seen earlier in Figure 1. The wood frame structure and the brick veneer must be supported by a noncombustible foundation, usually made of concrete or masonry. The wood backup structure typically comprises floor framing, walls built of 2x4 (1-1/2 in. x 3-1/2 in. [38 mm x 89 mm]) studs spaced at 16 in. (406 mm) on center (with exterior sheathing and interior gypsum wallboard), and roof/ceiling framing. The IRC (ICC 2009) provides design and construction requirements for all structural components of a home. MSJC (2011) simply recommends that such designs comply with ACI 318 for the concrete foundation, and with NDS (2005) for the wood frame structure; MSJC (2011) would be referenced for the case of designing a masonry foundation.

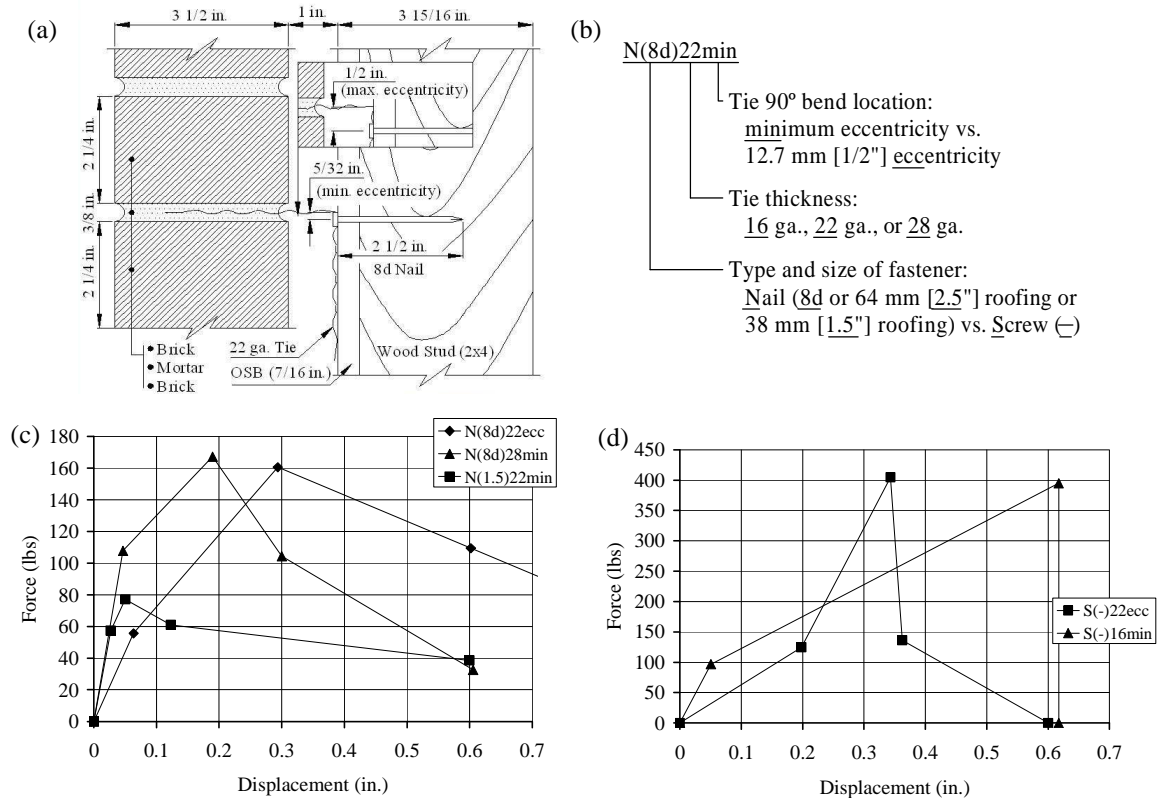
Figure 2. Tie connection details: (a) section view of installation, (b) parameters and nomenclature, (c,d) idealized force-displacement behaviour in tension. (1 in. = 25.4 mm; 1 lb = 4.45 N)

Prescriptive requirements for brick veneer over wood frame backup wall design and construction are specified in the MSJC (2011), the IRC (ICC 2009), and the BIA Technical Notes (2002, 2003). The tie connections should satisfy a set of performance requirements such as: a) sufficient strength and stiffness (in tension and compression) to transfer lateral loads to the backup, b) adequate transverse flexibility to accommodate differential vertical movements between exterior and interior walls, and c) resistance to corrosion and moisture transfer across the air cavity (BIA 2003). For anchoring brick veneer to a wood frame backup, the minimum tie thickness is specified as 22 ga., installed with a maximum bend eccentricity of 1/2 in. (12.7 mm) (with the exception of IRC, which does not specify tie bend eccentricity limits), and attached to the wood backup studs with at least 8d nails, as shown in Figure 2(a). Furthermore, the maximum wall area to be supported by the ties is limited to 2.67 ft² (0.25 m²) for construction in seismic design categories C and below (and for typical wind exposure conditions), and it should be reduced to 2 ft² (0.19 m²) in seismic design category D and above; respectively, these wall areas correspond to tie grid spacings of 24 in. x 16 in. (610 mm x 406 mm), and 16 in. x 16 in. (406 mm x 406 mm), in actual construction. Also, for seismic design category D and above, the ties should be attached to the wood backup with a No. 10 corrosion resistant screw, or a fastener having equivalent or greater pullout strength (MSJC 2011).
