# A Review of the Nonlinear Static Assessment Procedure in the Turkish Earthquake Code

## **SUMMARY**

The goal of this paper is to review the validity of the nonlinear static assessment procedure given in the Turkish Earthquake Code by comparing the assessment results with real structures from north-western Turkey, where the 1999 earthquakes occurred.

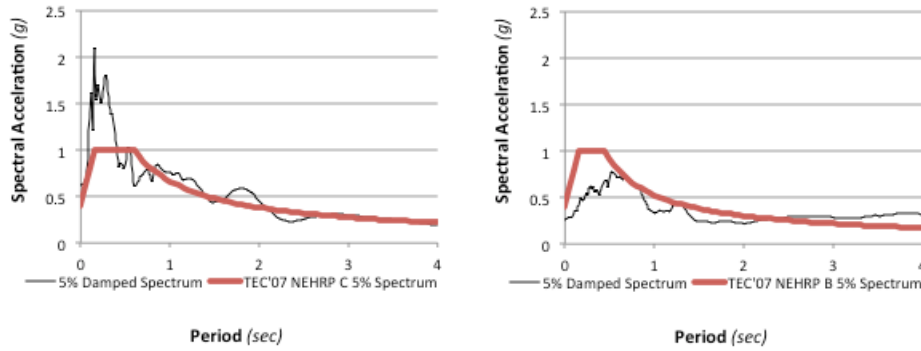
**Figure 3.** Comparison of the acceleration spectra for the Sakarya record (left) and Yarımcı record (right)

Two case study structures have been analyzed by using both nonlinear time history and nonlinear static analysis methods. SeismoStruct software (SeismoSoft, 2012), capable of modeling RC structures with distributed plasticity models, is used for analyses. The first case study structure was subjected to Sakarya record of the 1999 Earthquake while the second was in Gölcük, and was subjected to the East-West component of Yarimca record of the same earthquake. The records and their acceleration spectra are given in Figure 1 to Figure 3.

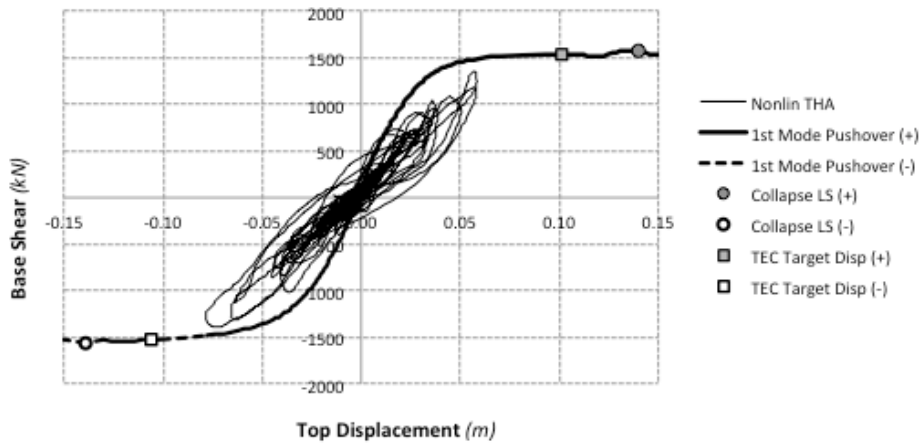
**Figure 9.** Comparison among the nonlinear time history analysis results, pushover analyses and the estimation of the target and collapse displacements for the First Case Study

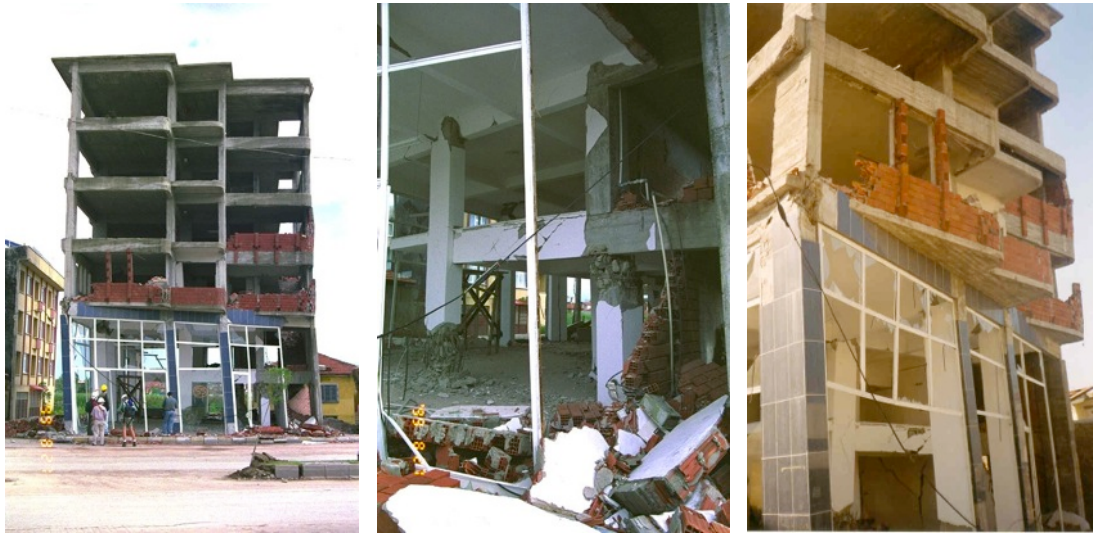
**Figure 10.** Overview of the damages of the 2<sup>nd</sup> case study structure

There are two case study structures examined in this study. The first structure is rather simple, but the second one has plan and elevation irregularities. There is a sub-floor created inside the ground floor, leading to very high levels of torsion. The structure experienced very high levels of residual drifts in the columns along the front façade, and extensive damage in the ground floor (see Figure 10).

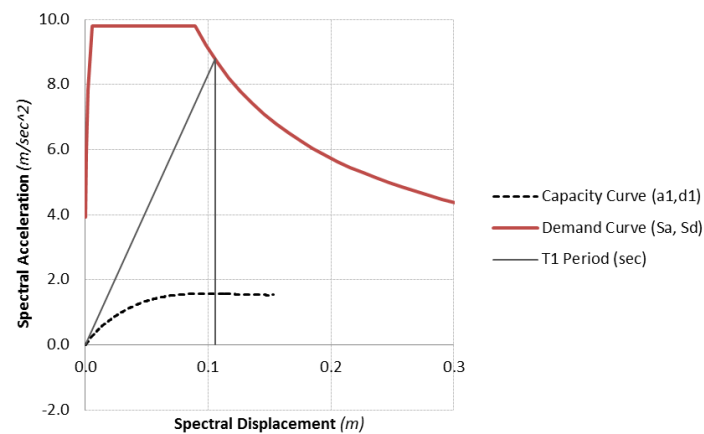
**Figure 11.** Estimation of the target displacement for the 2<sup>nd</sup> Case Study structure

Estimation of the target displacement of the 2nd case study, along the shorter axis of the structure as it was subjected in 1999, given in Figure 11, follows the methodology suggested in the Turkish Earthquake Code (TEC, 2007). The procedure simply follows the equivalent displacement rule since the fundamental period of the structure, 0.68sec, is longer than the corner period of the design spectrum, 0.6sec.
