HORIZONTAL LOADING AND VIBRATION TEST ON  
2-STORIED REINFORCED CONCRETE STRUCTURES

ABSTRACT

Four types of 2-storied reinforced concrete frames of office and hospital buildings for the Japanese National Railways were tested in order to find out their yield characteristics and destruction behaviour under static and dynamic horizontal load.

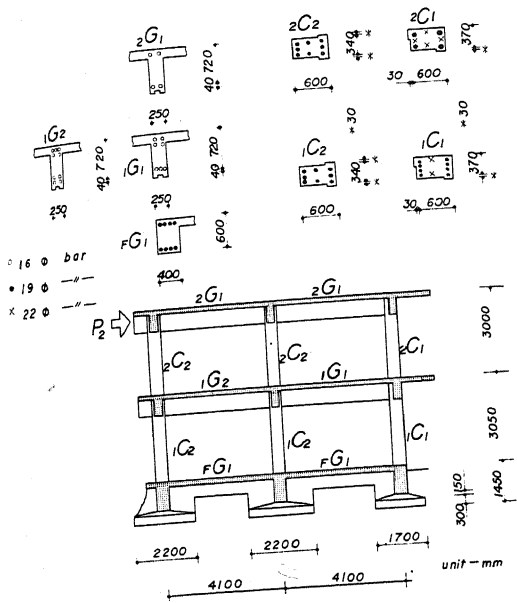
FIG. 1 SKELETON OF MAIBARA OPEN FRAME

The outside view and the skeleton of this building are shown on Photo. 1 and Fig. 1. Footings are supported with 4-5 precast concrete piles with 25 cm. diameter and 6 m. length, and the ground soil consists of the alternating soft clay (N = 2-9) and sand-gravel (N = 9-20) layers that extends over 17 m. depth.

- (1) A pair of two-spanned Open Frame of Maibara Car Maintenance Office JNR (Fig. 1).
- (2) Composite type of two-spanned Walled Frame and open frame of Hamamatsu Hospital JNR (Figs. 2, 3).
- (3) Balanced frame type of single Open Frame of Hamamatsu Hospital JNR (Fig. 4).
- (4) The same form as (3) type but with a seismic Shear Wall at the 1st story of Hamamatsu Hospital JNR (Fig. 4).

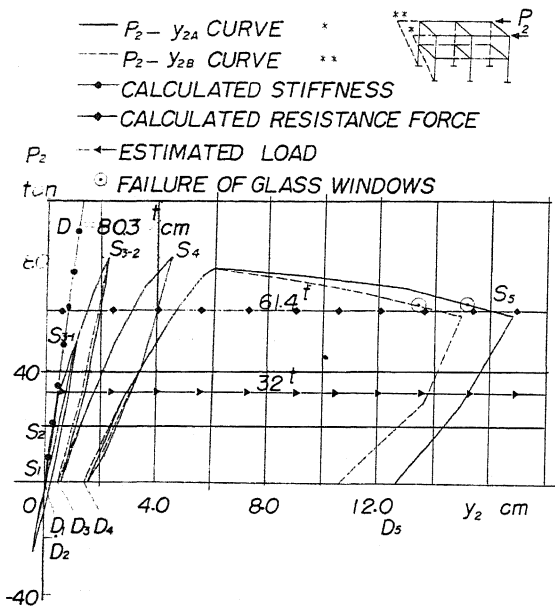
FIG.5 LOAD-DISPLACEMENT CURVE OF MAIBARA OPEN FRAME

- (1) Maximum value of horizontal resistance force ( $P_y$ ) was measured as 80 t., while the calculated value was 61.4 t.
- (2) The initial measured value of stiffness (D) was 50 t/cm while its calculated value was 80.3 t/cm.

And the value of stiffness at ultimate state was 30 t/cm (Fig. 5).

As a result of the static tests, load-displacement curves in Fig. 5 to Fig. 8 show the change of their stiffness and the yield resistance force of each static test with the calculated values of them.

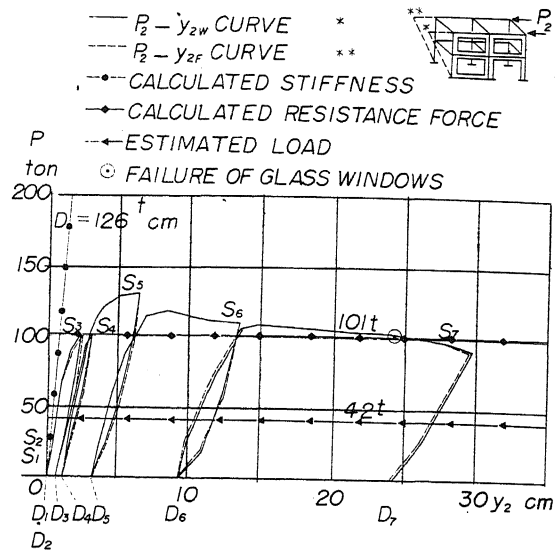
FIG.6 LOAD-DISPLACEMENT CURVE OF HAMAMATSU WALLED FRAME

- (1)  $P_y$  of this frame was measured as 130 t., while the calculated value was 101 t. It showed that the value of safety factor for lateral force of the usual design (2nd story 24 t., 1st story 42 t.) was sufficient.

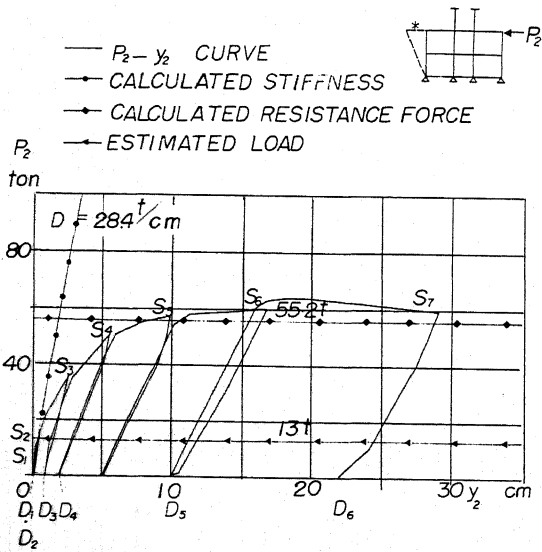
FIG.7 LOAD-DISPLACEMENT CURVE OF HAMAMATSU OPEN FRAME

- (1)  $P_y$  of this frame was measured as 63.4 t., while the calculated value was 55 t. The value of the safety factor for lateral force of the usual design (2nd story 8.4 t., 1st story 13 t.) was sufficient (Fig. 7).

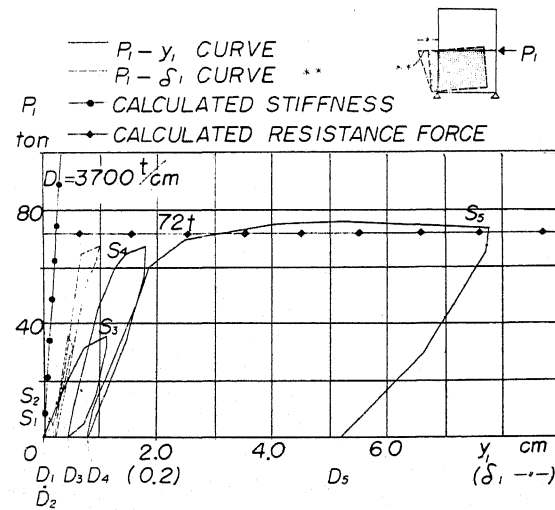
FIG.8 LOAD-DISPLACEMENT CURVE OF HAMAMATSU SHEAR WALL

- (1)  $P_y$  of this wall was measured as 76 t., while the calculated value was 72 t. (Fig. 8).
- (2) The wall base slipped on the footing beam and the upside of the footing and the bottom of the inner column had been heavily cracked (Fig. 16).

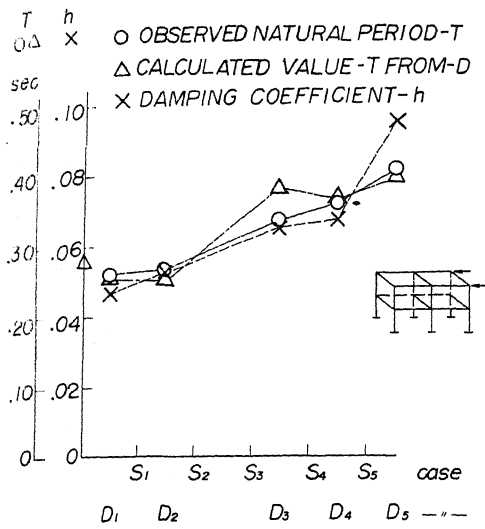
FIG.9- CHANGE OF STATIC AND DYNAMIC PROPERTIES OF MAIBARA OPEN FRAME IN EACH LOADING CASE

- (3) The observed natural period ( $T$ ) and damping coefficient ( $h$ ) of building covered a range of 0.28 sec. (initial) to 0.41 sec. (ultimate) and 0.04 to 0.095, respectively. The calculated value ( $T_0$ ) was 0.28 sec. (Fig. 9).

And as a result of dynamic tests, observed natural periods compared with calculated natural periods from the stiffness of each static test, and observed damping coefficients are shown in Fig. 9 to Fig. 12.

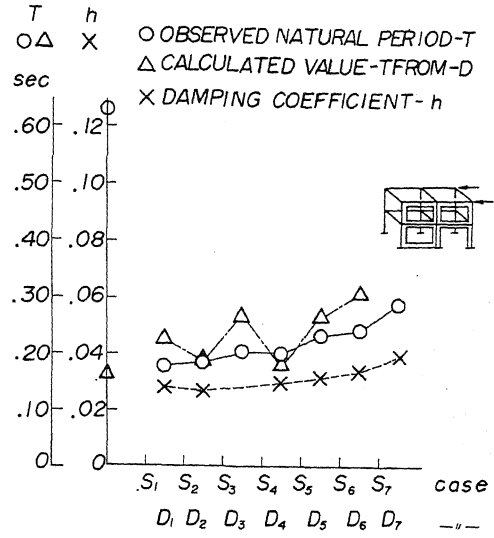
FIG.10- CHANGE OF STATIC AND DYNAMIC PROPERTIES OF HAMAMATSU WALL-ED FRAME IN EACH LOADING CASE

- (2) The observed values of  $T$  and  $h$  covered a range of 0.18 sec. to 0.29 sec. and 0.03 to 0.04, respectively, while the calculated value of  $T_0$  was 0.16 sec. (Fig. 10).

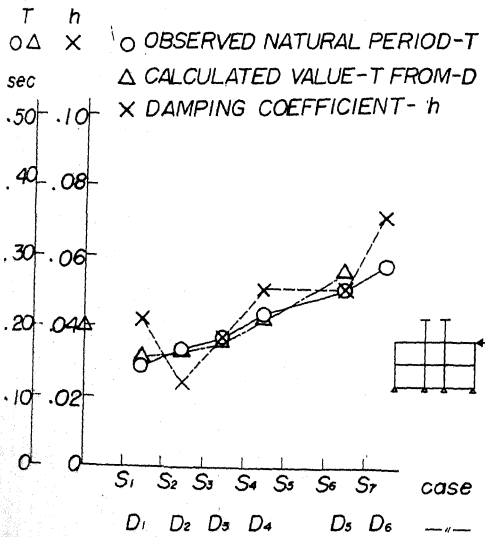
FIG.11- CHANGE OF STATIC AND DYNAMIC PROPERTIES OF HAMAMATSU OPEN FRAME IN EACH LOADING CASE

- (3) The observed values of  $T$  and  $h$  covered a range of 0.14 sec. to 0.29 sec. and 0.03 to 0.08, respectively (Fig. 11).

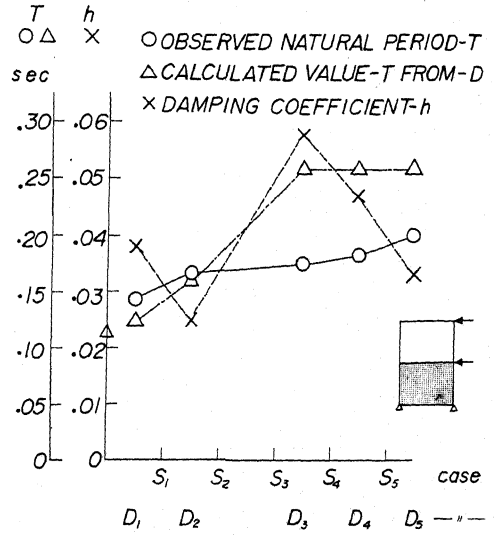
FIG.12- CHANGE OF STATIC AND DYNAMIC PROPERTIES OF HAMAMATSU SHEAR WALL IN EACH LOADING CASE

- (3) The result of free vibration test showed that the natural periods ranged from 0.14 sec. to 0.20 sec. and the damping coefficients from 0.03 to 0.06. These values seem to be independent of the yielding of the wall or the amount of amplitude in this case (Fig. 12).

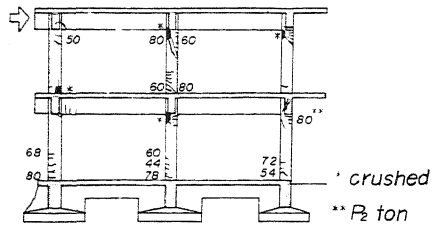
FIG. 13 CRACK IN MAIBARA OPEN FRAME

First, all of the tops and bottoms of the 2nd story columns cracked under bending moment; second, when the top of the frame moved about 6 cm., shear cracks developed at the top of the 2nd story interior column.

With an increase of the frame deflection, the shear crack developed at the bottom of the 2nd story interior column and the top and bottom of the 2nd story exterior column.

1st story columns were cracked under bending moment, but still there were little shear cracks and no failure under shear force. --(Fig. 13)(Photo. 7).

To know the destruction behaviour of these test frames, ultimate distributions of the cracks in them are shown in Fig. 13 to Fig. 16.

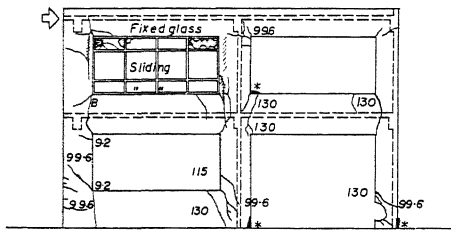
FIG. 14 CRACK IN HAMAMATSU WALLED FRAME

However, the development of shear cracks in the walled frame was remarkable in comparison with those in the open frame shown in Fig. 3. (see Fig. 14 and Photo. 12)

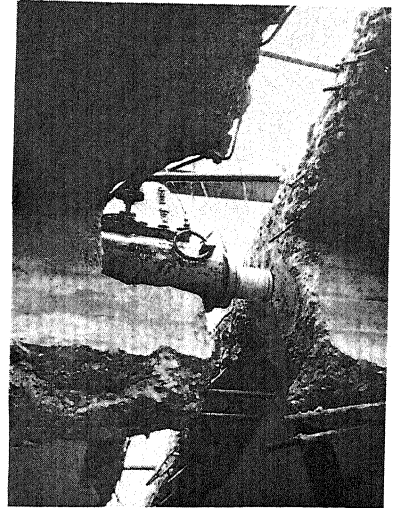
Between the test frame and the original frame, a pair of 50 t. oil jacks (Photo. 2) and a wire rope - chain block system (Photo. 3) were set to make it possible to push and pull the test frame.

Photo 2. Setting of 50ft. Oil Jack (Maibara).

PAGE 231: Photo 2. for 50 ft read 50 t

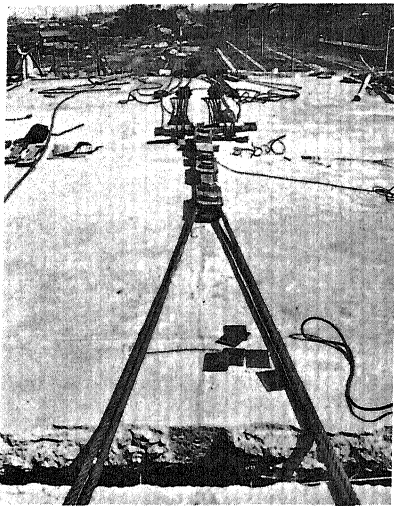
Photo 3. Wire-Rope, Chain Block System (Maibara).

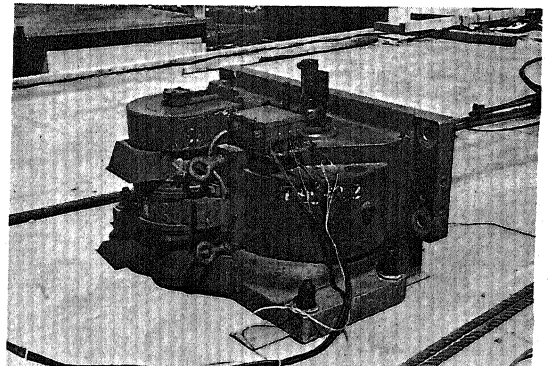
The building was separated vertically in two parts by concrete breakers and the one of two spans in the longitudinal direction of this building was tested, and the other remainder of three spans of original frame was used to support the testing load. At the center of the roof of the test frame, a vibration exciter was installed with four bolts (Losenhausen type of two unbalanced weights rolling about respective axis, with 0-2,460 kg.cm. unbalanced moment, 4-20 c/s frequency range, 2,000 kg. maximum vibration force, 850 kg. weight) (Photo. 4).

Photo 4. Vibration Exciter.

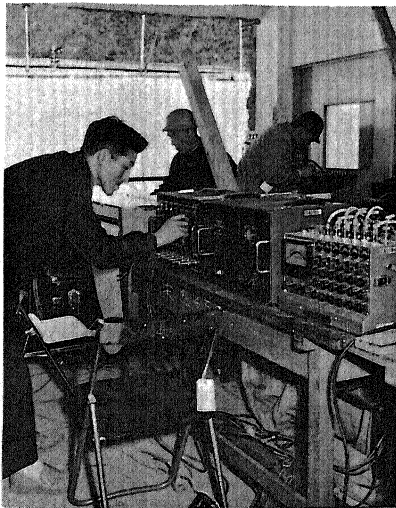
Photo 5. Amplifier and Recorder of Accelerometer.

In the dynamic test, the horizontal movement of each floor was measured by accelerographs and moving coil type vibrographs.

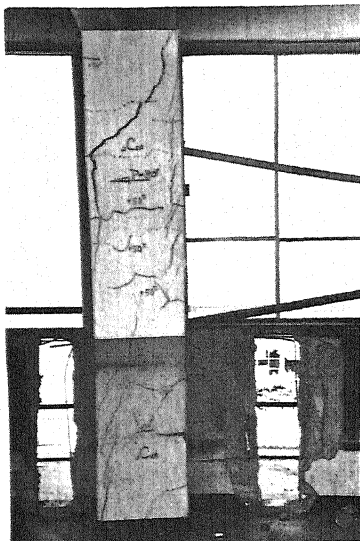
**Photo 7.** Shear Cracks in 2nd Storey Interior Column (Maibara).

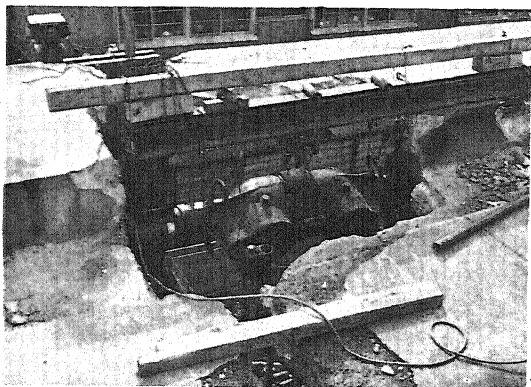
In the open frame test the lateral force is applied by means of 100 t. jacks from outside original structures (Photo. 9, 14).

**Photo 9.** Setting of 100rt. Jacks.

PAGE 232: " 9. " 100 ft " 100 t  
" 10. " P.V. " P.U.

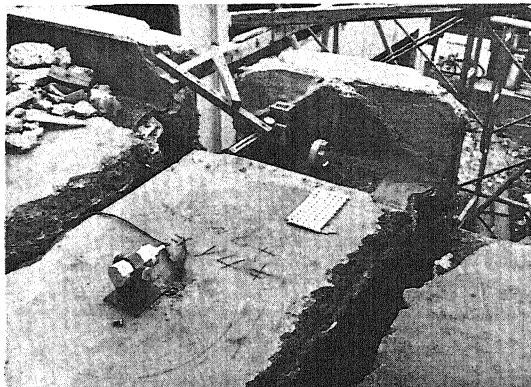
The horizontal displacement of each floor was measured by 1/100 mm. dial gauges and optical transits, and also the vertical displacement at the exterior column base was measured by dial gauges.

**Photo 10.** Dial Gauge F.V. Vibrograph and Coincidence Levelmeter (Hamamatsu).

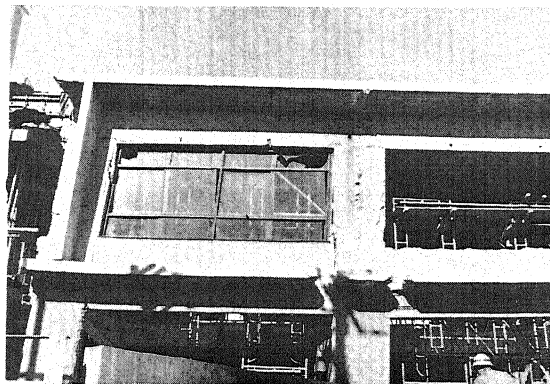
**Photo 12.** Cracks in Walled Frame and Glass Failure (Hamamatsu).

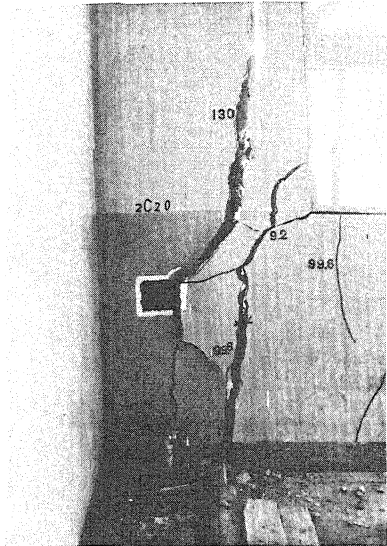
Photo 13. Cracks in 2nd Storey Interior Column (Hamamatsu Walled Frame).

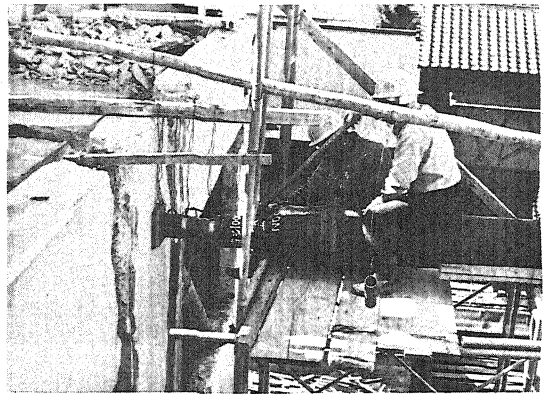
Photo 14. Setting of 100ft. Jacks. (Hamamatsu Open Frame Test).

PAGE 233: " 14. " 100 ft " 100 t

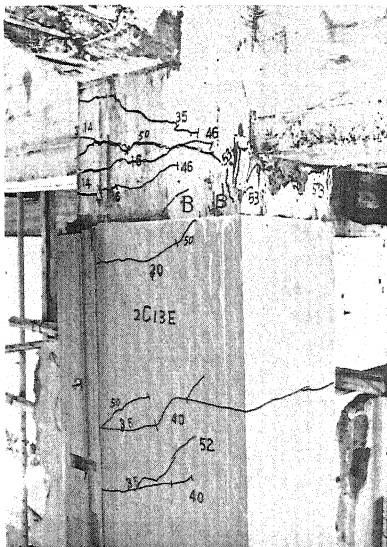
- (4) In the deflected open frame the rotation angle of the joint ( $\theta$ ) at the end of interior column was considerably large as compared with the mean deflection angles ( $R$ ) for the column, while the value of  $\theta$  at the end of exterior column was nearly equal to zero because the exterior column was of thin wall type with low stiffness.

Photo 15. Cracks at top of 2nd Storey Interior Column (Hamamatsu Open Frame Test).

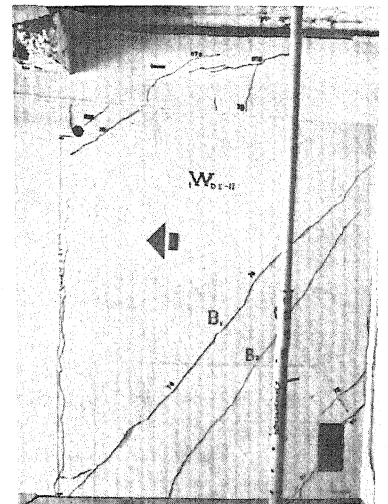
- (4) In comparison with recent experiences of seismic shear wall tests in laboratory, it can be noticed that the maximum shear resistance force of the actual wall becomes considerably smaller than expected, owing to the initial cracks due to piping or duct. The shear stress of the concrete was measured as 12 kg/cm<sup>2</sup> for the full section of the wall; 15 kg/cm<sup>2</sup> for the section without duct space.

Photo 16. Cracks of the Shear Wall (Hamamatsu Shear Wall Test).

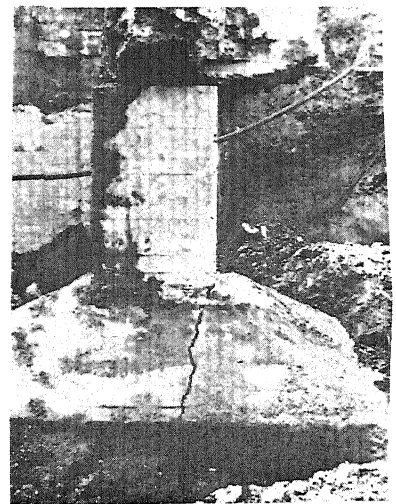
Photo 17. Cracks of the Footing of Interior Column (Hamamatsu Shear Wall Test).
