Some Tendencies in the Failures of Bridges
and their Foundations during Earthquakes

J. Kodera *

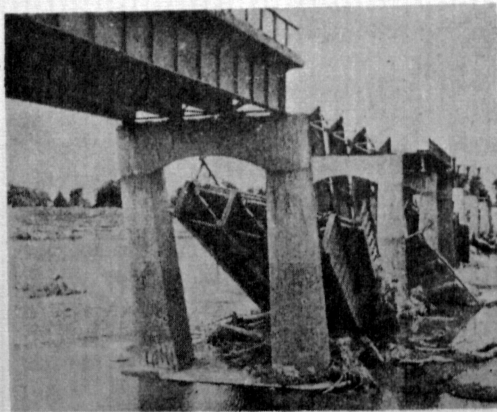
5

When the girders fall down not only the girders are destroyed, but also the pier to which the girder leans seems to suffer a damage, as seen in Fig. 2 and Photo. 5.
