Seismic vulnerability assessment
of the old city centre of Seixal, Portugal

T. Ferreira, R. Vicente, H. Varum & A. Costa
University of Aveiro, Portugal

15 WCEE
LISBOA 2012

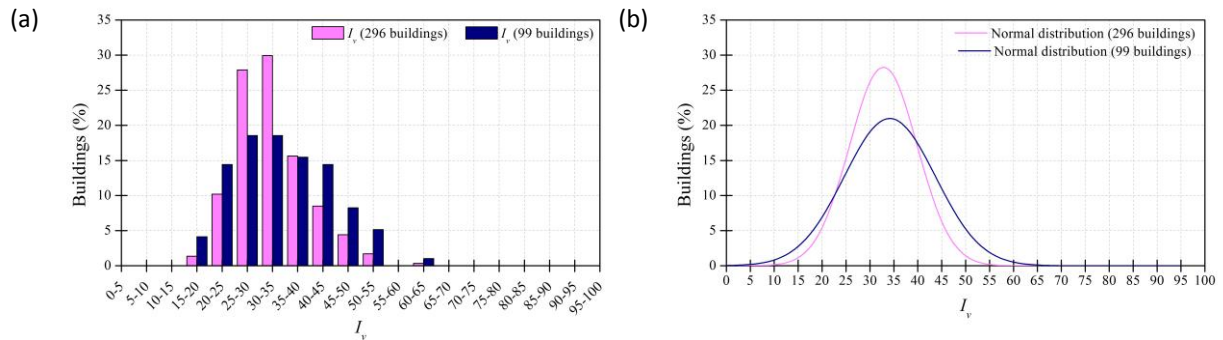
Figure 2. Vulnerability index distributions: (a) histograms; and (b) best-fit normal distributions

Figure 2 shows the histogram and the best-fit normal distribution curves resulted from the detailed (99 buildings) and non-detailed (296 buildings) assessment of buildings.

About 44% of the assessed buildings have a vulnerability index value over 40 (see Figure 5) and 16% over 45 (equivalent to vulnerability class A in the EMS-98 scale (Grünthal 1998)). In opposition, only 4% of buildings have an I_v below 20 (equivalent to vulnerability class B). The maximum and minimum I_v values obtained from the detailed assessment are 63 and 15, respectively.

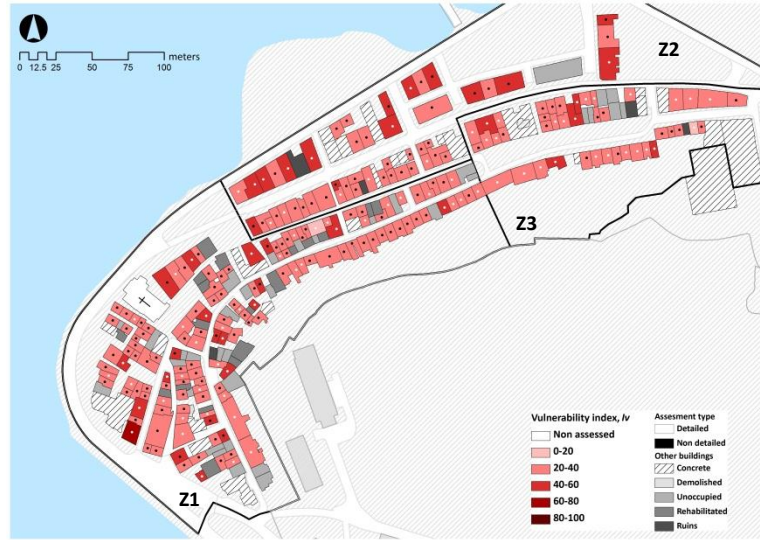
Figure 4. Vulnerability mapping of buildings in zones Z1, Z2 and Z3

Figure 4 and Figure 5 present the seismic vulnerability index distribution for all the buildings evaluated. Through the overall analysis of Figure 5, it is possible to identify the critical buildings, as well as the urban areas where an expressive concentration of buildings with high seismic vulnerability index.

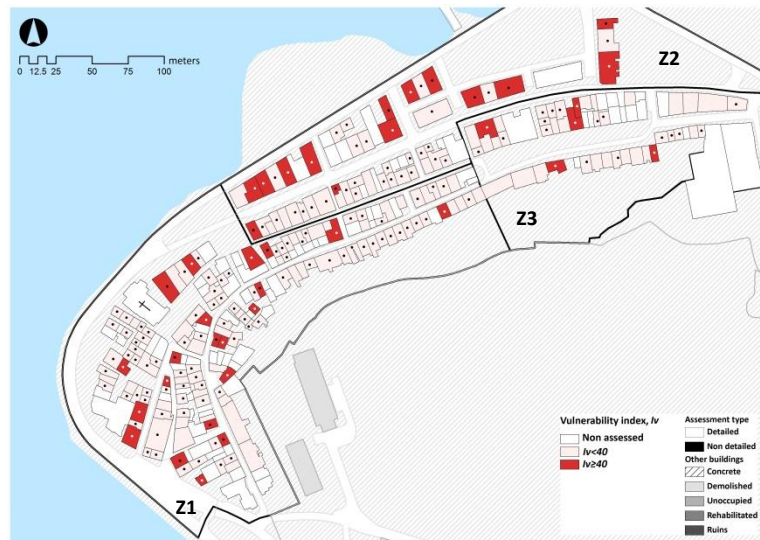
Figure 5. Identification of buildings with $I_v \geq 40$ in zones Z1, Z2 and Z3

Observing Figure 5 it is also possible to conclude that the corner and end row buildings of street blocks are in general more vulnerable due to their particular location and interaction conditions with adjacent buildings (Vicente *et al.* 2011b). For this reason, these buildings are recommended do to be reassessed with particular detail concerning eventual retrofitting or/and strengthening actions. According to the same author, it is recommended that masonry buildings with values of I_v over 45 should undergo a more detailed assessment (Pagnini *et al.* 2011).

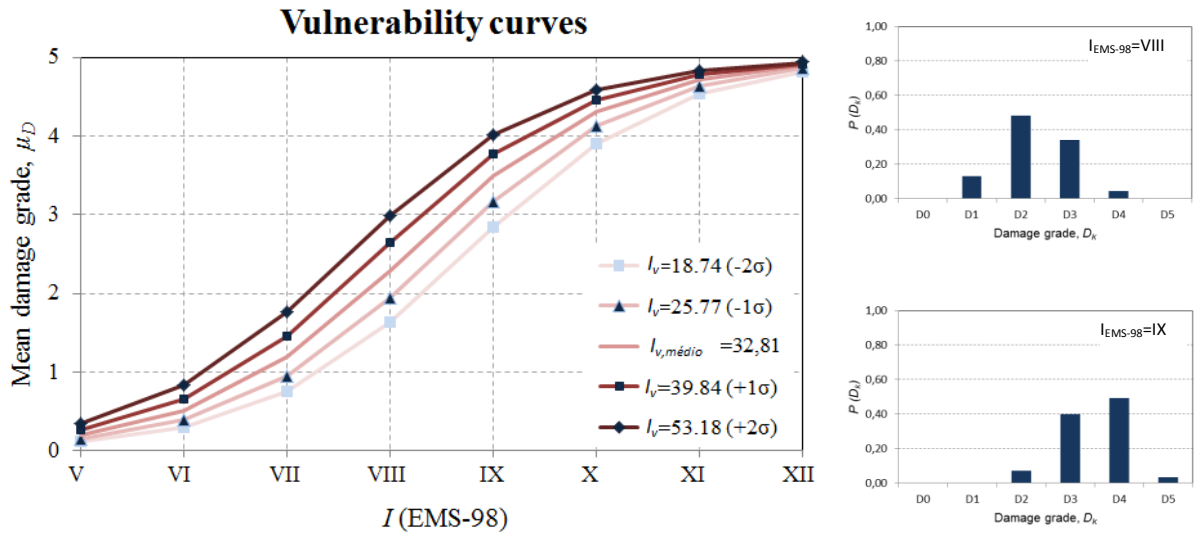
Figure 6. Vulnerability curves and mean damage grade distributions for Iv,mean=32.81

Figure 6 shows the vulnerability curves for the mean value of the vulnerability index, $I_{v,mean}$, as well as for the upper and lower bound ranges ($I_{v,mean} - 2\sigma_{Iv}$; $I_{v,mean} - 1\sigma_{Iv}$; $I_{v,mean} + 1\sigma_{Iv}$; $I_{v,mean} + 2\sigma_{Iv}$) for events of different macroseismic intensities. The same figure also presents two mean damage grade distributions, using a beta probability distribution for seismic intensities VIII and IX. The variance of the beta distribution was defined using the value of 8 for parameter t, 0 for parameter a and 5 for parameter b.
