Performance of Structures in the Andaman and Nicobar Islands (India) during the December 2004 Great Sumatra Earthquake and Indian Ocean Tsunami

C.V.R. Murty,^{a)} M.EERI, Durgesh C. Rai,^{a)} M.EERI, Sudhir K. Jain,^{a)} M.EERI, Hemant B. Kaushik,^{a)} Goutam Mondal,^{a)} and Suresh R. Dash^{a)}

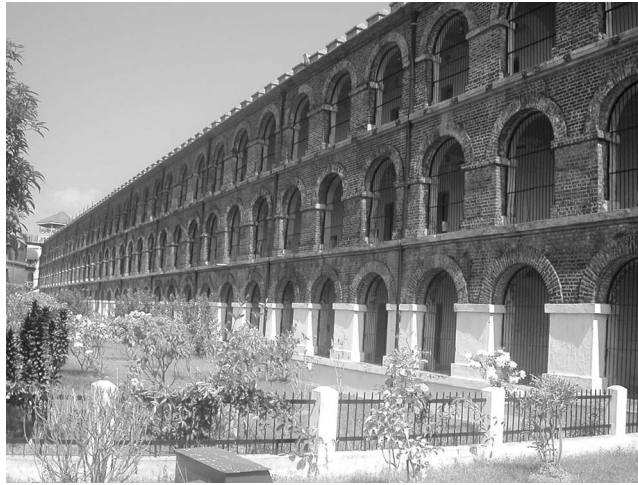
The A&N islands had several masonry buildings for residential and storage purposes, hospitals, schools, churches, jails, and so on before the severe earthquake of 26 June 1941 (magnitude 7.7). The famous masonry structure of the cellular jail was constructed in Port Blair over a period of ten years from 1896 to 1906 using solid brick masonry. The cellular jail was a huge structure, with a five-story central controlling tower and seven three-story wings containing 696 cells emanating from the central tower. The masonry used in the construction of the cellular jail was of a very high quality prevalent in India at that time (Figure 9).

Several masonry structures—including a part of the cellular jail—were damaged during the 1941 earthquake, and after independence in 1947 the Indian government declared the remaining three wings of the cellular jail a heritage structure. At present, only a few masonry structures are left in Port Blair, and these performed well during the shaking.

Figure 9. Undamaged three-story masonry structure of the cellular jail (photo: S. Jain).

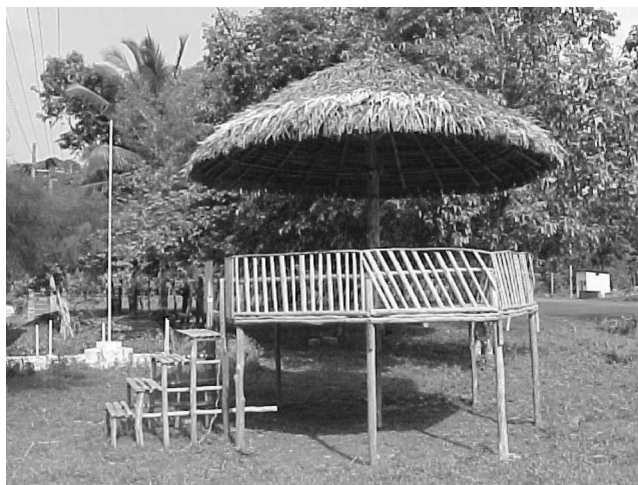
The traditional structures built by the native islanders also demonstrate an understanding of the effects of earthquake shaking on buildings. The huts made by the Sompnen tribe have a regular configuration and light mass (Figure 10). The 2-m-diameter circular structure on eight axisymmetrically placed 75-mm-diameter posts is built at an elevation of 1.4 m. The use of local material such as bamboo and thatch makes these structures the first choice for housing among the native population. Unfortunately, for many reasons, more recent migrants to the islands have chosen not to adopt these materials. These reasons include the prohibition against the use of wood in construction and

Figure 10. Typical hut built by the Sompian tribe living in the islands. This is a prototype hut built in the Army land area in Campbell Bay in Great Nicobar Island (photo: C. Murty).
