Performance of structures during the Sikkim earthquake of 14 February 2006

Hemant B. Kaushik*, Kaustubh Dasgupta, Dipti R. Sahoo and Gayatri Kharel

Performance of structures in different areas of Sikkim, during the earthquake of 14 February 2006, is reviewed. The earthquake caused damage to heritage structures as well as modern buildings. Both masonry and reinforced concrete buildings showed poor performance. On the other hand, traditionally constructed wooden houses performed extremely well. The damage seen in and around Gangtok was clearly disproportionate to the size of the earthquake, which was a moderate 5.7 on the Richter scale. This very clearly establishes the high level of seismic vulnerability of the region. The damage is primarily attributed to poor design and construction practices, and lack of quality control. Urgent need for trained human resources and for creation of a system of checks and balances, to ensure safe constructions in Sikkim is highlighted.

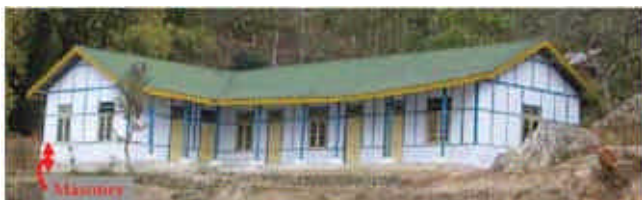
Figure 2. Traditionally constructed typical Ikra structure in Sikkim (school building at Nandok, East Sikkim).

Traditional construction in Sikkim consists mostly of typical bamboo houses, known locally as ‘Ikra’, and also known as Assam-type housing. Ikra houses are single-storey structures consisting of brick or stone masonry walls up to about 1 m above the plinth (Figure 2). This masonry supports the walls consisting of bamboo woven together with a wooden frame, and plastered with cement or mud plaster. The roof generally consists of GI sheets supported on wood/bamboo trusses, which laterally connect the parallel walls. Bamboo superstructure is connected to the masonry foundation walls using steel angles, and flats with

bolts and nails. There were no reports of any significant damages to Ikra structures during this earthquake.
