AN EMPIRICAL METHOD FOR PREDICTING DAMAGE CAUSED BY AN EARTHQUAKE TO ARTIFICIAL HOUSING SITES

Kenzo YOSHIKAWA¹, Takao ITO², Arturo B LUNA³, Akie ASADA⁴ And Yoshinobu MORI⁵

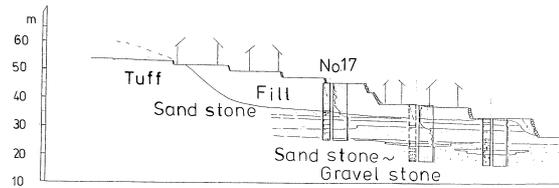
Fig.3(b) A-A' cross section

The Aramaki-Genshinden area is located in the northern section of Sendai City. Housing sites were constructed on a hillside, having an average inclination of 5 to 10 degrees from 20m to 80m above sea level from 1960 to 1962. The section underlying the rock bed was composed of loam, gravel, loose sandstone and tuff [Fig.3(b) and 3(c)]. Sites where houses received extreme damage were created using fill comprised of fractured rock. As shown in Fig.3(a), 8 houses were destroyed and 13 were partially damaged in this area. These houses were heavily damaged because they had been built on uncompacted fill. Conversely, houses built on the cut remained intact. Most of the houses built on the fill suffered severe damage due to ground fissures or collapse of masonry stone retaining walls. Housing sites were constructed by filling in the slope of the valley along Lines A-A' and B-B' to maximum depths of 10m and 8m, respectively. According to the standard penetration test, most of fill materials used registered N values between 1 and 10, as shown in Fig.3(b) and 3(c). In order to observe the long-term variation in ground movement, pipe strain meters were sunk into the ground at Points B-16, B-17 and B-17'. During the six months following the earthquake, no variation in strain was observed at these locations. Thus, no repair work was performed in the Aramaki-Genshinden housing area. As shown in Fig.3(a), locations B-17 and B-18 are in the right and left sections of Aramaki-Genshinden district, respectively. In Fig.4(a) and 4(b), variation in N values is indicated at an interval of one meter at locations B-17 and B-18 for 1978, 1986 and 1996. N values at a depth of 0 to 7m were lower in 1986 and 1996 than in 1978 at both locations B-17 and B-18. Thus, the housing ground softened during the eight years following the earthquake. Consequently, severe damage to houses seems likely to occur in the event of a similar earthquake because no preventive works were performed in Aramaki-Genshinden district.
