## THE STRENGTHENING OF AUCKLAND TOWN HALL

Trevor W ROBERTSON<sup>1</sup>

### SUMMARY

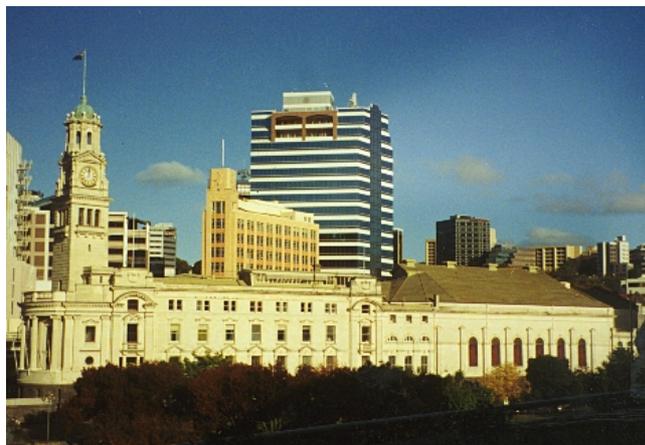
Built of unreinforced masonry, the building did not meet with current seismic strength requirements, particularly when its function as a place of assembly is considered.

**Figure 1: View of the Town Hall from the West.**

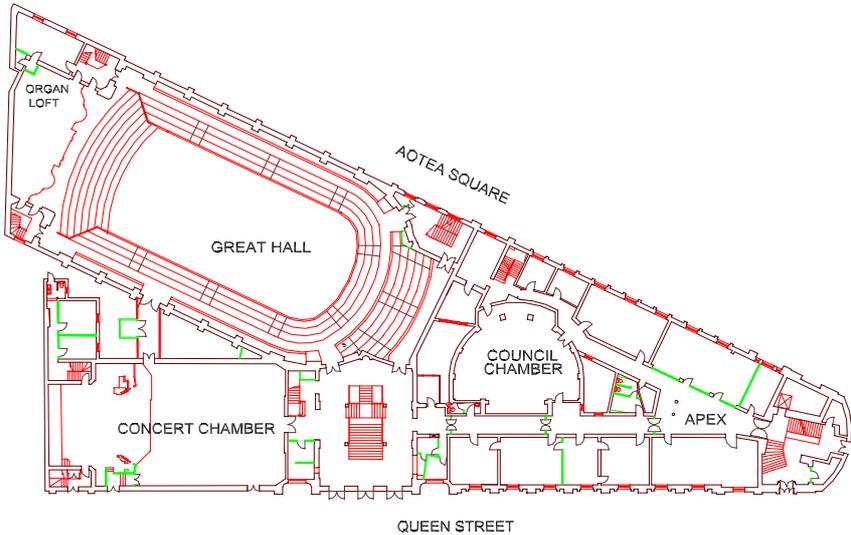
The West Elevation of the building is shown in Figure 1. The general form can be ascertained from Figure 2 which shows the floor plan at the Queen Street level. The building is wedge shaped in plan and divided into four main zones. These are identified as: the Great Hall, the Concert Chamber, the Apex (which houses the office area and Council Chamber) and the Prow, which includes and supports the clock tower at the north end of the building.

**Figure 2: Original Level G Floor Plan. (one level up)**

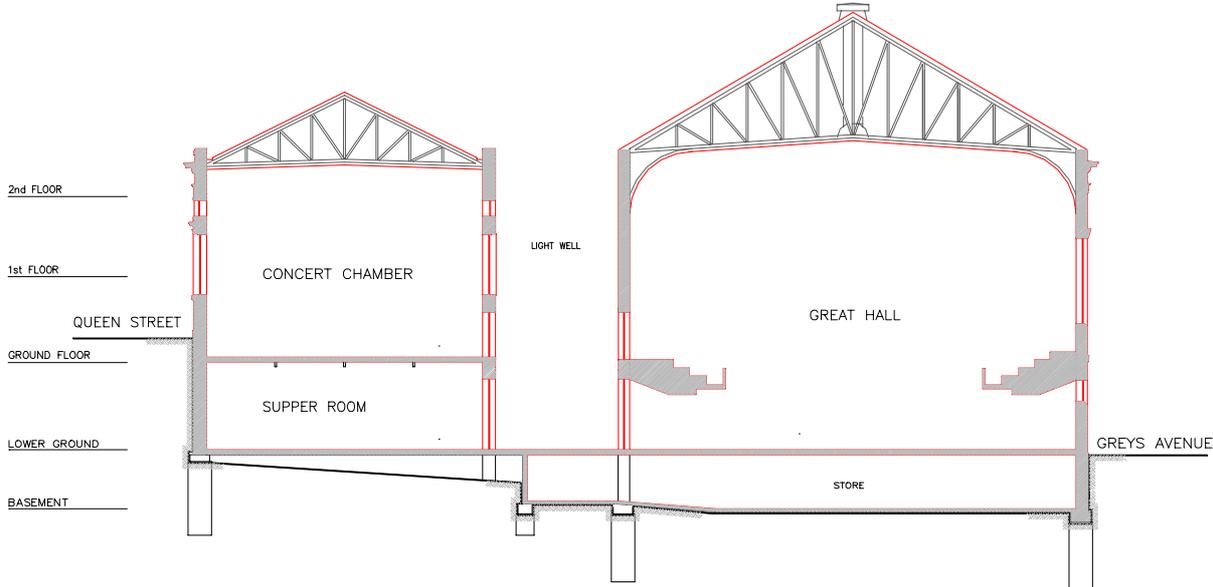
**Figure 3: Cross Section Through Great Hall and Concert Chamber**

The Great Hall, however, is a single volume space over all four levels, but also with a partial basement to the south. The Concert Chamber is significantly smaller with its auditorium floor one storey up, level with Queen Street. The Apex is well compartmented by internal walls but the cross walls have a slender aspect ratio due to the presence of two longitudinal corridors on each level.

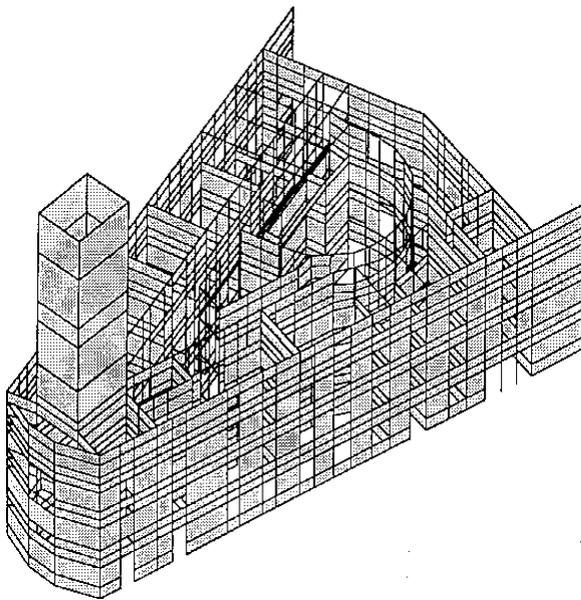
The northern Apex analysis model included the Tower, in order to model the distribution of its seismic reactions below roofline. The eccentricity of the Tower meant that modelling the flexibility of the diaphragms was particularly important otherwise, with stiff diaphragms, the Tower reactions would be analysed as distributed over a far wider distance than reality. All significant openings such as windows and doors were included in the model, as was the double storey height Council Chamber. Figure 5 shows the Apex model. (Floors and diaphragms not shown).

**Figure 5: Apex ETABS Model**

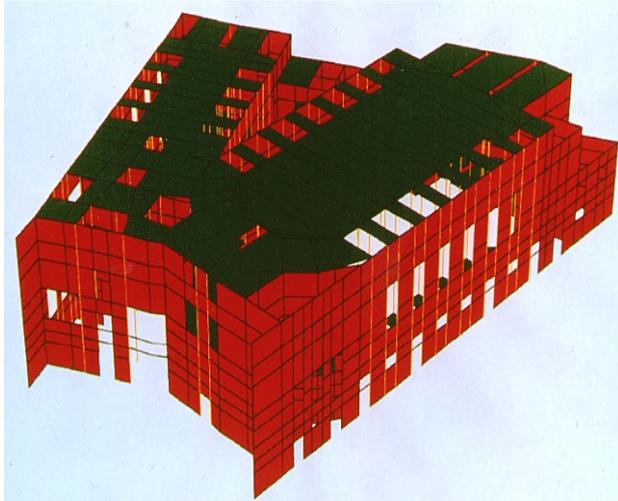
Quite significant interaction between the halls was expected at their common wall and this was confirmed by the analysis. Figure 6 shows the ETABS model for the halls, showing also the flexible floor layout at ceiling level. The diaphragm "patches" are not shown but fill the spaces between the floors.

**Figure 6: Halls ETABS Model, showing flexible “floor” panels with cut outs for mass locating diaphragms**
