## TESTING OF DAMAGED STEEL MOMENT CONNECTIONS

Four welded, beam to column, moment connections were taken from a two story building which was severely damaged during the Northridge earthquake (1994). All connections contained cracks which started in the weld at the bottom beam flange and propagated across the column flange into the column panel zone. The test specimens were tested in the "as received" condition to evaluate their residual strength and deformation capacity. They were then repaired in the laboratory and retested to evaluate the effectiveness of the repair procedure. A new "benchmark" specimen was fabricated and tested to serve as a basis of comparison.

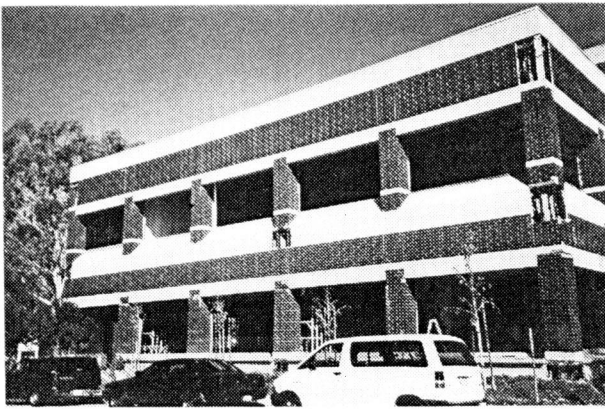
The building, shown in Fig. 1, is a two-story office building which was constructed in 1991 and is located about thirteen miles north of the epicenter. Lateral resistance was provided by single bay, ductile steel moment frames on each of the four sides of the approximately square structure. Following the earthquake, it was immediately "red tagged" as being unsafe for occupancy. Field observations indicated that it was out of plumb by four inches to the south and west with three inches of this displacement occurring in the first story. In order to inspect the moment connections, it was necessary to remove the architectural finish on the exterior of the building. Once this was done it was found that nearly all of these connections at the second floor level had major cracks which appeared to start in the weld at the lower beam flange and extend through the adjacent column flange and in many cases into the column panel zone as shown in Fig. 2.

Fig. 1 Two Story Building

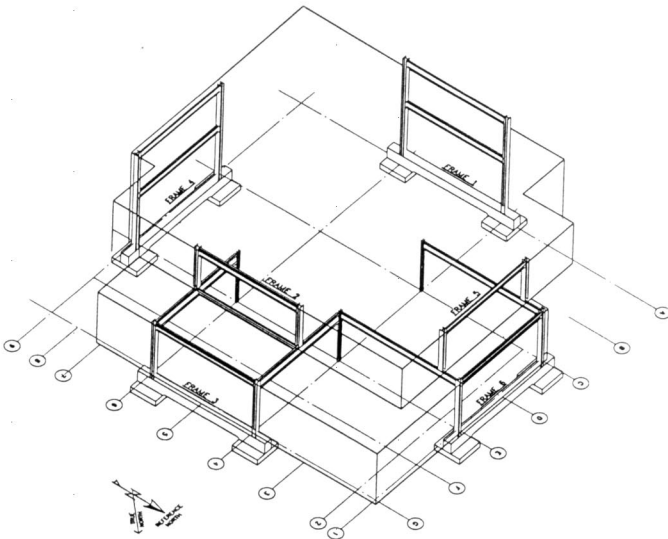
Fig. 5. Lateral Force Framing

Demolition of the building began in December, 1994. The four moment connections at the second floor level were obtained from the moment frames on the west and south sides of the building, Fig. 5. The columns were flame cut five feet above and below the beam flanges and the beam was flame cut eight feet from the column face. These "rough cut" specimens were transported to a local fabricator for cleanup and addition of end plates. The dimensions of the finished test specimen are given in Fig. 6. All columns are W14x132. Two specimens (#3 and #4) use W24x76 beams and two specimens (#1 and #2) use W27x96 beams. The steel was specified as A36, however, tests on coupon samples taken from the specimens indicate the yield stress is approximately 47.5 ksi.

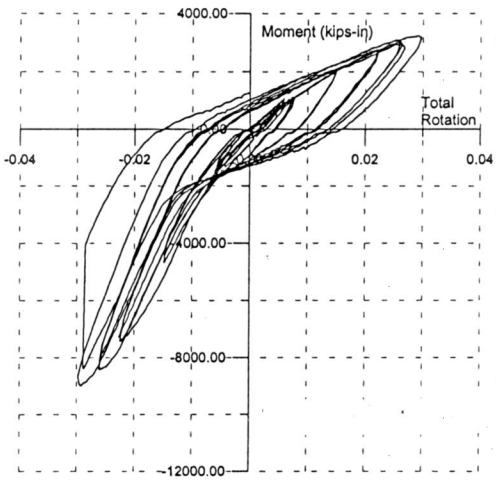
A picture of the panel zone is shown in Fig. 7. The hysteretic behavior is shown in Fig. 8, where it can be seen that the behavior remains quite stable up the crack in the top flange weld. With the application of positive load, the cracks are opening and with negative load they are closing. This action accounts for the lack of symmetry in the hysteresis loops generated by all specimens tested in the "as received" condition. The moment versus rotation curve indicates that the specimen was able to reach a positive moment of 4000 inch-kips and a negative moment of 8000 inch-kips compared to the plastic moment capacity of 9440 inch-kips based on the actual yield stress.

Fig. 8. Hysteretic Behavior, #4

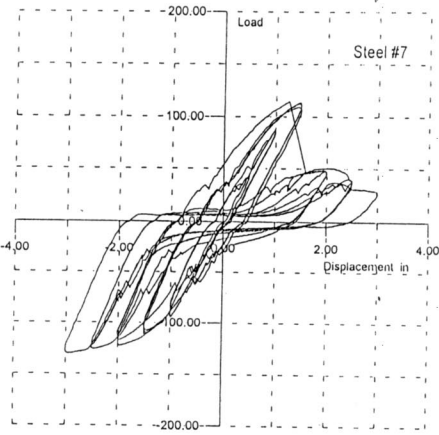
The test proceeded in a normal manner to a displacement amplitude of two inches at which point the specimen failed abruptly on the up stroke by a pull out of the bottom beam flange from the column flange. Rather than stop the test, it was continued under displacement control for six additional cycles. The hysteresis curve, shown in Fig. 9, indicates that at the time of pullout, the load drops from over 100 kips to a new equilibrium state just under 50 kips and the tip displacement continues increasing out to the controlled two inch displacement. With reversal of load, the specimen begins following a new hysteresis curve which is very similar to that obtained for the specimens in the "as received" condition. The test was stopped due to degradation of the bolted shear tab, Fig. 10.

Fig. 9. Hysteretic Behavior, #5

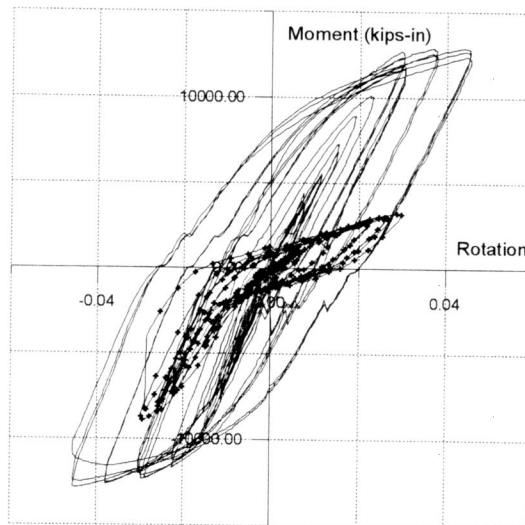
The repaired specimen performed very well on retesting. The specimen sustained nine cycles of loading with the last three cycles at a displacement amplitude of 3 inches (4.5% total rotation). The hysteresis loops of load versus displacement are shown in Fig. 12 along with the similar curve for the specimen in the "as received" condition. It can be seen that the repair has been very effective in restoring the original stiffness, increasing the moment capacity and increasing the rotation capacity.

Fig. 12. Hysteretic Behavior Initial vs. Repaired

Due to the crack across the column face at the level of the bottom beam flange, it was necessary to remove a section of the column flange and replace it with a new plate, a technique known as "flange replacement". The crack in the top beam flange which occurred during the initial tests also had to be removed. The crack in the panel zone was ground out with a stopper hole placed at the tip of the crack. Rectangular flange plates having the same thickness as the beam flange, were added to both the top and bottom beam flanges with fillet welds on three sides and a full penetration groove weld to the column flange. The shear tab, loosened during the initial testing, was welded on three sides to the beam web using fillet welds. The repaired specimen is shown in Fig. 11.
