CLEAVAGE SHEAR EXPLOSION OF REINFORCED CONCRETE SHORT COLUMNS
BROKEN DOWN BUILDINGS AND THE HANSHIN-EXPRESS HIGHWAYS
AT THE RECENT HANSHIN-AWAJI-EARTHQUAKE IN JAPAN ON THE 17. JAN. 1995

M. YAMADA

Department of Architecture, Faculty of Engineering,
Kansai University, Yamate-cho, 3-3-35
(564) Suita-City, Osaka, Japan

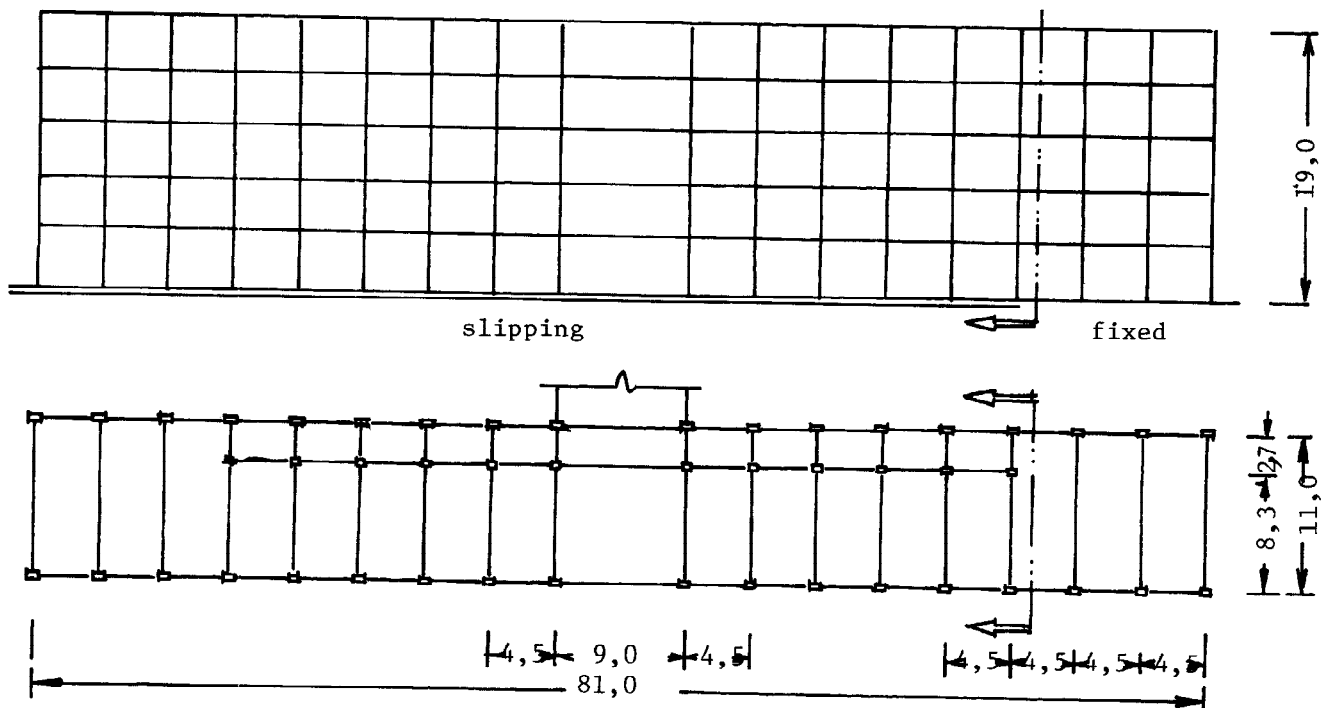
Fig. 3. Plan and elevation of the Nishinomiya City High School

At the first earthquake shock to the eastwards in the ground, the whole building was pushed to the westwards. The east two bays of the building were fixed at the stiff bank of the former pond. On the contrary, the main part of this building with 14 bays in the western side was sliding to the westwards by the liquifaction at the liquifacted layer under 3 m. Then the columns in the first and second story were sheared off, which remain after shock very clearly as shear crack pattern diagonally from east upper to west lower. Especially the 6 columns in the first story in the two bays at the east end were sheared off instantaneously by the huge horizontal pulling force of main western building to westwards such as illustrated in Fig. 2.-(2) like the fracture process state (2) by the stiff fixing action of their basis. By the pulling of main western side building part to westwards, the third bay was stretched out and the elongation of the span reaches over 10 cm at the base beam.

By the dead weight of the upper part of about 620 t of the two bays of east end, of which area is about 100 m², might fall down like the fracture state (3) in Fig. 2.-(3).

At the falling down process of the east two bays, the third bay might be pulled down at the east end. Then the neighbouring columns at the west end of this bay were pulled by east neighbouring column to east downwards. It was formed shear cracks of opposite direction i.e. west upper to east lower such as illustrated in the fracture process state (4) and clearly recognized in the Photo. 6. (left hand side column).
