CASE STUDIES OF THE PERFORMANCE OF RETROFITTED BUILDINGS DURING THE 1994 NORTHRIDGE EARTHQUAKE

MARTIN W. JOHNSON AND HENRI KOZA
EQE International, Inc.
18101 Von Karman Avenue, Suite 400
Irvine, California 92715

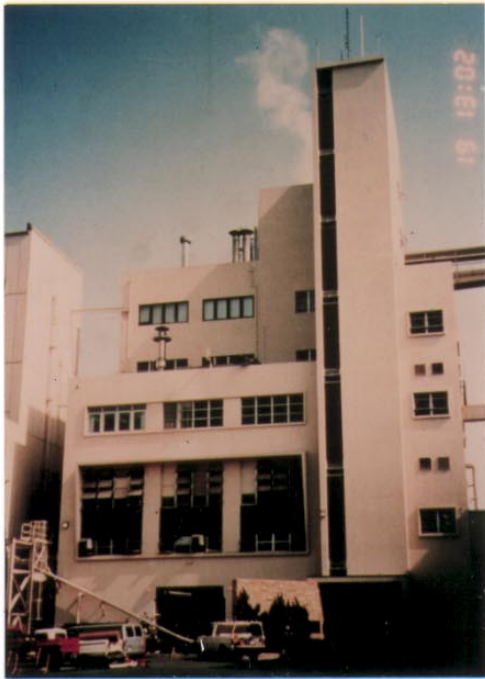
Figure 2: Elevation of the Industrial Building In Van Nuys Before Retrofit

After the initial building analysis was conducted, the building was retrofitted by EQE in 1989 to a level of seismic strength and safety intended by current codes, and within the owner's objective for operability following a significant seismic event. Figures 2 and 3 show the subject building before and after the structural seismic retrofit. Note that openings were infilled in the upper floors, and while not apparent from the photograph, walls at the lowest level in line with the infilled walls above were also thickened.

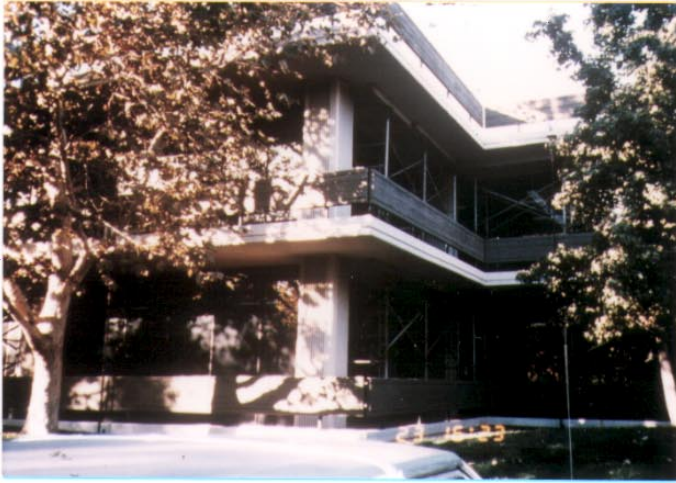
Figure 5. View of Building Exterior

This building is located on West Valencia Boulevard, in Santa Clarita, California. It is a two-story, concrete frame structure, with a footprint of approximately 132 feet by 252 feet in plan, with a total height of 24 feet. The building has a long, narrow skylight/atrium opening penetrating the long axis of both the roof and second floor levels. A photograph of the building exterior is shown in Figure 5.

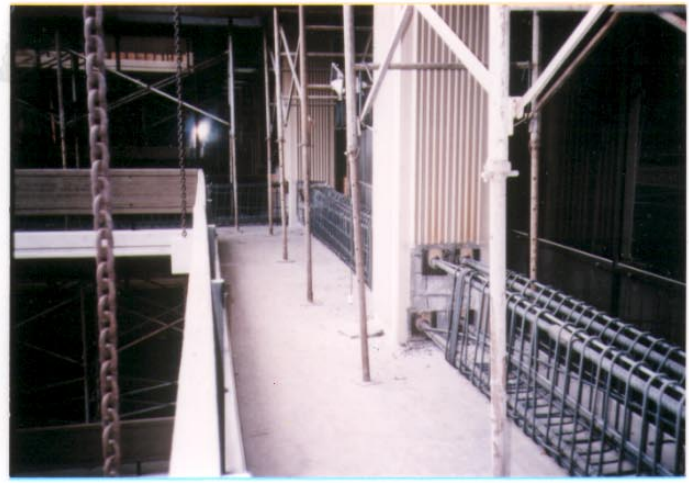
Figure 6. Beam and Joint Reinforcing at Second Level

Figure 6 shows the typical beam and beam-to-column joint reinforcing at the second level (similar for the roof level), and Figure 7 shows the finished beams at the second level, which blend well with the existing architectural features of the building.
