AN INVESTIGATION OF THE EARTHQUAKE EFFECTS ON ARTICULATED BRIDGES LOCATED ON FAULT RUPTURES

Turel GUR¹ and Mete A. SOZEN²

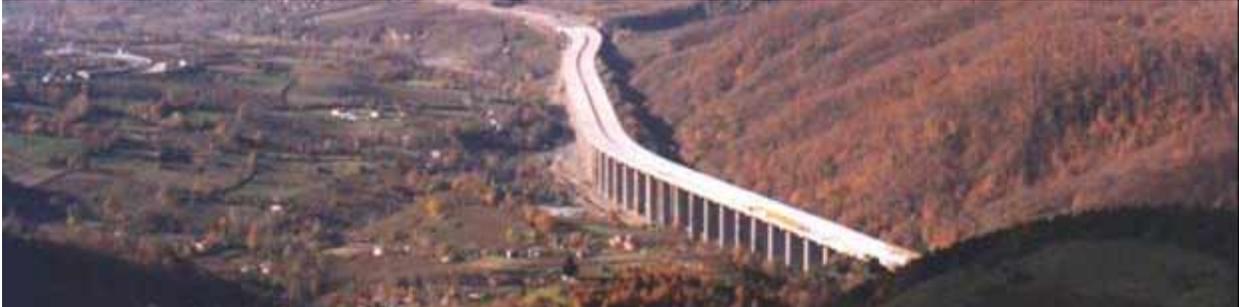
Figure 2. The Bolu Viaduct

In addition to the other examples of the bridges on fault ruptures mentioned above, the Bolu Viaduct in Turkey (Fig.2) was crossed by the surface rupture of the 1999 Duzce earthquake. The viaduct, which was not yet open to the traffic, was affected by the Marmara earthquake, as well. The positions of the girders and the piers were surveyed in detail before and after the earthquakes. The 2.3-km viaduct comprises two parallel carriageways. The piers, located at every 39.2 m, are supported by 20-30 m deep pile groups composed of 12 reinforced concrete drilled piles (Fig. 3a and 3b). Except at the ends of the viaduct, the piers range in height

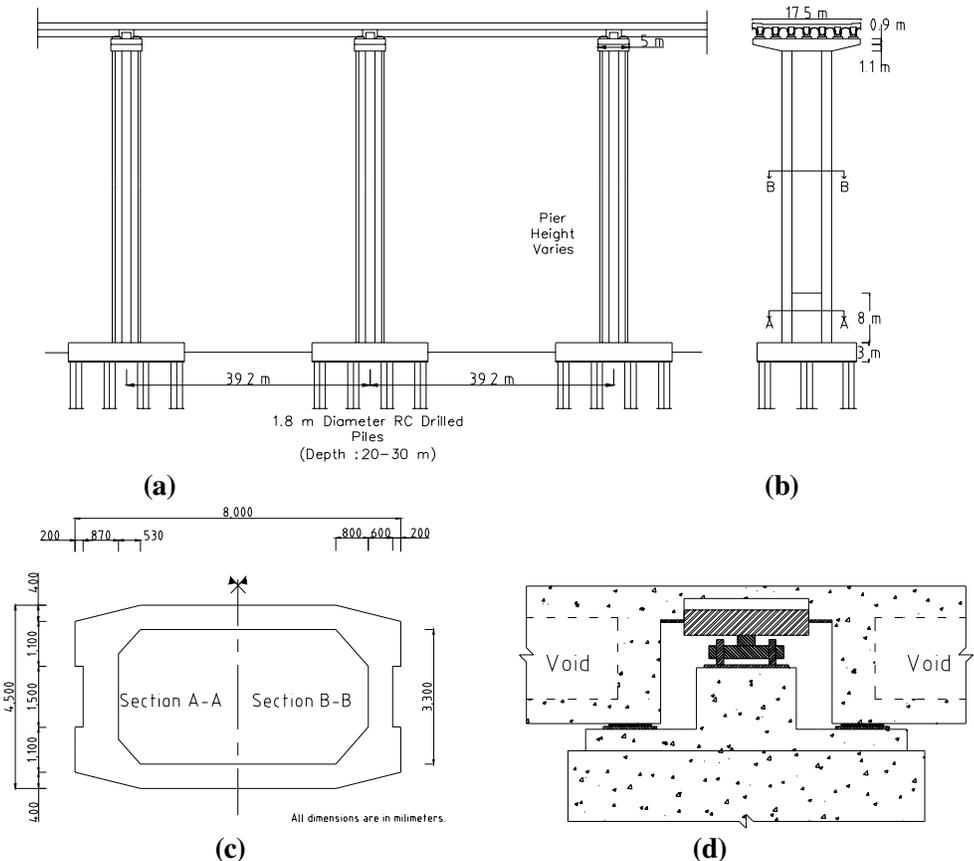
Figure 3. Dimensions and details of the Bolu Viaduct. a) Side view, b) Transverse direction c) Pier cross sections, d) Side view of the joint between the deck and piers

from 44 to 49 m. The piers have cast-in-place hollow sections (Fig. 3c). There are seven precast and pretensioned girders in each span of each carriageway. The girders rest on free sliding bearings. The slab was cast continuously with an expansion joint every tenth span. The deck is connected to each pier through energy-dissipating units (EDU) that permit a maximum relative movement of 0.48 m between the deck and the pier (Fig. 3d).

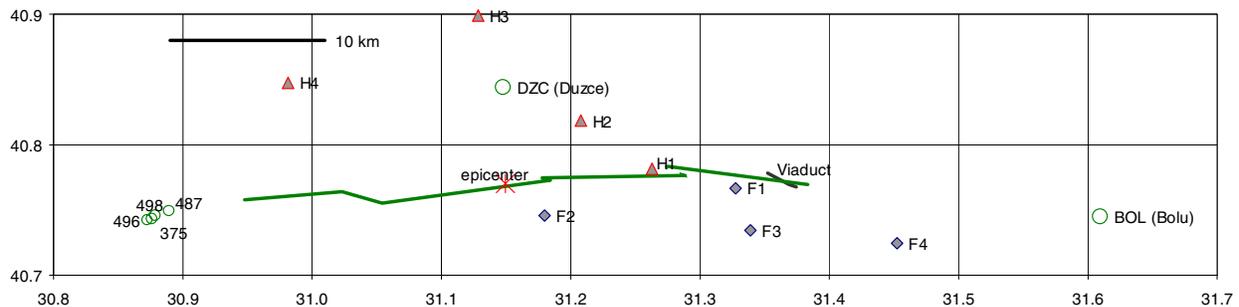
Figure 4. The surface rupture of the Duzce earthquake. Triangles and diamonds indicate the locations of the GPS stations. Circles show the location of the strong motion stations.

The permanent strong motion stations at Duzce (DZC) and Bolu (BOL) recorded the motion. In addition, there were other records obtained by 12 temporary stations near Karadere installed for the aftershocks at the end region of the Marmara earthquake fault. Six of the stations (stations DZC, BOL, 375, 487, 496 and 498) recorded horizontal accelerations exceeding 30% of the gravitational acceleration and the approximate locations of these stations are shown in Fig. 4. The highest horizontal acceleration of 10 m/s² was recorded at station 496.

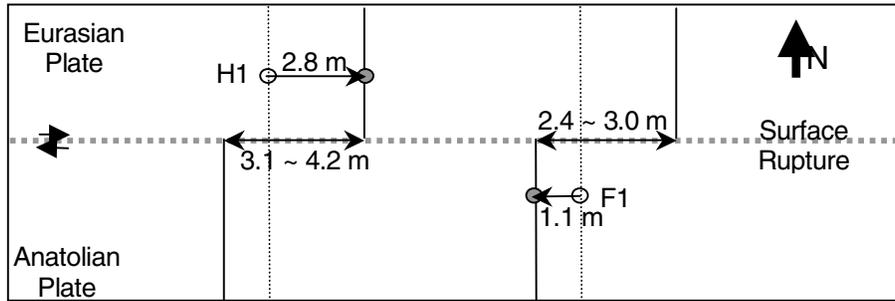
- Stations H1 and H2 drifted 2.8 and 1.7 m toward east, respectively. The slip at the fault in this region was observed to be between 3.1 and 4.2 m. Station H1 is very close to the surface trace whereas station H2 is located 4 km away. It can be inferred that most of the right-lateral movement occurred in the northern plate in this region (Fig. 5). It is also interesting to note that the displacement measured 4 km away from the surface trace is approximately half the displacement observed right at the trace.
- The westward movement at Station F1 was 1.1 m (Fig. 5). The slip observed near station F1 was in the range of 2.4 to 3.0 m. The contribution of the movement of the southern plate to the overall slip

should be less than that of the northern plate. It can be concluded that the ratio of the movement of the northern plate to that of the southern plate is approximately 2.

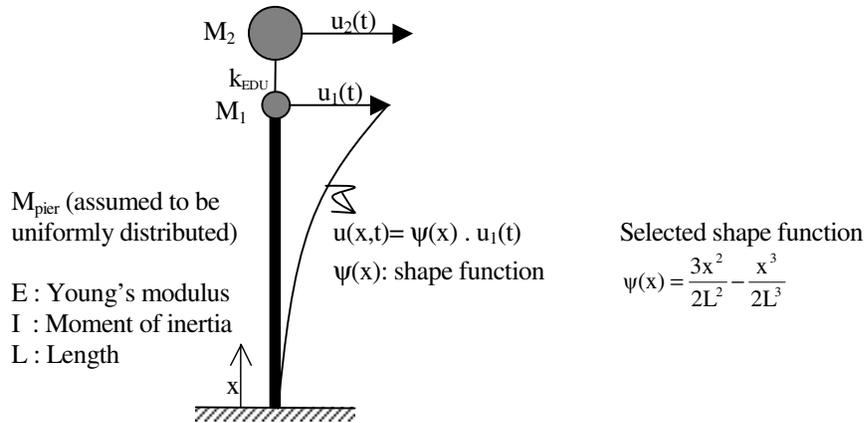
Figure 9. Simplified model of the viaduct for ground shaking

The simplified model of the viaduct (Fig. 9) comprised two nonlinear springs in series. One represented the pier with its mass distributed along its height. The other represented the EDU seated on the pier. The moment of inertia of the pier is 102 m^4 in the transverse direction and 37 m^4 in the longitudinal direction. The mass of the deck was attached to the spring representing the EDU. Another mass representing the mass of the pier cap was lumped at the end of the pier. The masses of the deck, the pier and the pier cap in the model were estimated to be 1540, 1830 and 160 tons, respectively. The elasticity modulus of concrete was taken to be 28 000 MPa. The equations of motion were derived by assuming a shape function for the bending of the pier and solved by using a step-by-step iterative procedure [7]. The critical damping ratio is equal to 0.02 in the analyses.

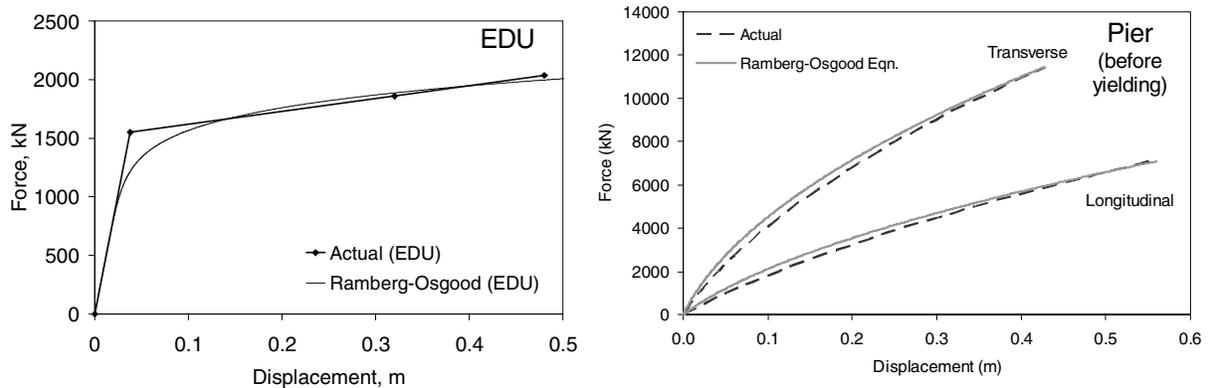
Figure 10. The force-displacement characteristics of the members

deformation function defined by Ramberg and Osgood [8] was used in this study. Figure 10 shows the “actual” and the fitted force-displacement relationships of the members in comparison. The actual force-displacement curve of EDU was based on its mechanical properties reported by Marionni [4] whereas the force-displacement curve of the pier was based on the moment-curvature relationship at its bottom section. The reinforcement layout and the material strength provided in the design drawings were used in the calculations. The longitudinal reinforcement ratio at the base of the pier was 2.4%. The steel type was indicated as St50 on the drawings. The design strength of concrete is specified to be 35 MPa. After moment-curvature diagram is obtained, the coordinates of each point on the curve is transformed into force and displacement values by assuming a plastic-hinge length equal to the depth of the section.

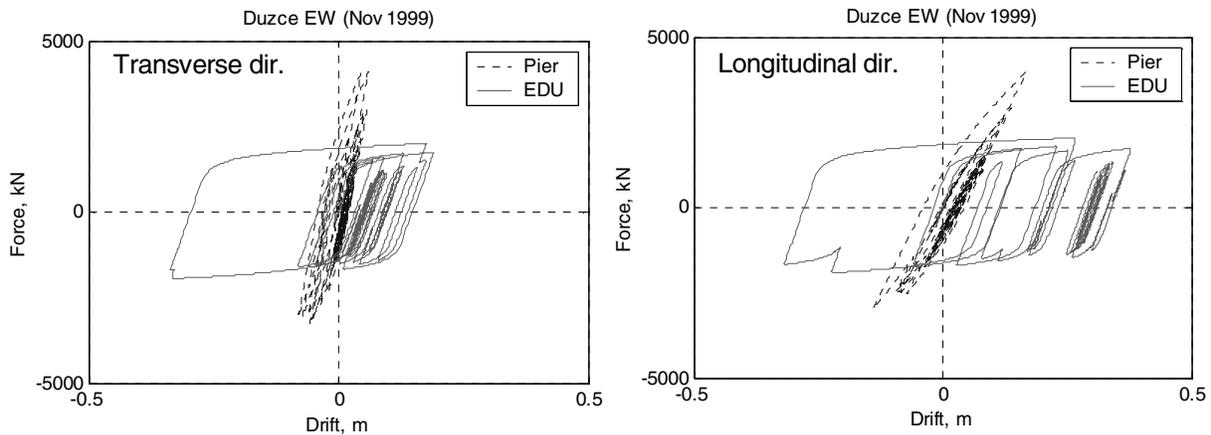
Figure 11. The hysteresis curves of the elements in the analysis with record DZC-EW (Nov.)

The east-west component of the DZC record of the November 1999 earthquake (PGA = 0.51g) created the highest displacement demand on the members (Fig. 11). The other records of the same earthquake such as BOL (PGA = 0.8g), 496 (PGA = 1.0g) and 375 (PGA = 0.8g) did not force the structure over the limits foreseen in its design which is 0.32 m. The observed relative movement of the girders in the longitudinal direction exceeded 1 m at some piers. However, the maximum calculated response in the analyses stayed within the 0.5-m displacement capacity of the EDU.

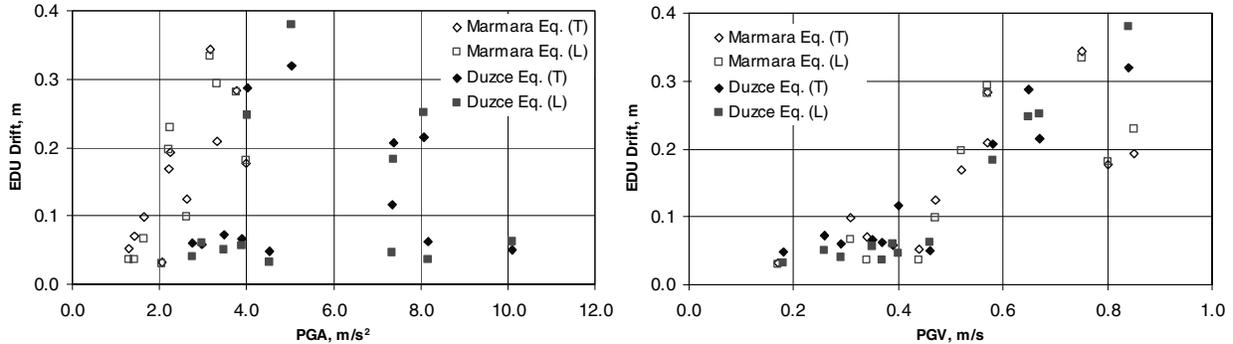
Figure 12. The correlation of the maximum EDU drift with the PGA and PGV of the records

The results of the analyses showed that the maximum EDU response is not proportional to the PGA of the input ground motion. The graphical presentation of the maximum EDU drifts and the peak ground accelerations in Fig. 12 reveals the scatter in the results more clearly. A better correlation was observed between the maximum response of EDU and the PGV of the selected ground motions.

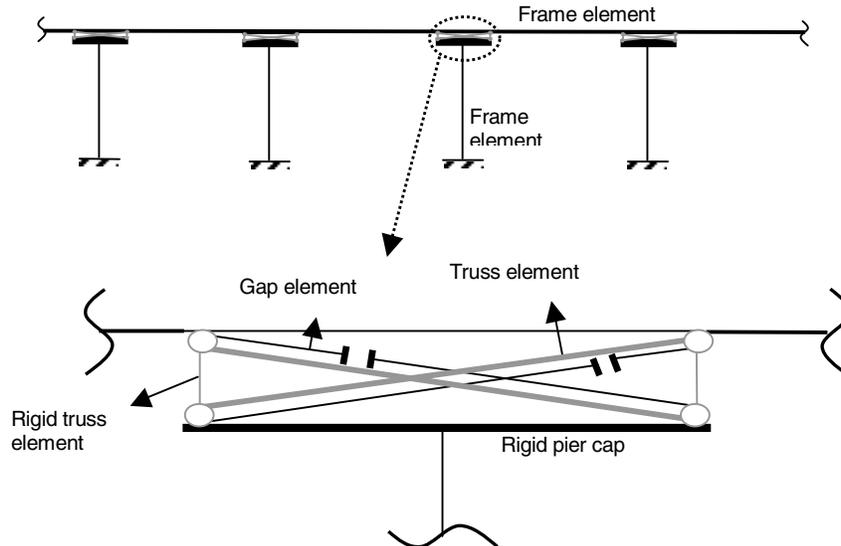
Figure 13. The elements of the model of the viaduct for ground deformation analyses

The piers were represented by elastic frame elements with two plastic springs at the ends. The mass of each pier element was distributed to the nodes along the height. The plastic hinge properties were based on the moment-curvature of the base section of the piers. The pier caps were represented by two rigid-frame elements placed on top of each pier horizontally as shown in Fig. 13. Its mass was distributed to the far ends.

In the observed state of the structure after the earthquake, the amount of relative movement between girders and pier cap was high enough not only to close the 0.5-m gap between center girders and plinths but also to break the plinths. The initial gap between the girders and the plinth is approximately equal to the displacement capacity of the EDU's. Therefore, the EDU's must have failed at the instant of contact between plinths and girders. The effect of the shear failure of the plinths on the response was included in the model by introducing the diagonal gap elements placed as shown in Fig. 13. The lateral stiffness of the plinths was calculated to be 14E6 kN/m by combining its flexural, shear and slip characteristics as proposed by Sozen and Moehle [11]. The calculation of the shear strength of the plinths was based on the shear-friction formula in ACI 318-02 [12].

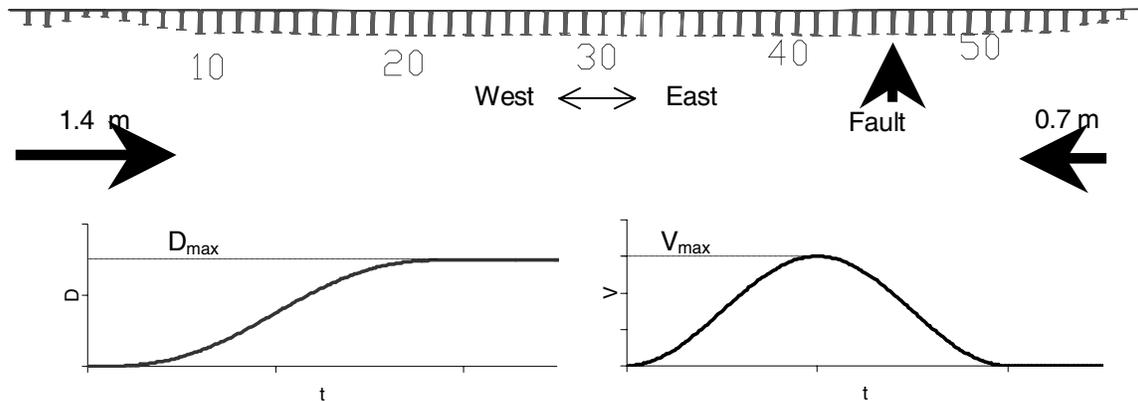
Figure 14. Movement at the abutments

In all the analyses, the maximum ground movement was set at 1.4 m at the west abutment and 0.7 m at the east abutment (Fig.14). The maximum ground velocity at the site is not a measured quantity or cannot be inferred from any other evidence at or near the site of the viaduct. Therefore, it was changed within a range of 0.75 m/s to 3 m/s to investigate its effect on the structural response. The amplitude of the movement was scaled for each pier on the same side of the fault. The duration of the movement for each pier was equal to the duration of the movement of the abutment moving in the same direction with that pier. There was no phase lag between the movements of the piers or the abutments in the analyses.
