## ANALYSIS OF THE CUT AND COVER TUNNELS DAMAGED IN THE SOUTH-HYOGO EARTHQUAKE OF 1995

Seiji NISHIYAMA<sup>1</sup>, Itsuo KAWAMA<sup>2</sup>, Hiroshi HAYA<sup>3</sup>

### SUMMARY

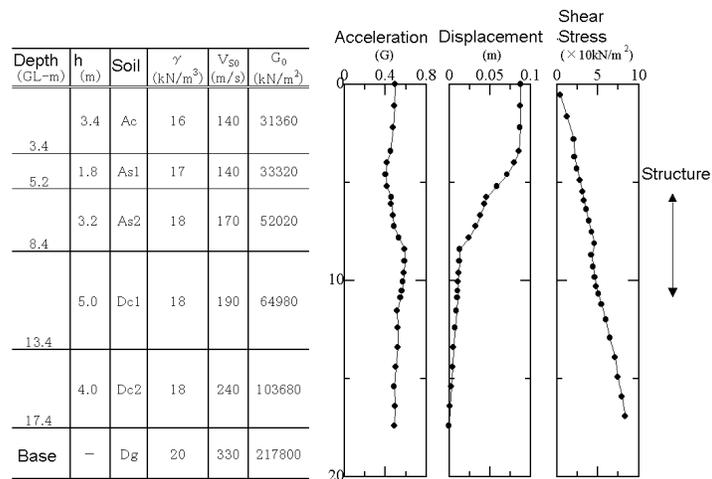
**Fig.4 Soil properties and response of ground (Daikai station and Turnout part)**

The soil profile and the material properties at Daikai station site are shown in Fig.4. The dynamic analysis of free field was carried out. Fig.4 shows the distribution of ground response at the time when the relative displacement between ceiling and bottom slab is the maximum (4.1cm).

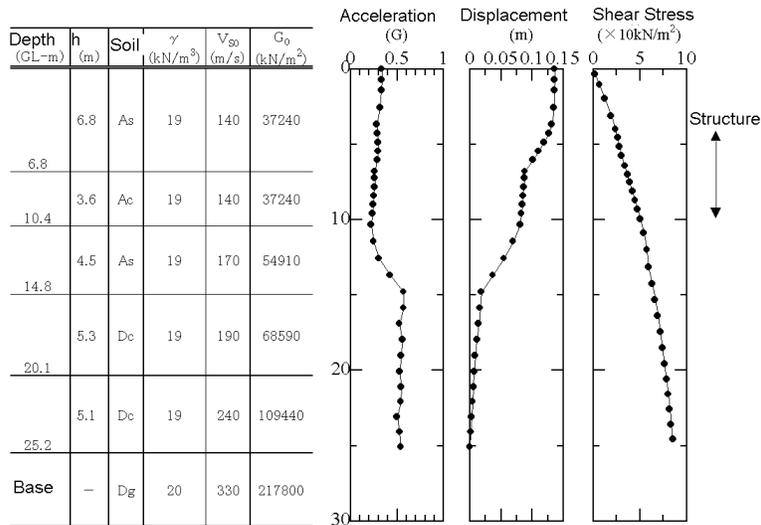
**Fig.7 Soil properties and response of ground (general part D3)**

The soil profile and the material properties at general part D3 for double tracks is shown in Fig.2 and Fig.7. The shear wave velocities were set according to the investigation at Daikai station site. Input motion for the dynamic analysis of free-field ground was the same with that used in Daikai station. Fig.7 shows the distribution of ground response at the time when the relative displacement between ceiling and bottom slab is the maximum. The maximum relative displacement was 5.4cm.

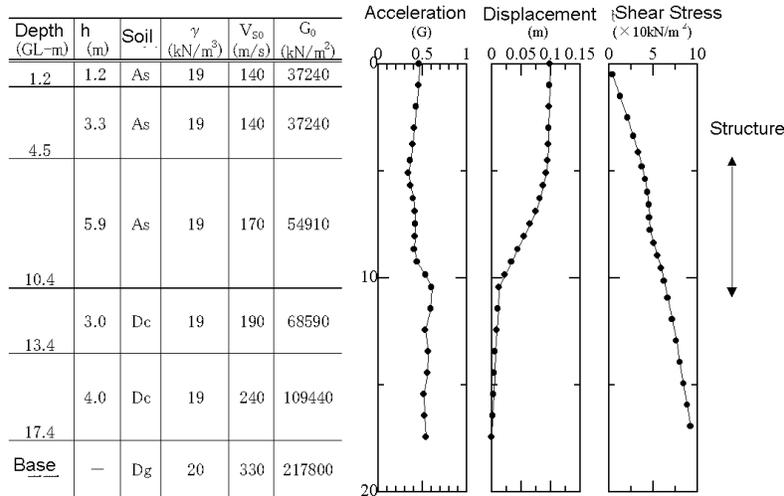
**Fig.9 Soil properties and response of ground (general part D4)**

The soil profile and the material properties at general part D4 for double tracks is shown in Fig.9. The shear wave velocities were set with the same procedure as that of D3 site.

Input motion for the dynamic analysis of free-field ground was also same with that used in Daikai station. Fig.9 shows the distribution of ground response at the time when the relative displacement between ceiling and bottom slab is the maximum. The maximum relative displacement was 8.6cm.
