## **EVALUATION OF HOUSING LOSSES IN RECENT EARTHQUAKES IN LATIN AMERICA**

**Mario RODRÍGUEZ<sup>1</sup> and Marcial BLONDET<sup>2</sup>**

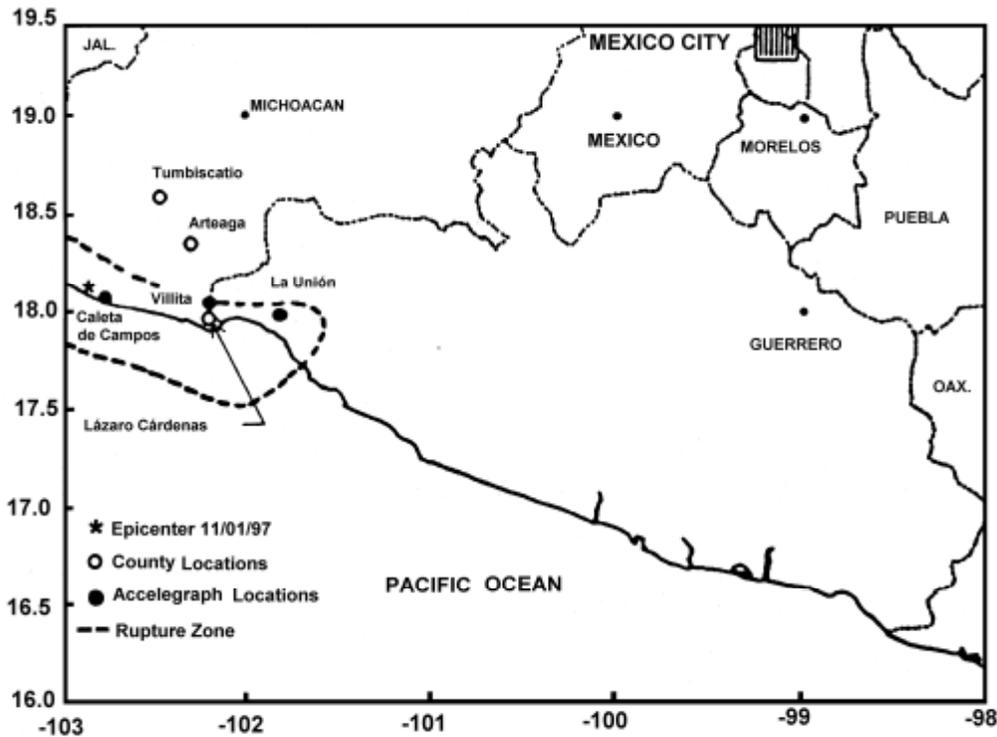
**Figure 1. Epicenter and station locations in the 1985 Michoacan and 1997 Caleta de Campos Earthquakes**

Rodriguez et al. (1998) have also studied the statistics of observed damage during the CC97 in masonry dwellings the towns of Arteaga, Lazaro Cardenas and Tumbiscatio, located in the Michoacan area, near the epicenter of the earthquake (Figure 1). Unconfined masonry dwellings suffered considerable damage, much higher than that observed during MI85 in the same area, particularly with a high rate of damage in adobe dwellings. These results are surprising because the 1985 event has a magnitude  $M_S = 8.1$ , much higher than that of the 1997 event,  $M_S = 7.1$ . This suggests that intraplate earthquakes are more damaging to masonry structures than interplate events with higher magnitudes.

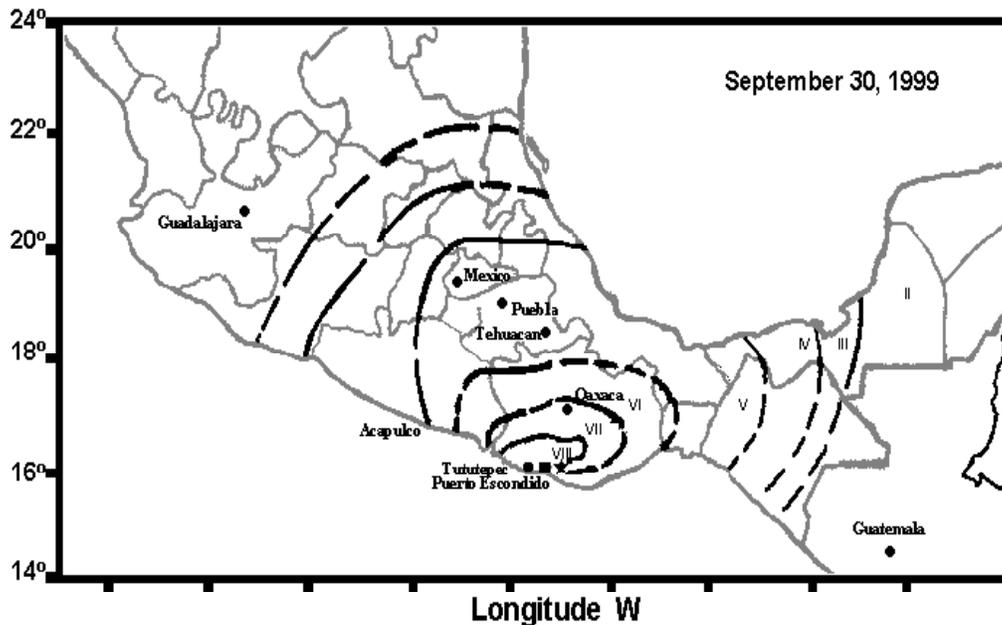
Another Mexican earthquake that is interesting from the point of view of the seismic behavior of masonry dwellings is the 1999 Oaxaca earthquake. Figure 2 shows the epicentral location in the Pacific coast and the distribution of Mercalli intensities of this event. The earthquake has been classified as normal-faulting intraplate type (Singh et al., 2000). According to some statistics of the observed damage in the state of Oaxaca, the earthquake affected more than 41,000 dwellings, mostly made of unconfined masonry or adobe. For example, in the town of San Pedro Tututepec in the Pacific coast near the epicenter, 3,000 dwellings collapsed and 3,200 experienced some degree of damage (Singh et al., 2000).

**Figure 2. Epicenter and isoseismic maps of the Oaxaca earthquake of 30 September 1999**

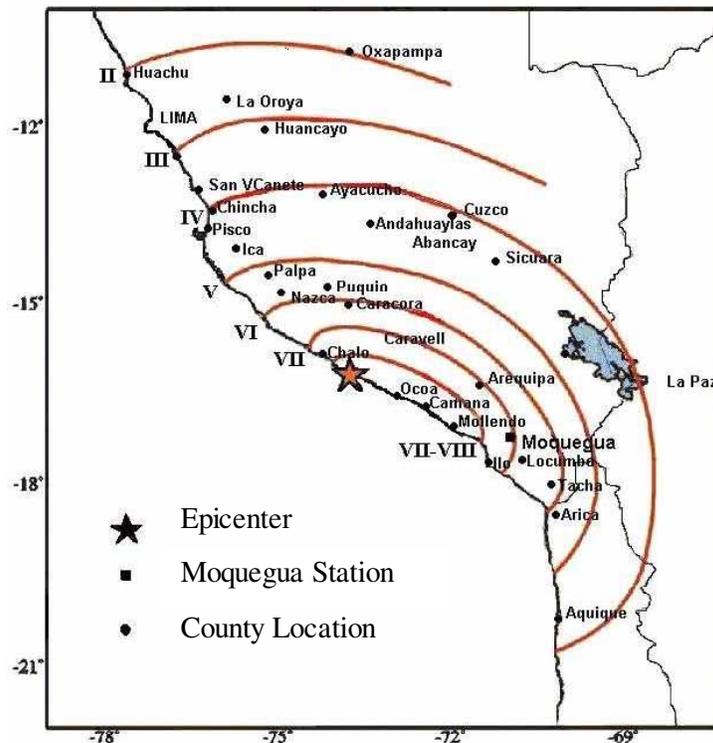
Figure 3. Epicenter and isoseismic map of the Arequipa, Peru earthquake of 23 June 2001

Damage levels in masonry dwellings in towns near the epicenter, such as in Ocoña, were lower than those observed in the city of Moquegua or even in Tacna, a city at the border with Chile, see Figure 3. (PEER, 2002). This paper presents only the observed damage in dwellings in the city of Moquegua, with respect to the ground motion recorded in that city. This city was the most affected by the earthquake (Lermo et al., 2002). There was a high rate of damage and collapse in adobe construction, including colonial buildings over 100 years old. Brick construction without seismic resisting details or built without proper construction procedures also suffered considerable damage (Muñoz and Tinman, 2001; Lermo et al., 2002; PEER, 2002). It has been mentioned that the damage to structures in Moquegua caused by this earthquake was enhanced by site effects, particularly due to recent developments of the city (Lermo et al., 2002).
