SEISMIC VULNERABILITY OF CUZCO CATHEDRAL, PERU

**Ricardo PROAÑO¹, Miguel TORRES², Carlos ZAVALA³, Zenón AGUILAR⁴,
Jorge OLARTE⁵, Hugo SCALETTI⁶, Martín RODRIGUEZ⁷**

SUMMARY

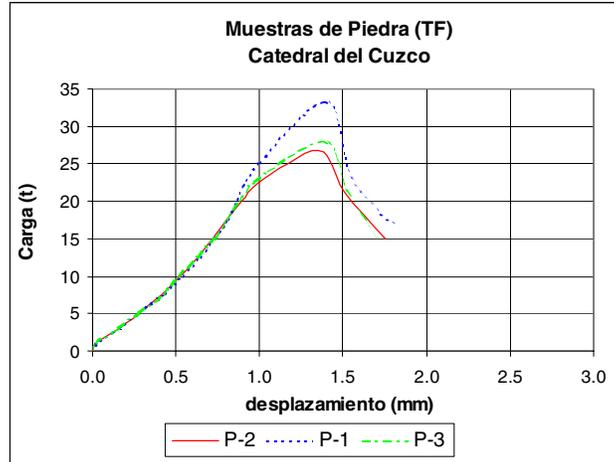
Figura 2. Stone sample results

Figure 2 shows the force deformation relation obtained from the samples. The way of the compression failure is typically in tension in the transversal direction. After apply low level of stresses (30% and 50% of its resistance) we observed the first cracks in longitudinal direction. They will propagate and appear un the axial direction and finally opened because transversal tension producing a pattern like the observed in Figure 3.

Using a regresion process of the curve presented in Figure 2, it was found the acerage resistance value for the samples 451 kg/cm^2 (45 MPa) and a Moulus of Elasticity of 194000 kg/cm^2 (19400 MPa). The density of this stone is in the order of 2.2 g/cm^3 .

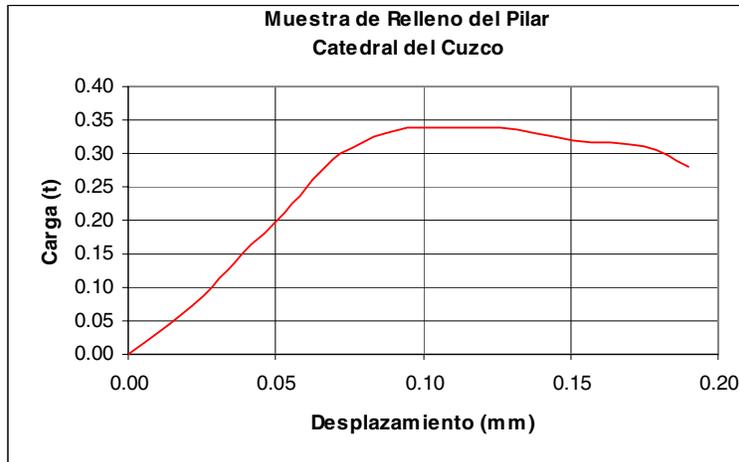
Figura 4: Compression test on Filled material in columns.

The columns of the Cathedral have a box section of stone masonry filled with a mix mortar. For the filled material a densty of 1.76 g/cm^3 was found. Axial compression test with the results of are presented in Figura 4. The compression resistance was 10.9 kg/cm^2 (1.09 MPa). Under a regresion process in the elastic range a Modulus of Elasticity for the filled material of 6270 kg/cm^2 (627 MPa) was found.

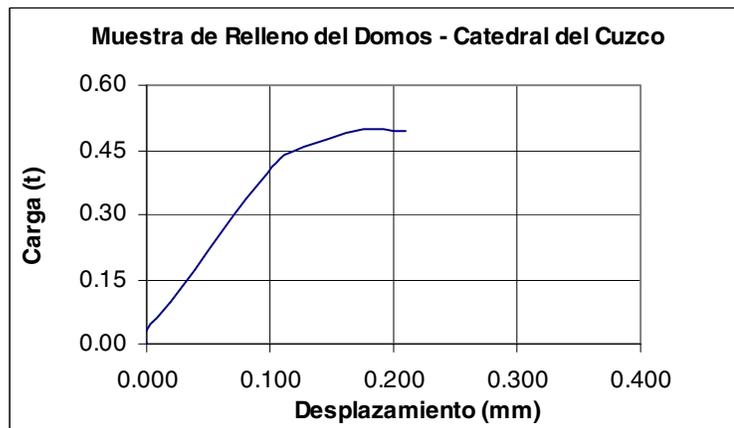
Figura 5: Compression test in filled material in domes

Also test of the filled material for domes were performed. Here the density of this material was in the order of 1.76 g/cm^3 . After a series of compression test as the presented in Figure 5, the average value of the compression resistance for the samples of 5.8 kg/cm^2 (0.58 MPa) was found. After a regression process in the elastic range, a modulus of elasticity of 3480 kg/cm^2 (348 MPa) is found. Finally and after a comparison process with analogous problems it is possible to consider a tension resistance of $1/10$ of the compression resistance.

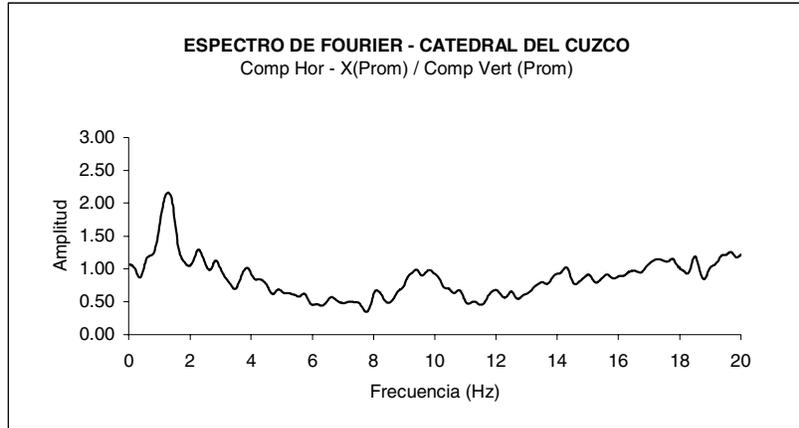
Figure 9

Due to the action of the flexibility of domes, the modal shapes on the whole structure model were used as calibration parameter for the model through the Microtremor measurements. For that purpose microtremor measurements were performed over the domes and over the columns. Also the soil dynamic characteristics was measured soil type classification purpose. In the case of the soil measurements the horizontal and vertical movements presents a peak in the Fourier Spectra of 1,26 Hertz (Figure 9). It means the period of the soil in its surface layer is in the order of 0.8 sec. which is typical of a flexible soil. However the structure has a foundation very deppely. When measures on columns were performed it was found an average value on X direction at 4,3 Hertz (Figura 10). It will correspond to a natural period of 0,23 s. Finally when domes frecuencies were measured a peak amplitude was observed at a frecuency in the order of 0,84 Hertz. It correponds to a period of 1,17 sec. This values apperas also for horizontal components If this values are compared with the values measured over the columns is possible to conclude arch and domes are more flexible than columns. Under this flexible conditions the following consequences are possible:

- Large displacements in domes are possible and it could produce opening bewteen blocks and the collapse.
- The performance of the combination domes and arch as a diaphragm is not corrected al all for the numerical analysis.

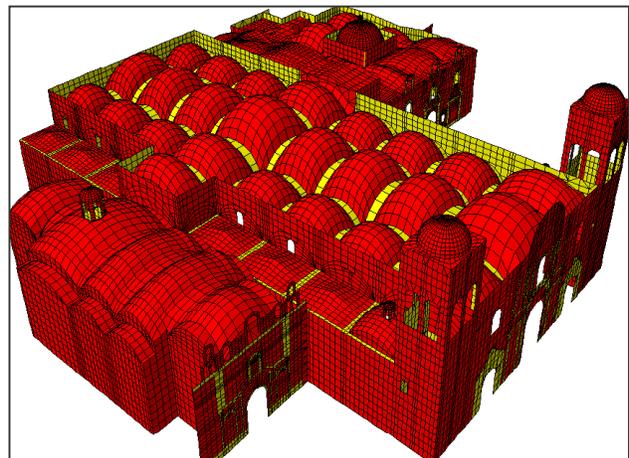
Figure 14: WholeCathedral model

In the whole cathedral model presented in Figure 14, the prior models where used in the generation of equivalent elements which represents the behavior of columns, domes, arch and its interaction.

Numerical simulation of the Cuzco cathedral with quakes of PGA 600 gals and PGA 1200 gals were performed, with a maximum response of 28 mm. on the top of the towers and 8 mm. on the top of the domes; this displacements could be consider small for the structure, however high tension stresses (8 MPa) were produced on the domes. It could produce brittle failure on the domes. If domes fail the columns became isolated structures, then the isolated structure behave similar to the column, arch, dome model with shear stress of 6.5 MPa and normal stress of 28 MPa, where this values are quite excessive for the used material. Then failure pattern is predicted as failure in domes following with arch and columns failure.
