SEISMIC UPGRADE OF CHIMNEY STACK AT LIONS GATE HOSPITAL IN NORTH VANCOUVER, CANADA

This paper outlines the evaluation and cost comparison of six different retrofit options, and the details of the design, construction, and cost aspects of the selected option.

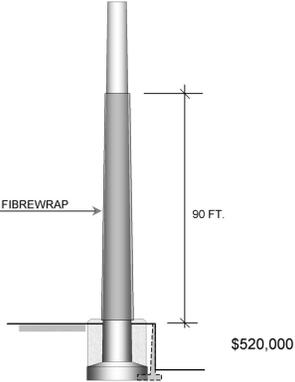
Retrofit concept 1 consisted of wrapping Fibre Reinforced Polymers (FRP) fabric around the chimney structure by using one of the commercially available products. The system was designed to add flexural capacity and ductility to the existing structure by the use of high strength hybrid glass fibre/epoxy composites. A major advantage of this retrofit concept lies in the ease of installation and the lightweight of FRP material. It also allows for the preservation of exterior appearance of the existing structure. In order to ensure the effective force transfer from the stack to the foundation, special anchorage arrangements were developed for this concept.

<p>\$520,000</p>

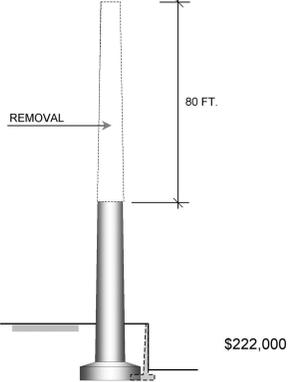
Retrofit concept 2 consisted of demolishing the upper 80 feet of the stack structure. Alternate option (2a) was to only reduce the height of chimney and (2b) to replace the demolished upper part with a new steel shell. This scheme has a benefit of lowering the centre of gravity of the structure. In addition, option 2b has the benefit of replacing a portion of the existing 40-year-old concrete stack with a new steel shell.

This option cannot achieve compliance for 100% of the code specified base shear, but only some 60% for the option of removal or removal/replacement respectively. This option was presented for consideration only if funding was unavailable to achieve the full upgrade, and if reducing the height of the stack emissions was environmentally acceptable.

<p>\$222,000</p>
<p>RETROFIT CONCEPT 1 - FIBREWRAP</p>	<p>RETROFIT CONCEPT 2a - REMOVAL OF THE UPPER PART OF THE STACK</p>

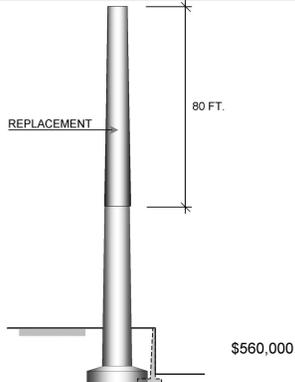
<p>\$560,000</p>

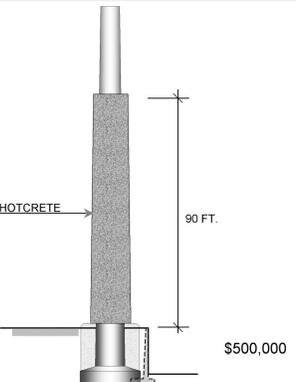
<p>\$500,000</p>
<p>RETROFIT CONCEPT 2b - REPLACEMENT OF THE UPPER PART OF THE STACK</p>	<p>RETROFIT CONCEPT 3 - SHOTCRETE</p>

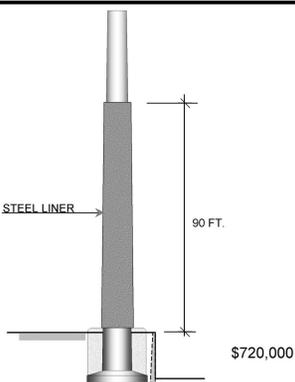
<p>\$720,000</p>

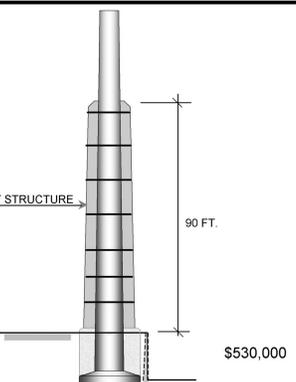
<p>\$530,000</p>
<p>RETROFIT CONCEPT 4 - STEEL LINER</p>	<p>RETROFIT CONCEPT 6 - INDEPENDENT STRUCTURE</p>
