RECONSTRUCTION, SEISMIC STRENGTHENING AND REPAIR OF THE ST. ATHANASIUS CHURCH I LESHOK – CASE STUDY

SUMMARY

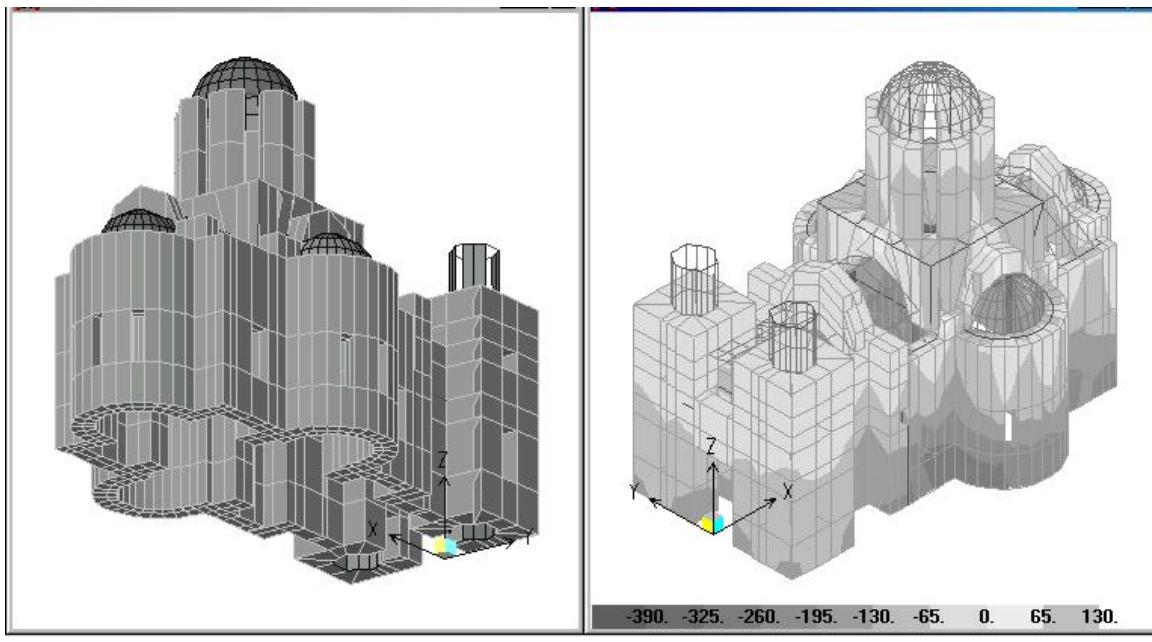
Figure 7. Results form the Finite Element Analysis

Based on the defined structural systems of the two individual structural units and the defined strengthening structural elements of the structure, a static and equivalent seismic analysis has been performed by using the finite element method and the computer software package SAP 2000 (Structural Analysis Programme, UC Berkeley, California). Taking into account the complexity and the specific nature of the structural system and the materials built-in the model of the structure on one hand and the possibilities offered by the programme package on the other, an attempt has been made to define a model by finite elements that shall most appropriately represent the structure. A moderately dense mesh of a total of 5191 nodes and 1901 elements has been adopted, involving the global geometrical characteristics of the model without paying attention to the inhomogeneity of the material, (Fig. 7a).

The bearing massive walls and the tambour walls have been modeled by the SOLID three-dimensional finite element with eight nodes, i.e., by a total of 938 elements. The steel vertical and horizontal strengthening elements were modeled by a 3D-FRAME, i.e., 3D-TRUSS elements, i.e., by a total of 362 elements. All the vaults and the domes have been modeled by a total of 601 SHELL elements.

For such modeled structure, a static analysis has been performed for the effect of dead weight and equivalent seismic forces computed according to the regulations, whereat the following values have been adopted as specific weight of masonry; (i) stone masonry $\gamma = 22.5$ kN/m³ and (ii) brick masonry $\gamma = 18.5$ kN/m³.

The results from this analysis given in the form of digital and graphic presentations of stress and strain states for different loading cases, give an insight into the designed values of all the static quantities referring to the individual types of elements, which justifies the selected solution for repair and structural strengthening, (Fig. 7b). The power of the programme as to the definition and detailed presentation of stress-strain state under different load combinations is also evident.
