THE 1ST OF MAY 2003, BINGOL, TURKEY, EARTHQUAKE, A STUDY OF THE PERFORMANCE OF THE BUILDING STOCK

SUMMARY

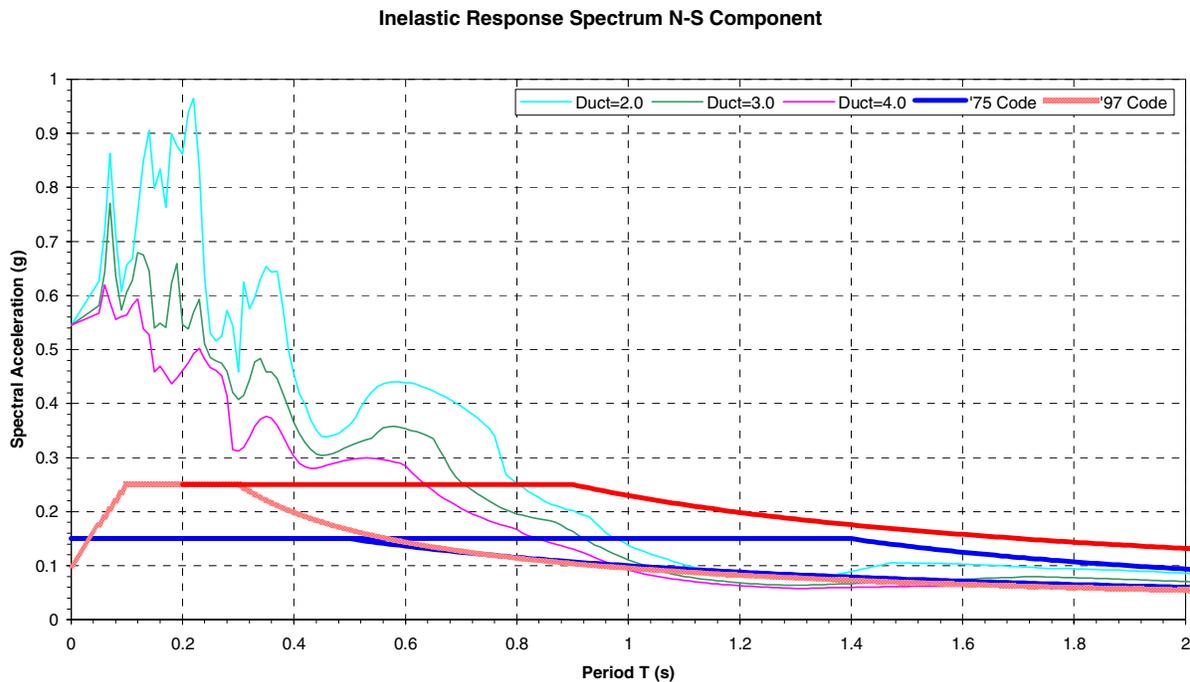
Fig. 4 Comparison between inelastic spectra of N-S component of strong motion record and design spectra of the two Turkish Seismic codes (5% damping)

In order to compare possible demand and supply, the non-linear spectrum for the N-S component of the only available record is compared in **Figure 4** with the design seismic spectra as defined in both codes. Both Code spectra are shown with their respective minimum reduction factors as detailed above. The record spectra have been calculated with differing ductility values ranging from 2 to 4, derived by using an elasto-plastic model with kinematic strain hardening, having a strain hardening parameter of 0.05, together with a damping value of 5%. As the soil condition underlying the accelerogram is a medium to stiff dense sand and gravel, it pertains to a local site class 2 or 3, as defined by the 1998 code, therefore the design spectra are shown bounded at each end by either extreme of the possible underlying soil class.

The majority of reinforced concrete buildings up to 5 storeys and with lightweight infill frames have a fundamental natural period of under 0.7s. Clearly therefore they would have been subjected to forces much higher than those anticipated in the 1975 code. As regards the 1998 revision, the spectrum envelopes buildings having a fundamental period of over 0.7s, therefore the five storey LE-MIRCF constructions would still have been subjected to higher forces than designed. It is important to note however that local site effects might have played a part in the recorded motion due to its location as explained in [18]. Nevertheless, it appears that even for a relatively moderate event, a significant part of the building stock in the town was subjected to forces higher than those prescribed by the codes. Thus emphasizing the inherent vulnerability of such constructions without ductile detailing, which rely mostly on over-strength to resist additional seismic forces to those specified in the codes.

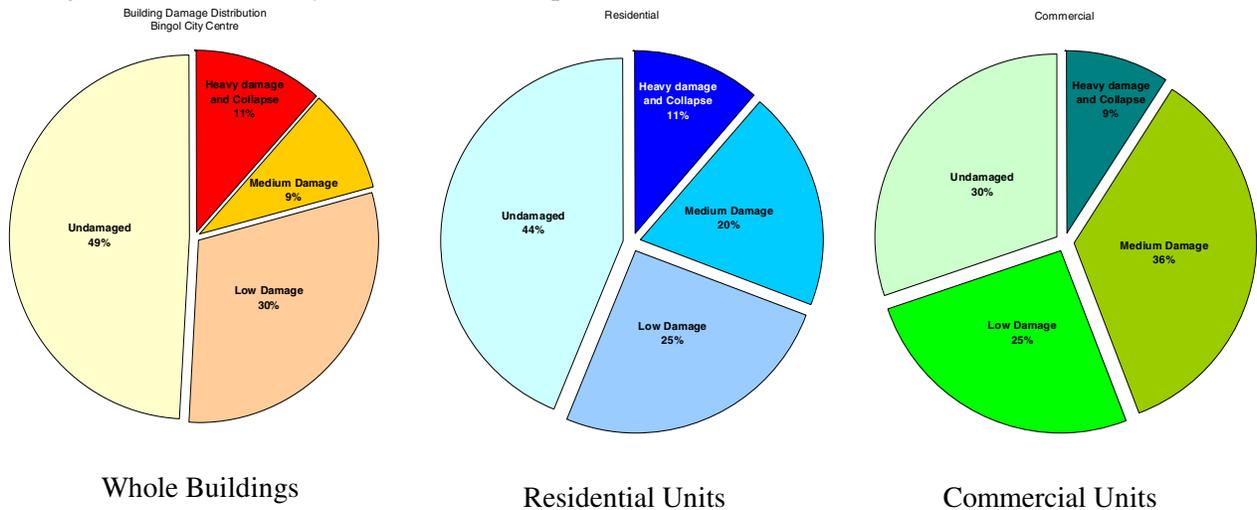
Fig. 5 Damage Assessment Data [6]

Building statistics from the Year 2000 Census [7], show that there were a total of 17,209 building units in Bingol town, of which the gross majority, 14,348 were classed as being residential, 763 as mostly residential and 1,481 as commercial establishments, together with various other building classes each with no more than 150 units. It is the norm in Turkey to report the number of construction damage on the basis of the number of dwellings or individual building units, and not the number of separate buildings, hence the three tier subdivision. Furthermore the figures indicate that in Bingol, less than 20 reinforced concrete buildings actually collapsed, or 0.4% of the city's total building stock, 11% of all buildings suffered heavy damage, 9% suffered moderate damage, 30% had slight damage, and the remaining 49% were undamaged (**Fig 5**). Separate damage statistics for both residential and commercial premises are also shown, wherein the higher vulnerability of commercial units, most of which are located at ground floor, is clear, as 45% suffered moderate damage and above, whereas only 31% of residential units suffered a similar damage level. This is just but a first indication of the increased vulnerability of the weak ground storey configuration which mostly house commercial premises.

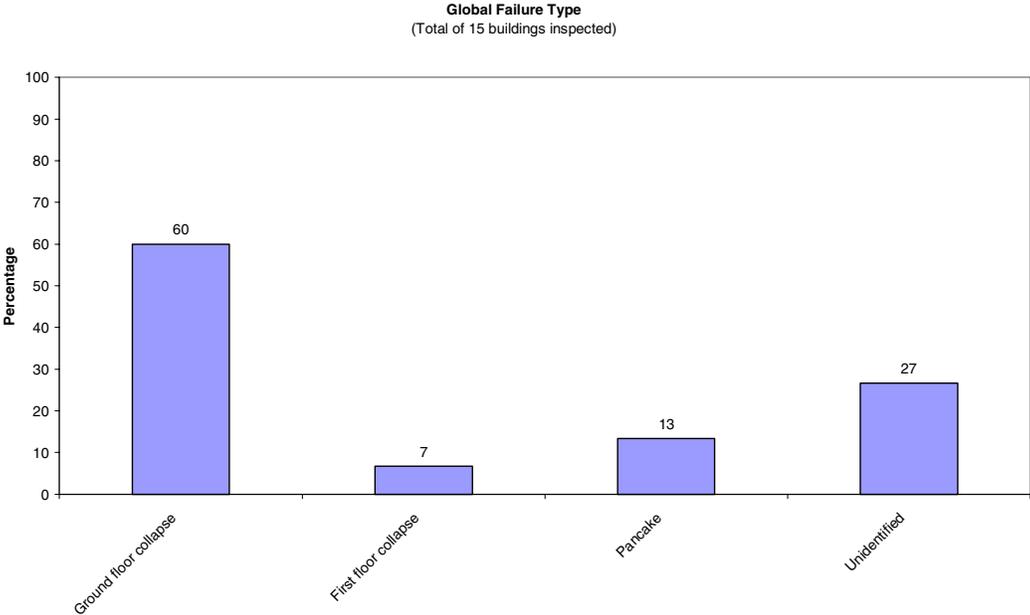
Fig. 6 Global collapse mechanisms from buildings surveyed.

A total of 15 collapsed buildings were surveyed, which amount to around 75% of the LE-MIRCF buildings which were reported to have collapsed [6]. The corresponding distribution of global collapse mechanisms for these buildings is represented in **Figure 6**. The most common cause of global collapse was by far precipitated by the presence of a weak ground storey in the form of a ground floor collapse or a first storey one, when the basement was semi-visible. Pancake type collapse, usually triggered when a more even distribution of stiffness in elevation is present, was identified as the other global failure mechanism, whilst the unidentified refer to the four buildings that were demolished prior to inspection. No instances of overall soil failure, building overturning or structural roof failure were observed. From these buildings only two were internal developments and thus had buildings adjacent to them, the rest were either completely isolated or, as in a couple of instances, at the end of a row of buildings.

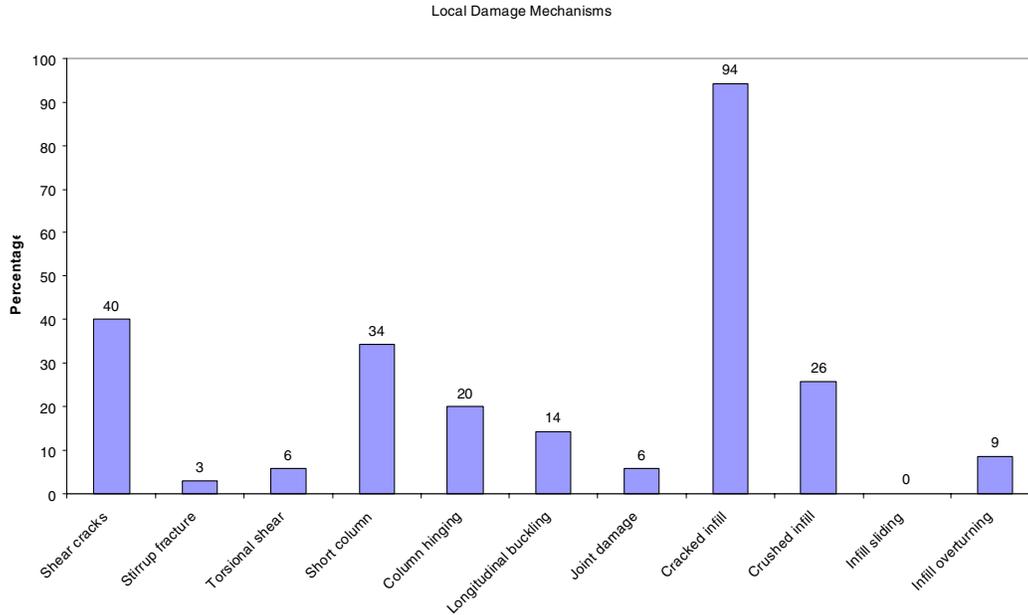
Fig. 7 Local failure mechanisms from buildings surveyed.

Members exhibiting some form of discernable localized damage were prevalent in 35 of the surveyed buildings and are represented in **Figure 7**. The varying local failure types were identified individually in constructions, or were frequently present in varying combinations. Diagonal cracks in the infill panels were noted in all the constructions which were classified as lightly damaged or above. No evidence of horizontal cracking in the mortar joint was observed, though in 26% of the 35 buildings, the infill panels

actually had crushed masonry units, whilst in 9% overturning of a wythe or whole panel was observed. This fact reinforced the feeling acquired on site that the mortar used in the gross majority of cases was relatively strong when compared to the highly perforated individual masonry units. As regards the reinforced concrete elements, damage caused by shear effects in columns (including compressive type x-cracks) was prevalent in 40% of the buildings, the short column effect in 34% and clearly visible column hinging in 20%. What became apparent from the surveyed building stock was that few buildings exhibited elements which could be classed as being moderately damaged and consequently, if reinforced concrete elements were damaged, they were either heavily damaged beyond repair, or had caused the building to collapse. This is attributed to the brittle failure modes prevalent in these buildings due to the lack of ductile detailing
