# **RETROFITTING AND STRENGTHENING QUALITY EVALUATION FROM RIGIDITY VARIATIONS OF A DAMAGED BUILDING**

M. N. Farsi<sup>1</sup>, J-L Chatelain<sup>1,2</sup>, B. Guillier<sup>1,2</sup> and S-A Zermout<sup>1</sup>

The rigidity of a six-story shear wall building, damaged by the May 21, 2003 Boumerdes (Algeria) earthquake is evaluated before the event, in its damaged state, and after retrofitting, using the estimation of the frequency and damping factor of the structure. The pre-event parameters are estimated through a numerical analysis, based on the structure drawings complemented by a micro-tremor investigation of an identical non-damaged building located on the same site. The damaged and retrofitted parameters have been obtained using only micro-tremor recordings on the studied building. The variation of the frequency and damping factor during the three stages of the building went through allows to evaluate its rigidity changes, and therefore to control the quality of retrofitting and strengthening.

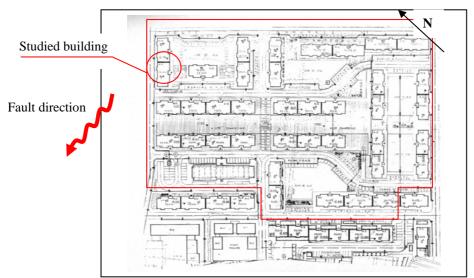
Figure 04: General plan of the COSIDER neighborhood

The building is oriented, in its longitudinal direction, along the fault direction, i.e. in the same direction as the fault (figure 04). In this longitudinal direction the building rigidity is insufficient because there is only one eccentric shear wall (figure 01). The damages were located therefore on this shear wall at the first and the second levels and resulted in cracks of shearing that reached more than 10cm of opening in some places (photos 02 and 03). The buildings that are perpendicular to the fault directional effect exhibit practically no damage due to the strong rigidity in the transversal direction. The reinforcement of this longitudinal shear wall is made by 2 tablecloths of diameter 12mm steel bars constituting a mesh of 20cm x 20cm. Four steel bars forming a column of 20cm x 20cm cross section (figure 05) are put at each extremity to rigidify the openings. As shown in the figure 05, the more seismic loaded lintels are also reinforced by four steel bars.

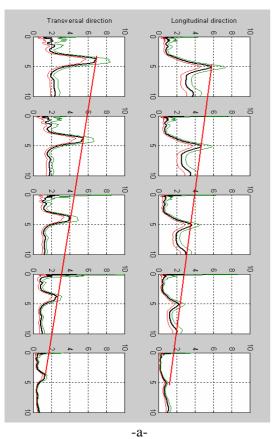
Figure 11: modal shape of first mode

The repairing and retrofitting, as explained above, have strongly rigidified (5.1 Hz) the longitudinal direction but more than the initial state (4.20 Hz). Based on these results we can admit that the repairing and retrofitting operation has been a success and the choice technique is good. However, looking on the modal shapes (figure 11 a and b) we can note that, if on the first level the building is more rigid than on the other levels (that is normal because of the retrofitting), on the third level exists a "fracture" which is probably due to no detected microcracks.
