## **THE ADANA-CEYHAN EARTHQUAKE OF 27 JUNE 1998: SEISMIC RETROFIT OF 120 R/C BUILDINGS**

**Haluk SUCUOĞLU<sup>1</sup>, Türel GÜR<sup>2</sup> And Polat GÜLKAN<sup>3</sup>**

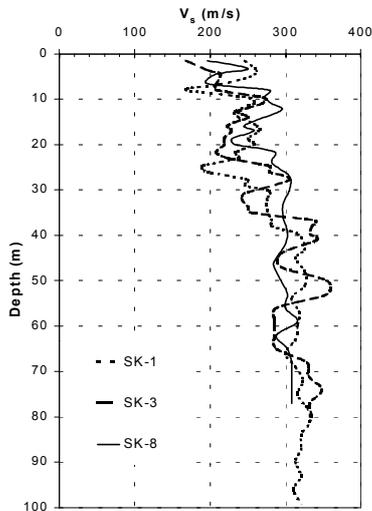
**Figure 5. Shear wave velocity profile in Ceyhan**

Shear wave velocity profiles were obtained along three boreholes by exploiting the SPT values obtained at the laboratory. The profiles are shown in Figure 5, where SK-1 is the site of the Ceyhan strong motion station. These profiles confirm that mechanical characteristics of the deep alluvial deposit underneath Ceyhan do not exhibit appreciable spatial variation. This conclusion is important in assessing the distribution of structural damage in Ceyhan during the 1998 earthquake.

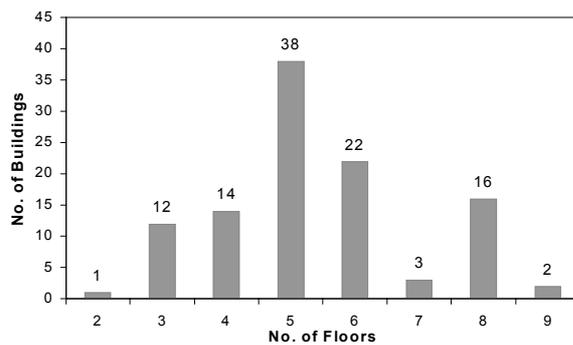
**Figure 7. Story distribution of moderately damaged buildings in Ceyhan**

The distribution of the 120 moderately damaged buildings with respect to the number of stories are given in Figure 7. The procedure followed in seismic assessment and retrofit works is outlined below.

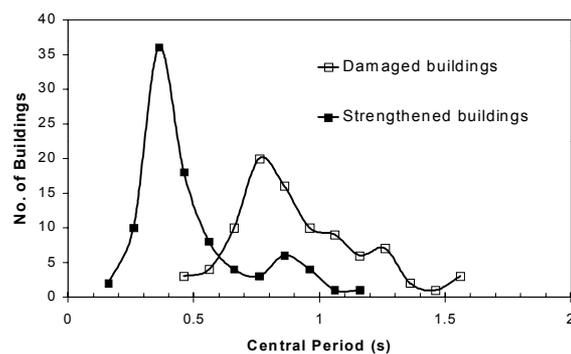
**Figure 8. Vibration periods damaged and strengthened buildings**

Naturally, the stiffnesses of buildings increase after seismic retrofit which leads to reduction in vibration periods. The overall shift in the fundamental periods of existing and strengthened buildings is shown in the form of a frequency distribution in Figure 8. This figure indicates that the mean increase in lateral stiffness for retrofitted

buildings is roughly  $\frac{k_r}{k_e} = \left( \frac{T_e}{T_r} \right)_{\text{mean}}^2 \times 1.1$

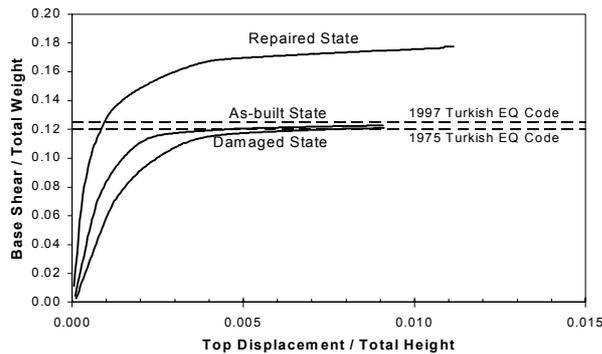
**Figure 12. Capacity curves of three states of the structure in the short direction**

the ground floor and the fifth floor, similar to the observed damage in the building. The lateral load carrying capacities are given in Figure 12. The implemented seismic retrofitting results in an increase of 47 percent in ultimate strength and 22 percent in deformation capacity which satisfy seismic code requirements specified for an ordinary frame-wall system with limited ductility.

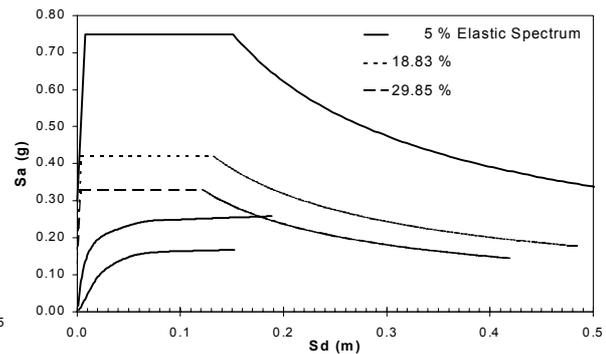
**Figure 13. Application of Capacity Spectrum Method**

Further, Capacity Spectrum Method (CSM) is employed to estimate the performance level of the repaired frame under design spectrum [ATC, 1996; Freeman, 1998]. The acceleration-displacement response spectra (ADRS) format representation of the capacity of the structure and the earthquake demand are shown in Figure 13. The performance point cannot be obtained for the damaged state even for the maximum allowable damping value of 18.83 percent whereas for the repaired state, the capacity and demand curves coincide at 29.85 percent damping giving a performance of 0.176 g base shear coefficient and 0.127 m top displacement.

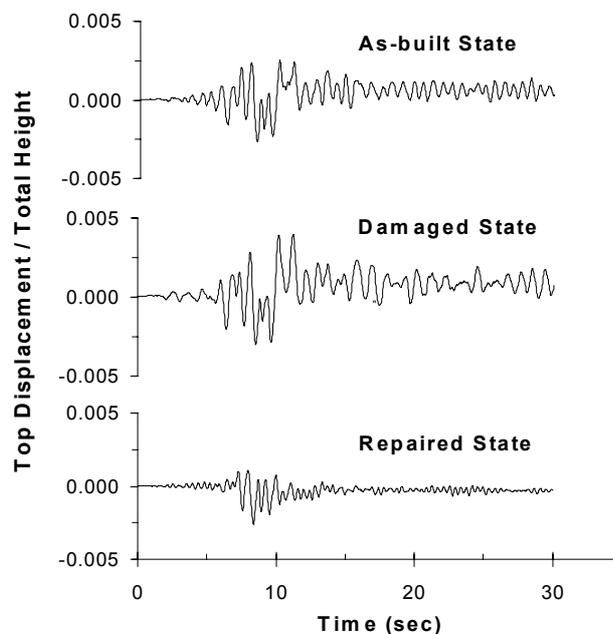
**Figure 14. Top displacement time history of three states of the structure under the NS Component of Ceyhan ground motion record**

Finally, time history analysis procedure was employed for the nonlinear models using the NS component of Ceyhan ground motion record. The normalised top displacement time histories are given in Figure 14 from which the effectiveness of the retrofitting applied to the structure is evident. The original and the damaged frames exceed global yield level in several cycles. The shear walls added to the system, however, limit the deformations which is important not only for structural safety but also for the protection of the non-structural elements.
