STRUCTURAL BEHAVIOR DURING THREE MODERATE MEXICAN EARTHQUAKES.

SUMMARY

This paper summarizes the experiences obtained by the Grupo Interuniversitario de Ingeniería Sísmica (GIIS), of three epicentral Mexican areas during three important earthquakes in 1995: September 14th, in Ometepec, Guerrero; October 9^h, in Manzanillo, Colima; October 21st, in Villaflores, Chiapas. Different types of failures are analyzed and discussed in adobe, masonry, concrete and steel structures.

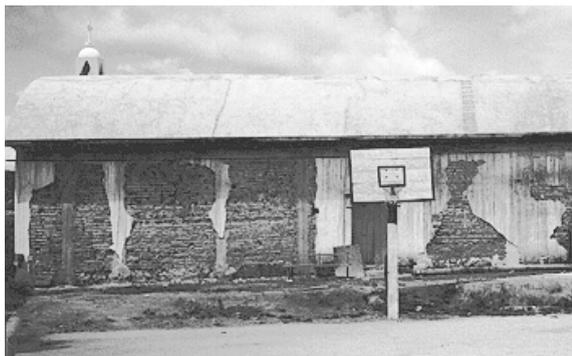
In this epicentral region of Guerrero there are few structures having vertical and horizontal elements that improve the seismic behavior of these adobe structures. These reinforcing elements are made of wood or concrete, (called dalas and castillos). This region of Guerrero has an important seismic activity, and therefore the adobe structures have been retrofitted and reinforced with those elements, some of the adobe structures were reinforced before the Ometepec earthquake, (figure 5).

Figure 5. Reinforced adobe wall structure.

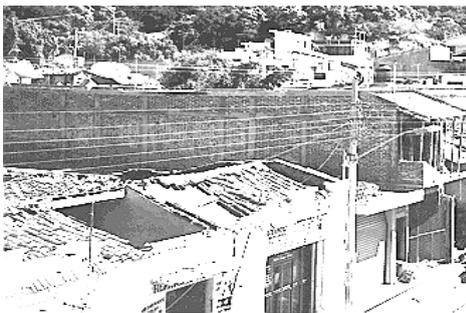
Castillos and dalas add confinement and resistance to the masonry walls, (figure 13). It should be noted that Jaluco and Barra de Navidad were two of the towns affected by the Manzanillo earthquake and the liquefaction, a geological effect of the earthquake. Even though, the reinforced masonry structures of these two towns were properly design and constructed some of them were heavily damage by liquefaction and subsidence. A maximum subsidence of about 50 cm was observed, resulting in large differential settlements and severe structural damage to the houses in the area.

Figure 13. Dalas and castillos improve the seismic behavior

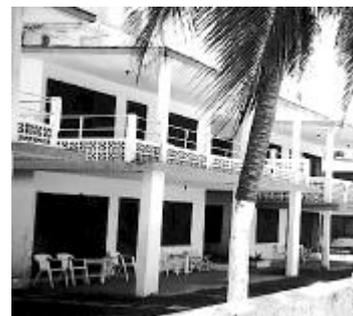
Figure 16. Adequate design procedures led to good seismic behavior.

Reinforced masonry structures have good seismic behavior when they are properly designed, as shown in figure 16, regularity, simplicity and symmetry led to a good behavior in the Manzanillo earthquake, even though this structure was placed in the most affected area by the earthquake.

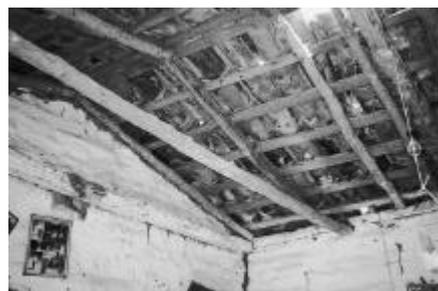
Figure 18. Roof system in Villaflores, Chiapas.

Those adobe structures observed in Villaflores are very similar to those in Ometepec and Manzanillo, except on the roof system, (figure 18). The roof system is made of wooden poles supported along the peripheral walls; some wooden poles are placed as dalas around the walls, providing confinement to the typical adobe houses. This configuration of the roof system improves the seismic behavior of the entire structure. The failures observed in this epicentral area are similar to those discussed before. The roof system did not induce failures of walls, but it was very common that the roof collapses inside of structures. The quality of the adobe bricks was very good, having natural fibers inside of it, improving its seismic behavior, (figure 20).

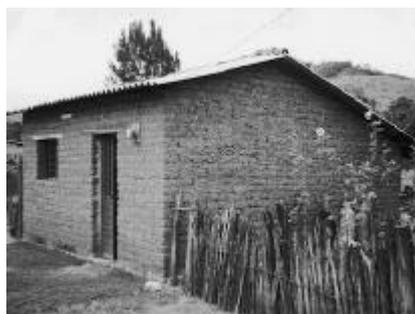
Figure 20. High quality adobe brick houses.

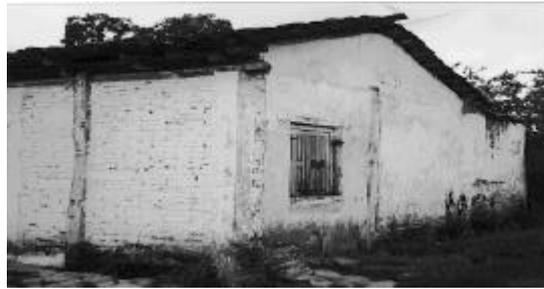
These types of structures performed well during the Villaflores earthquake, even though wooden poles were used as dalas and castillos, (figure 22). In figure 23, a reinforced masonry structure presented no damage, while this adobe structure was completely collapsed. Those structures that performed poorly during the earthquake were because of the poor structural configurations, irregularities in plan and elevation, weak first stories, (figure 24), and inadequate lateral reinforcement.

Figure 22. Wooden poles used as dalas and castillos.

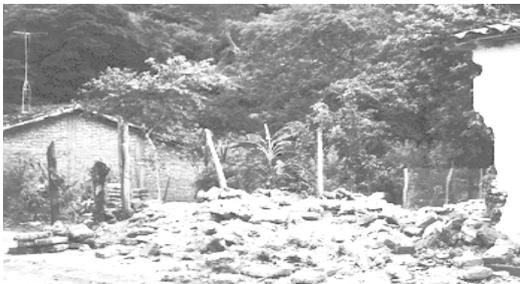
Figure 23. Reinforced masonry structures with no damage.
