HOSPITALS BEHAVIOR DURING THE SEPTEMBER 1997 EARTHQUAKE IN UMBRIA AND MARCHE (ITALY)

SUMMARY

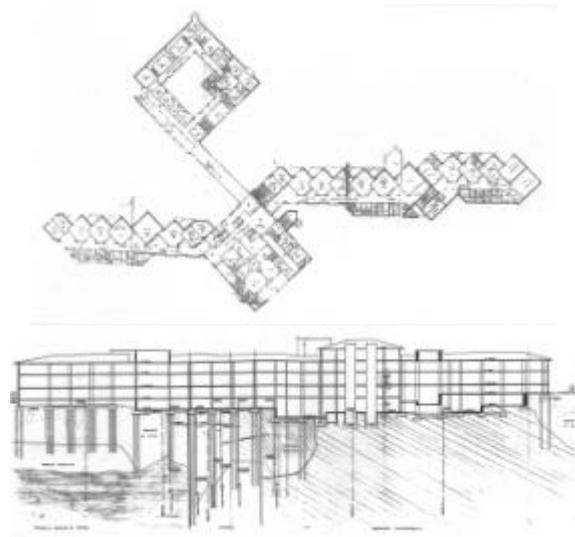
Fig 2: Assisi – typical floor plan and longit. section

The Assisi hospital is composed of two buildings, the main one and the secondary one, linked by a footbridge. The structure is composed of frames in r.c. with partition walls having the external layer with solid bricks and the internal with hollow bricks. The main building has a rectangular oblong shape and is divided by technical joints. The secondary building has a square cross-section. Three floors are over ground or partially under ground. The hospital is founded on a slope on the same side and downstream with respect to Assisi on an area affected by

a landslide. The high heterogeneity of the foundation grounds motivated during the building phase (1996) a detailed study of the foundation system. The foundation ground was also characterized via in site seismic testing. It was finally decided to build the foundation system partly on piles and partly with superficial foundation (Fig. 2). Probably due to the landslide movement, displacement between the two parts of the structures of the main building is evident, localized in a construction joint. The hospital after the earthquake of September 25 has been inspected many times also because of the continuous shaking. The first survey showed the absence of damage to the structures in r.c. besides a column near the joint where the dislocation was evident. Damages were essentially concentrated in the interior walls where some partial collapses were also evident. The first measure concerning the usability has been to forbid the uses of the damaged areas until some retrofitting interventions had had done. Damages have increased with the successive shocks; even the one concerning the structure in r.c., that initially consisted in shear failure in the column at the floor level, has undergone a successive displacement of 1 cm at least. In the last survey of October 7 the hospital has been shortly judged unusable in order to do more accurate analysis concerning both the structural aspects and the soil stability. Also the heating and water installations have shown damages, but their immediate functioning has been possible. The boiler, the conditioning system, the fridge, the electrical installations, the part concerning medical gases, did not show any damage.

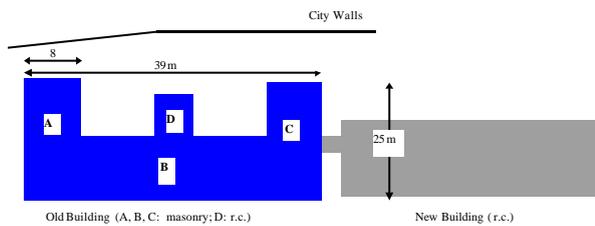
Fig 3: Treia – hospital layout

The hospital is located in the historical center of the municipality near the town walls and schematically consists in two buildings linked by a footbridge: the new hospital in r.c. (no damages) and the older one, in masonry, built in 1820 with enlargements in 1947, retrofitted in 1962. The old hospital is E shaped with the backside parallel to the walls and three arms orthogonal toward the valley. The external dimensions are about 39 x 25 m and each floor has an average surface of about 750 sq. meters. Four floors are present with three completely over ground, while the first is partially underground towards the valley. The maximum height of the building is about 18 m and the total volume is of 13'000 cubic meters. The vertical structures are for the most part in masonry, except for the transversal central arm built in 1947 in r.c. (building D in Fig. 3). Besides the external walls, two longitudinal walls parallel to the longer side of building B are present. The parts built in 1820 are of masonry similar to that of the adjacent historical buildings, with irregularities and cracks. Floors are generally borne by cross and cylindrical vaults in masonry. In some case r.c. floors are present. The roof floor is in wood. The roof of the B building is carried by trusses in the central part and simple beams for the remaining. The ceiling of the rooms at the last level is connected to the walls with false vaults in plaster on canes. Damages due to the last earthquake are concentrated at the last level. The wooden roof has shown some discontinuities along the tiles but no damages were found in the bearing structure or in the supports. The floor at the last level has undergone the most evident damages, i.e., falls of some plaster from the roof and starting of slipping of the wooden beams from the masonry. These damages were not dangerous immediately. Some small cracks visible from the outside in the masonry near the doors and the windows have been found. Cracks were present in correspondence of the joints between the older part and the newer one. The last level has been immediately judged unusable whereas the lower ones remained in working order. No damage to the plants was found.

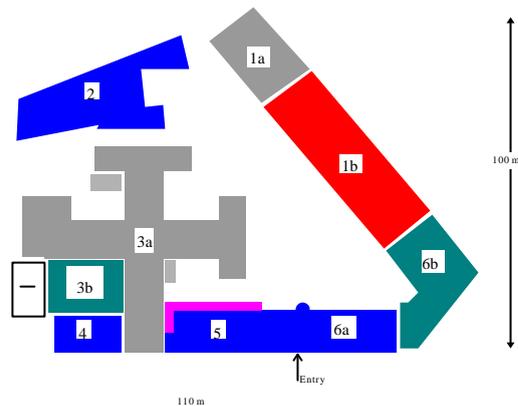
Fig 4: Foligno – hospital layout

The hospital has been ideally decomposed in structural unites homogeneous as far as possible with respect to the building period, the materials, the relationships with the other buildings (Fig. 4). Structural joints have been found only in the newer r.c. buildings; in the other cases the quake itself caused the formation of joints (Fig. 5). Buildings 1a and 1b are in r.c., adjacently built in different periods. Building 1b is divided in two parts, structurally independent through an intermediate joint 2 cm wide where columns are doubled. Both buildings have been built before the seismic classification of the municipality of Foligno. These are the least damaged with small cracks in interior walls (Fig. 6) and an increase of 1-2 mm of the width of the joints with the masonry buildings 6b. Building 2 has a mixed structure (masonry and r.c. frames). Building 3a and 3b are the older ones in masonry. These showed a clear degradation in external masonry at the last level. The less frequent damages found are X shaped cracks in the interior walls, cracks near the windows, incipient separation of the facade; the worst damages are some walls heavily cracked and the collapse of a beam (Fig. 8). In the cloister some vertical cracks in the columns have been noticed, probably preexisting but to be carefully checked. Building 4 in masonry might be an appendix built in successive periods near the cloister. The removal of the cracked plaster showed that the whole stair wall is built with parts of different nature, one on top of the other and almost never connected each other. Cracks on the bearing walls, beams, arches have also been noticed. The interaction with the roof of the adjacent church is probable (Fig. 7). Building 5, in masonry, looks similar to the 6a but is actually different, because part of it has been expanded through a r.c. structure. In the area of the operating rooms at the 2nd and 3rd level no cracks have been noticed. The elevator to the operating rooms was put out of order during the main shock because of the excessive displacements. At the higher levels important oscillations must have taken

place; this caused, beyond the derailing of the elevator, the fall of the light batteries from the racks (Fig.9). This has been confirmed also by the readings taken by the accelerometers installed in building 1 by the Servizio Sismico. During the earthquakes after September 26, at the second level an acceleration peak more than three times the PGA was recorded. Some losses of oxygen from the pipelines were also observed.

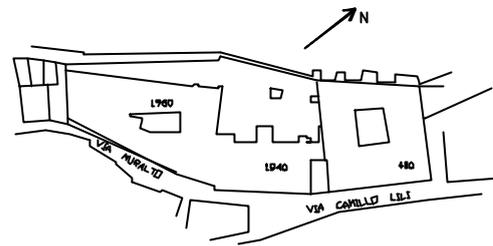
Fig 10: Camerino – location of the hospital

The hospital is located inside the historical center of the city (Fig. 10). It consists of three buildings. The oldest one dates back to 1400 and is in masonry with square cross section. The elevation is of three very high floors. The second dates back to the period 1935-50 and is built with a mixed structure of masonry and r.c. The 3^d building, built during the sixties next to the second building, is built with a mixed structure with big central columns and r.c. beams. This last building contains a first level partially over ground and five more levels. The whole structure looks toward a small road descending from E to S-W. On the opposite side the complex is founded on the slopes of the town itself with about 20 meters of difference of level. The 14th century building in the S-W corner extends up to the base of the town slopes. No structure is designed according to the seismic regulations because the area was seismically classified only in 1983. The hospital beds number is 221.

The facility was externally in good state, particularly the newer two buildings, where a light pounding in correspondence of the joints was only visible. The situation, due to the localization of the complex, was different and heavier with many dangerous stone falls on the narrow street, which gets at the hospitals. The 14th century building showed cracks also externally particularly in the S-W corner and in the N facade (Fig. 11). The former namely is the point of higher fragility of the complex whereas the two modern buildings showed damages only in correspondence of the joints because of the pounding (Fig. 12). In the E side important damages are present in the whole 14th century building. Cracks on the walls and on the floor are visible. The whole area, which looks toward the Camerino town, particularly the areas in the S-W corner, was particularly damaged. The whole W facade looked separated from the floors; some E-W chains looked damaged; one of the S facade chains was broken and partially expelled by the walls, whereas the chimney that goes beyond the roof showed a clear fracture in correspondence of the last level, with a displacement of some centimeters. The particular plan distribution of the different buildings and the abrupt stiffness variation due to the interruption of the building showed clearly the seismic sensitivity of the S-W part.
