## **1994 NORTHRIDGE EARTHQUAKE: DAMAGE TO A FOUR-STORY STEEL BRACED FRAME BUILDING AND ITS SUBSEQUENT UPGRADE**

**Dominic J KELLY<sup>1</sup>, David R BONNEVILLE<sup>2</sup> And Stacy J BARTOLETTI<sup>3</sup>**

### **SUMMARY**

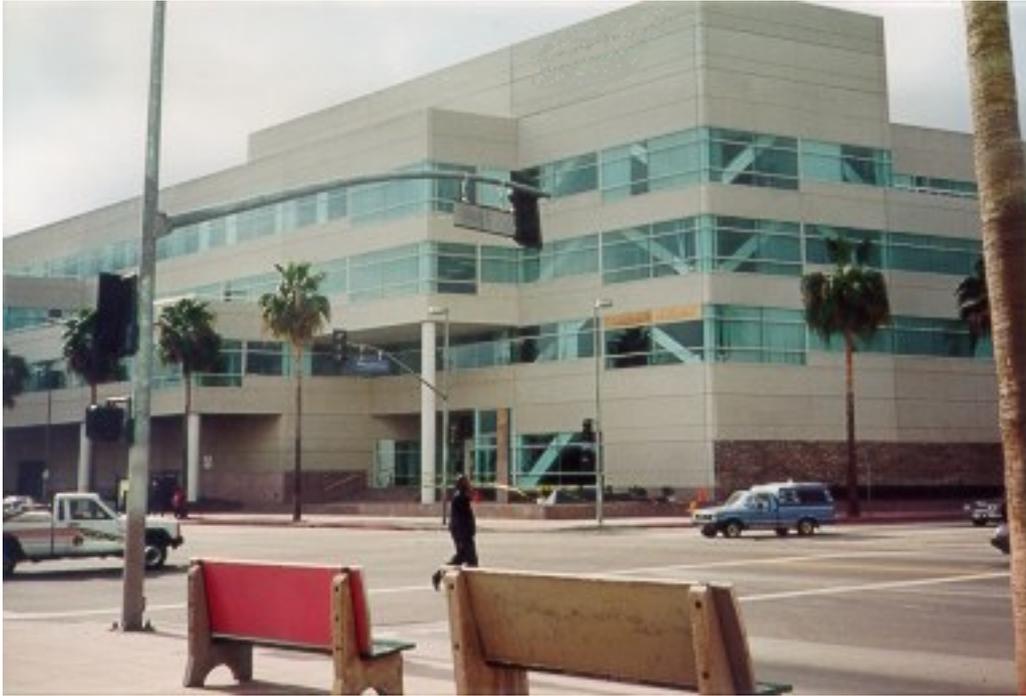
**Figure 1: Building Elevation**

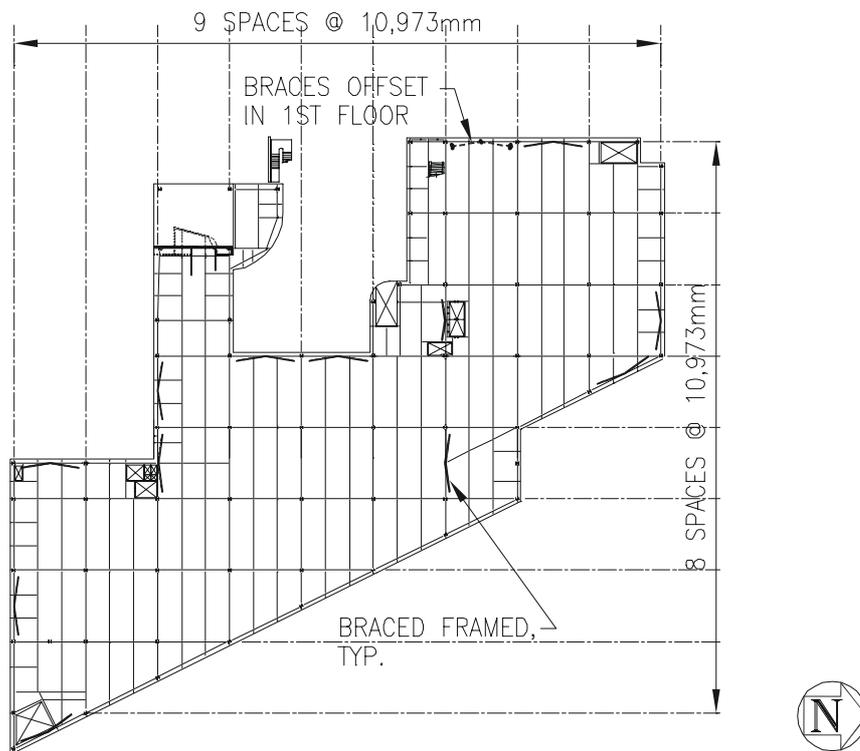
In plan, the building has several reentrant corners and one of the elevations is skewed relative to the framing layout as shown in Figure 2. The building originally had minor load transfer discontinuities; in particular, one bay of bracing was offset in-line, shifted one bay in the first level relative to the upper levels. Approximately 50% of the building layout has a basement story for underground parking and storage.

**Figure 2: 4-Story Steel Braced Frame; 2nd Floor Framing Plan  
(3rd, 4th and Roof Similar)**
