Building in Resilience for Remediated Residential Housing

J.R. Leeves & T.J.E. Sinclair

Tonkin & Taylor Ltd, Auckland, NZ

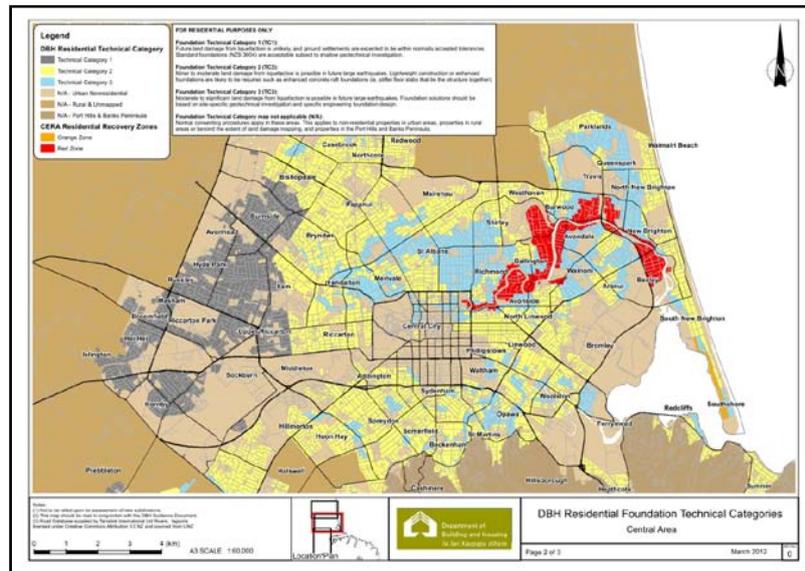
Figure 5. DBH Technical Category map of central Christchurch

The Green Zone, however, required further sub-division on the basis of low, medium and high probability of future liquefaction. This was done by DBH primarily on the basis of observations from the various earthquake/aftershock events but also with the aid of sub-surface data from a series of detailed investigations throughout the affected suburbs. These divisions of the Green Zone required different technical foundation solutions and hence have been termed Technical Categories (TC1, TC2 and TC3). These are defined in Table 2 and shown on Figure 5.
