# On Damage of Oil Storage Tanks due to the 2011 off the Pacific Coast of Tohoku Earthquake (Mw9.0), Japan

S. Zama, H. Nishi, K. Hatayama, M. Yamada, H. Yoshihara & Y. Ogawa

National Research Institute of Fire and Disaster, Japan

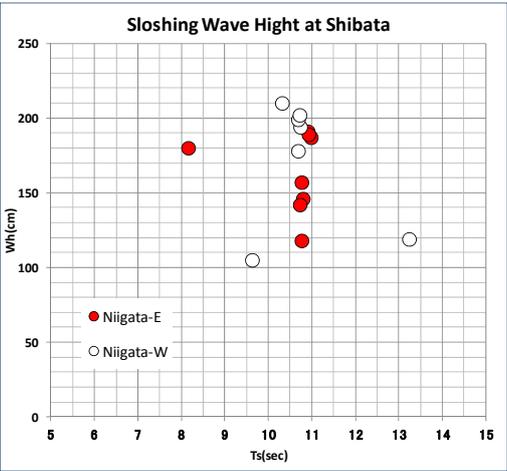
Figure 7. Relation between sloshing wave height and natural period of liquid sloshing

Typical damage of oil storage tank caused by liquid sloshing was found in Niigata and Sakata districts, such as sinking of inner roof, leakage of oil onto deck, deformation of gauge pole, and fracture of pontoon. We measured the sloshing wave height based on oil marks on the surface of the shell plates found in oil storage tanks in the Niigata district. Fig.7 shows the relation between sloshing wave height and natural period of liquid sloshing. Maximum sloshing is about 2m at a period of about 10.7 sec, where red and white circles correspond to the data at east- and west-side tanks at the Niigata-Higashi Port for petroleum reserve, respectively.

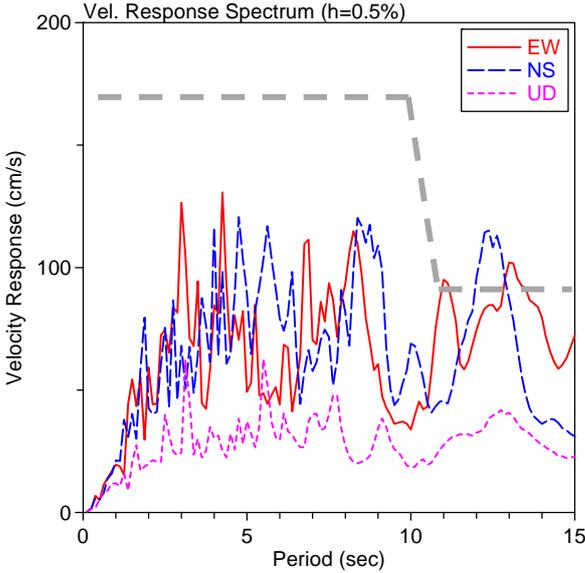
Figure 8. Pseudo-velocity response spectra (Sv) of 0.5% damping at the east site and the regulation spectrum (gray dashed line)

Fig.8 shows the pseudo-velocity response spectra ( $S_v$ ) of 0.5% damping at the east site where we have installed velocity-type strong motion seismograph. Dashed gray lines show the regulation spectrum for Niigata district in the Japan Fire Service Law. Using the 2-D sloshing response analytical method

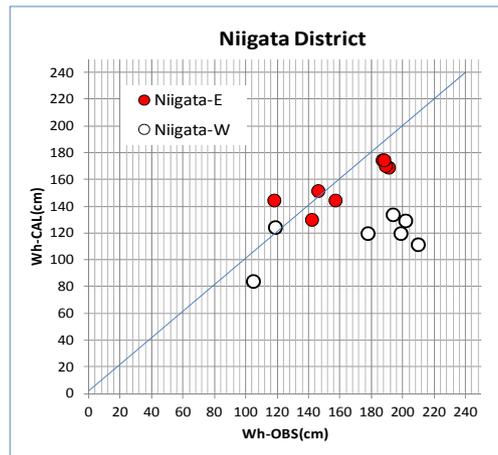
**Figure 9.** Comparison between observed (Wh-OBS) and calculated (Wh-CAL) sloshing height

(Zama, 1985) based on the velocity potential theory for liquid sloshing, we calculated the sloshing wave heights and compared with the observed ones as shown in Fig. 9. Although the calculated heights agree well with the observed ones at the east site of the port, the calculated ones for the west site was underestimated as about 60cm. This means that about 50% of Sv at a period of 10.7sec varies from east to west site, despite of the short distance of 2.5km between east and west sites.

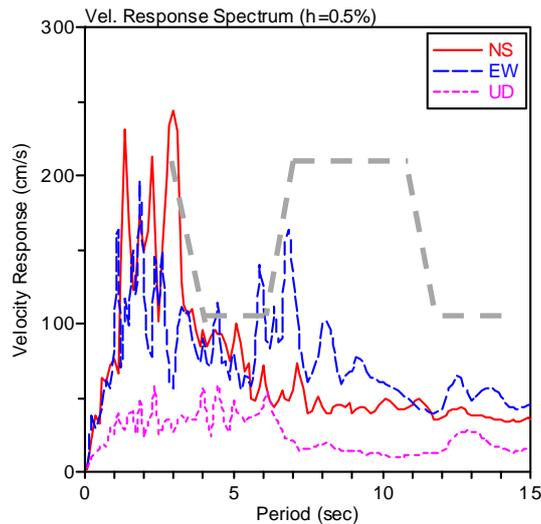
**Figure 12.** Pseudo-velocity response spectra ( $S_v$ ) of 0.5% damping at the Kawasaki and the regulation spectrum (gray dashed line)

In Kawasaki city, floating roof of heavy oil tank completely sank three days after the earthquake as shown in Fig.11. According to the regulation, this tank's roof should be reinforced by 2029, but not conducted yet. The cause of sinking is considered as the inadequate buoyancy by failure of the pontoons due to the liquid sloshing. According to our observation near the tank, Sv is, however, 75cm/s at the natural sloshing period of 7.8s of the tank as shown in Fig.12, and the estimated sloshing wave height is no more than 1.0m. As the liquid sloshing of the tank is seemed to be too small to explain the failure of the pontoons based on the technical standard of the Fire Service Law, a rational explanation is required.

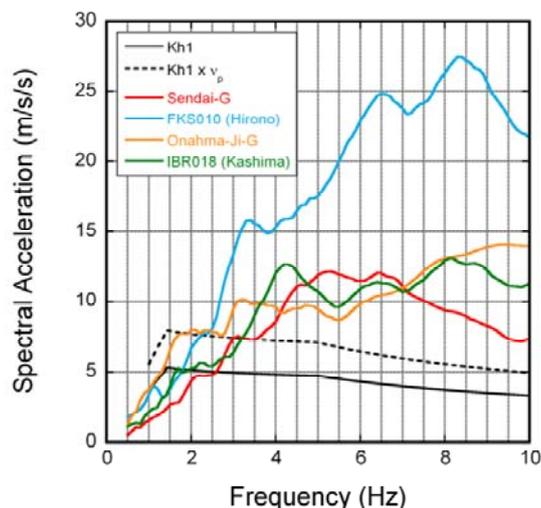
**Figure 13.** Acceleration response spectra  $S_a$  of 10% damping near the tank sites in Sendai (Sendai-G), Fukushima (FKS010), Iwaki (Onahama-Ji-G), and Kashima (IBR018) compared to the spectra in the Fire Service Law of Japan

Fig.13 shows the acceleration response spectra  $S_a$  of 10% damping near the tank sites, from the records at Fukushima (FKS010) and Kashima(IBR018) presented by National Research Institute for Earth Science and Disaster Prevention and at Sendai(Sendai-G) and Iwaki(Onahama-Ji-G) presented by Port and Airport Research Institute, compared to the spectra in the technical standard of the Fire Service Law, where  $Kh1$  and  $Kh1 \times v_p$  are corresponding to the level 1 and 2 earthquake ground motions, respectively. Although  $S_a$  exceeds the level 1 at the frequencies more than about 2Hz, and exceeds the level 2 more than about 3Hz, within our investigations, damage to cylindrical tanks due to strong ground motions was only found as the elephant foot bulge of a water tank at Sendai and the extraction of anchor bolts of an oil storage tank at Kashima.

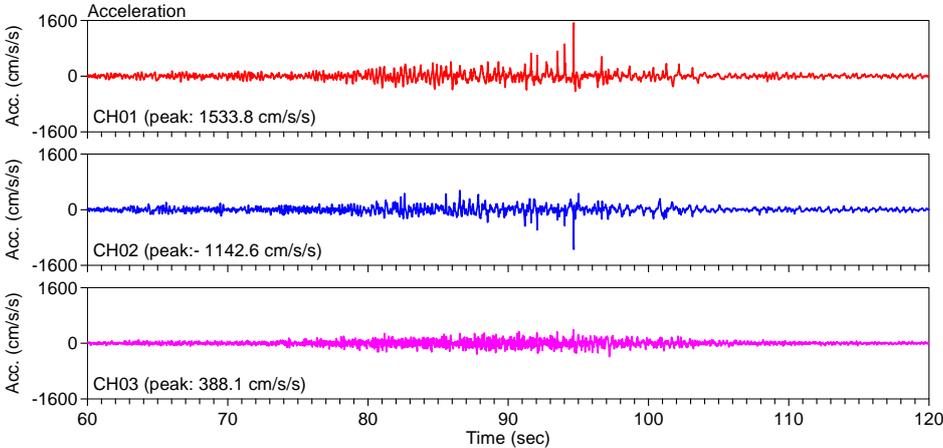
**Figure 15.** Acceleration waveforms indicating cyclic mobility at the at the Onahama Port observatory near the tank site operated by Port and Airport Research Institute

In Iwaki city along the Pacific coast, there was damage due to liquefaction caused by strong ground motions as shown in Fig.15, which was recorded at the Onahama Port observatory near the tank site operated by Port and Airport Research Institute. PGA is  $1533.8\text{cm/s}^2$  and the cyclic mobility can be seen as phenomenon of strong non-linearity. Fig.16 indicates the situation of settlement of oil storage tank. The valve of the tank slightly contact to the ground, therefore the asphalt of the scarcement was removed in order to avoid the failure of the neck of the nozzle in the further settlement due to the future earthquakes. Furthermore, the center part of bottom plate was relatively uplifted about 50cm high owing to the lateral flow of neighboring soil of the tank, and the welding area of the bottom plate cracked and oil leaked.
