# URBAN EARTHQUAKE DAMAGE ASSESSMENT AND RECONSTRUCTION: 2010 HAITI EARTHQUAKE

**H. Kit Miyamoto and Amir SJ Gilani**

*Miyamoto International, Sacramento, CA, USA*

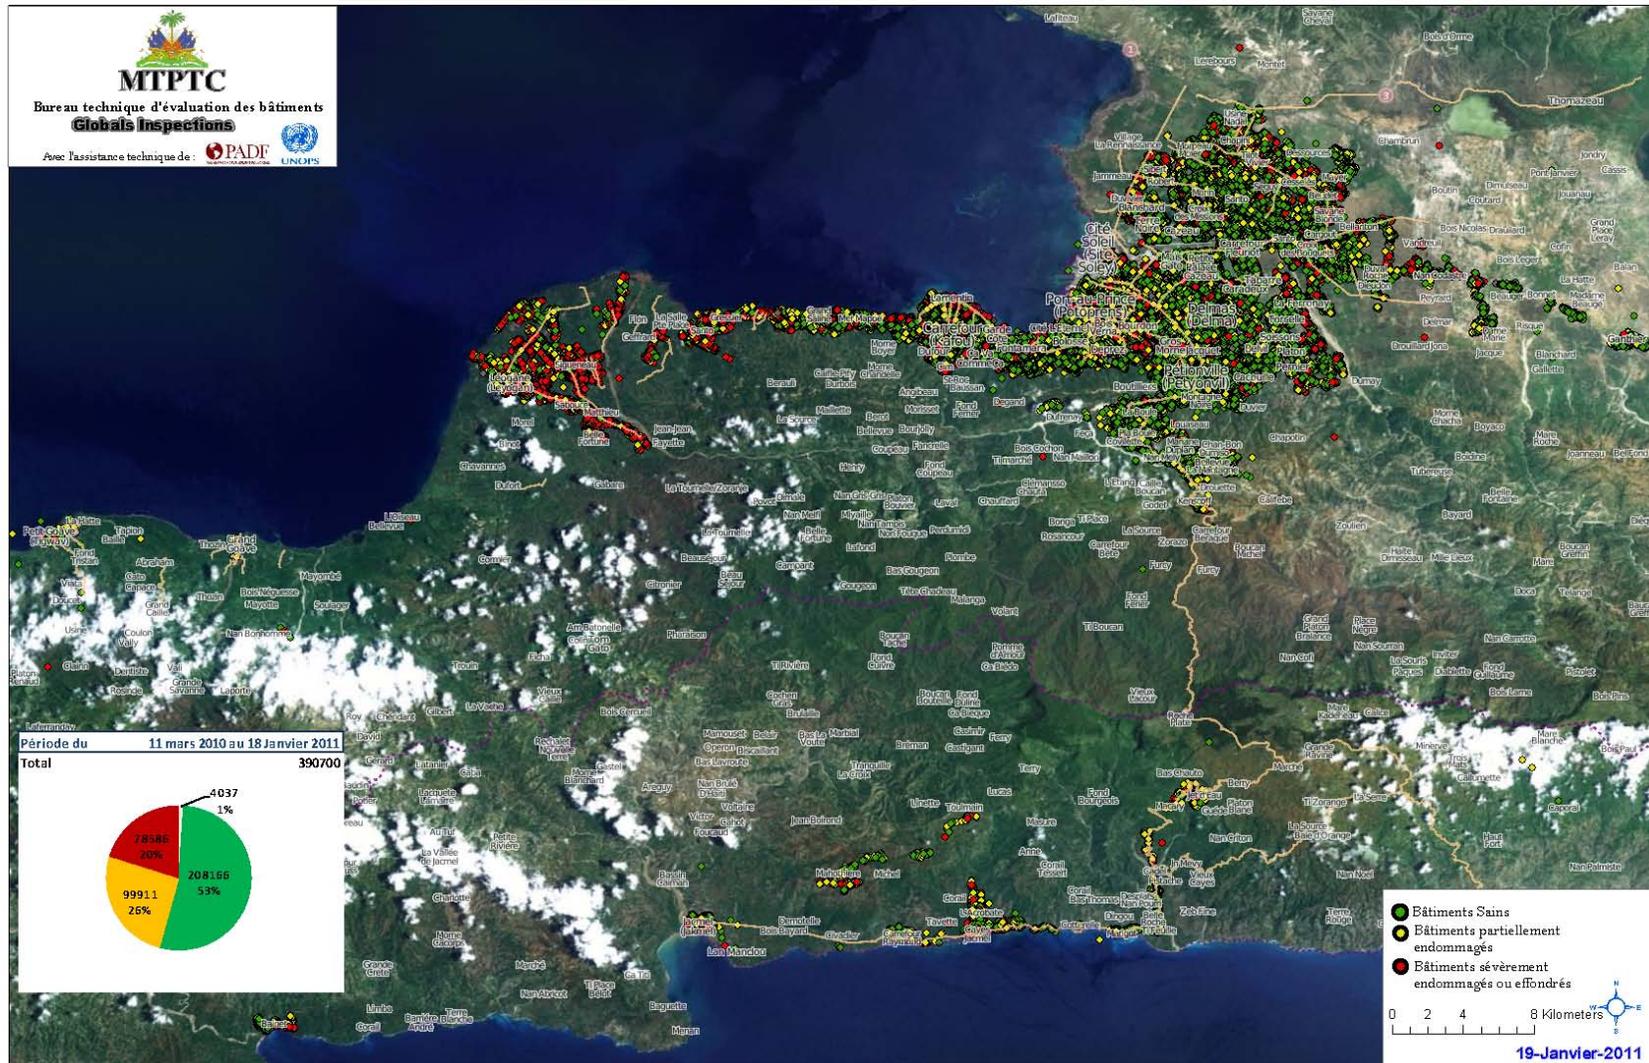
Figure 5. Map of Port-au-Prince showing the location of green-, yellow-, and red-tagged buildings as of March 2011

The majority of the damaged and collapsed buildings were in the low-lying districts west of the airport, which includes downtown Port-au-Prince, Nazon, Turgeau, Canape-Vert, Carrefour, and the lower portion of Delmas. By contrast, more southerly and easterly regions, in particular Juvenat and Pétionville, suffered much lighter damage (see Figure 5).
