# Performance of RC Buildings along Hill Slopes of Himalayas during 2011 Sikkim Earthquake

**A.R. Vijaya Narayanan, Rupen Goswami and C.V.R. Murty**

*Indian Institute of Technology Madras, Chennai, India*

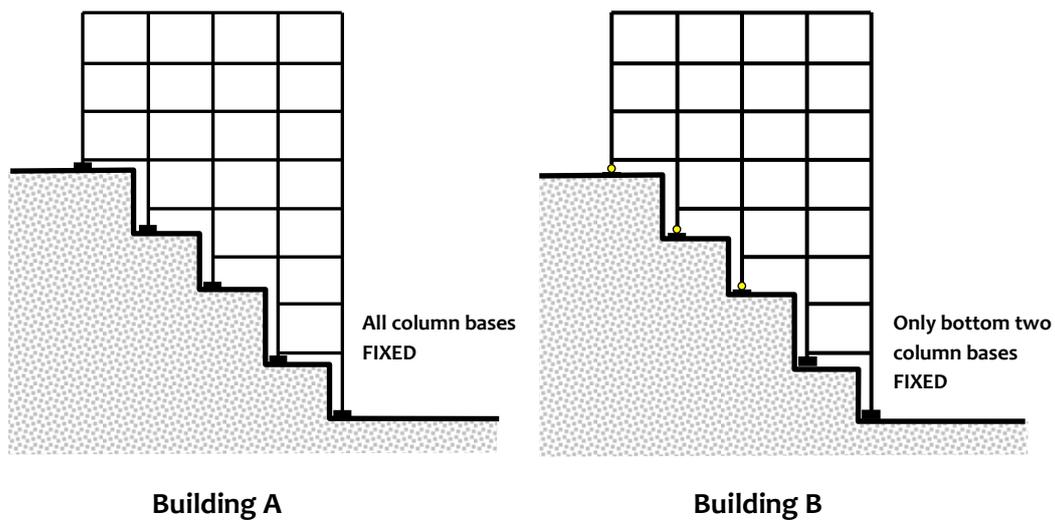
Figure 3.2 Building with different support conditions

Consider two buildings A and B (of same width along the road direction) with three storeys above and four storeys below ground level, but with different restraints at base of columns (Figure 3.2); Building A has fixed column bases, and Building B has roller column base except underneath the tallest valley-side column. Buildings rest on hard rock strata behave more like *Building A* during low intensity of ground shaking, wherein the lateral frictional resistance under the columns is more than by the horizontal shear induced in the building by lateral earthquake shaking. Once the inertia force exceeds the frictional resistance during strong ground shaking, these buildings behave more like *Building B*, wherein except the last column on the valley side, all other start sliding from the ground in the lateral direction.
