Vulnerability Study of Electric Power Grid in Different Intensity Area in Wenchuan Earthquake

R.S. Liu, M.J. Zhang & Y.B. Wu

Institute of Engineering Mechanics, China Earthquake Administration, Harbin 150080, China

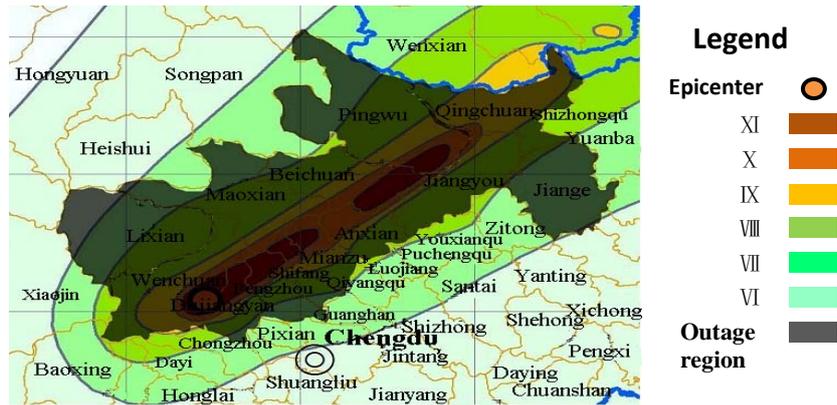
Figure 2.1. Outage situation of county or county-level city

According to the survey in Sichuan province, the earthquake had plunged some counties into total electric blackout, as shown in Figure2.1 where the blackout regions of Shanxi, Gansu and parts of Sichuan are not marked.

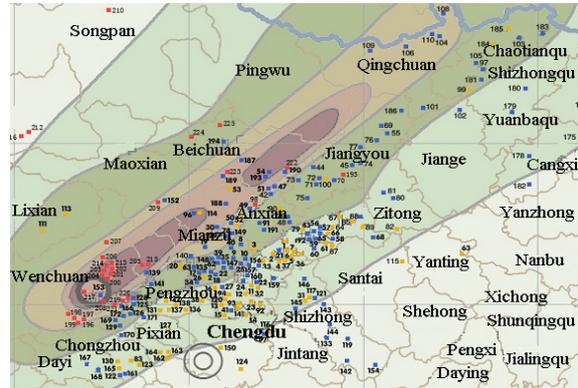
Figure 4.1. Distribution map of substation
 Note: the red is the hosted substation of state grid corporation, the blue is the outage substation and the yellow is the non outage substation

According to the collections of earthquake damage investigation, some statistics for substation outage status was conducted. The related area included Chengdu, Deyang, Mianyang, Guangyuan and Aba. Figure 4.1 illustrates the distribution of sample substations operating from 35kv to 500kv and located in intensity VII and above areas. The composition of the power supply system in Sichuan province includes the state grid and some local power companies. Nevertheless, only the state grid and the host part of the local power grid are studied here and taken as statistical samples. Since the seismogenic fault of the Wenchuan earthquake is located at the brim of the Sichuan basin, the southeast to the fault is the bottom of the basin that is a plain area with a dense population, many industries and well-developed power grids. Therefore, the samples were concentrated in this area.

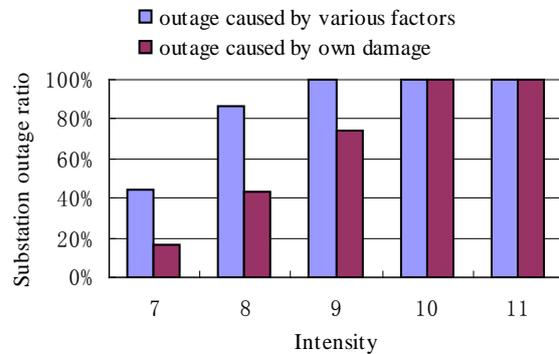
Figure 4.2. Distribution map of substation outage ratio in different intensity zones

Figure 4.2 shows the ratio of substations out of service. These substations are located in various intensity zones and belong to the state grid and the host part of the local power grids. As can be seen from the figure, in the intensity VII area, the outage ratio of electricity substations closes to 50%; in the intensity VIII area it is 85%, while almost 100% goes off in the intensity IX and higher-intensity area. In the lower intensity area such as intensity VII areas, those factors such as the power failure of the upper substation, the transformer protection and so on, dominate, while with the intensity increasing to X and above, the structures of substations were severely damaged and all outages were caused by the structure failure. This result agrees well with Figure 1 which shows the situation of many whole-county blackouts.

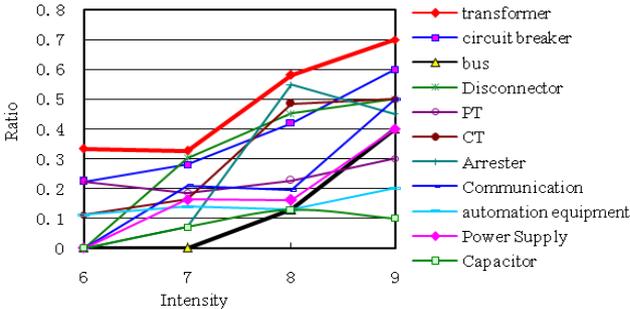
Figure 4.3. Damage frequencies of various equipments in damaged substations

In the areas with various intensities, the damage ratios of all kinds of high-voltage electrical equipments of damaged stations are shown in Figure 4.3. It is observed that, 1) the outdoor high-rise porcelain equipments such as transformers, circuit breakers, disconnect switches, current transformers, voltage transformers, lightning arresters etc. are vulnerable to damage, especially transformers; 2) indoor equipments such as batteries, monitors and so on, are less damaged unless they encountered house collapse; and 3) the bus is less damaged, which was often caused by the insulator support failure.

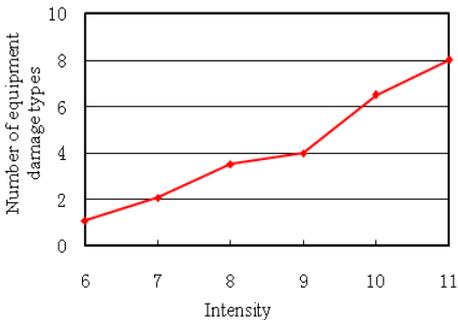
Figure 4.4. Relation between intensity and the average number of the Equipment damage type

communication equipments, capacitors and power sources. The average numbers of damaged equipment groups at outage substations are as follows: 1-2 in the intensity VI, VII area; 3-4 in the intensity VIII, IX area; 6-7 in the intensity X area; and all in the intensity XI area as shown in Figure 4.4.

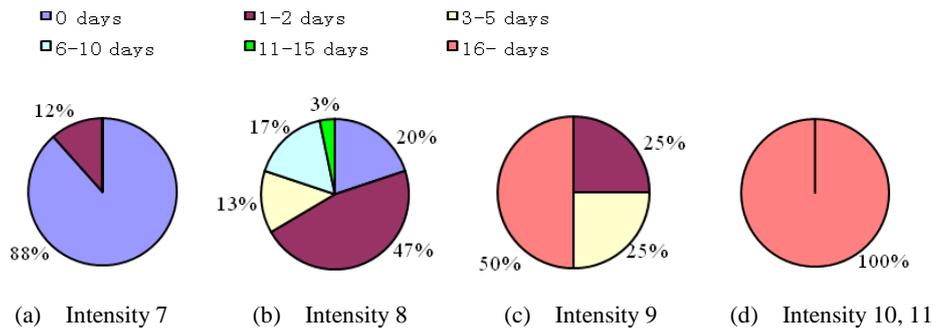
Figure 4.5. Recovery time of outage substation

The recovery times of those out-of-service substations are shown in Figure 4.5. These substations are located in the areas with intensities from VII to XI. From the figure, in the area of intensity VII, nearly 90% damaged substations can be resumed in the same day; in the intensity VIII area most damaged substations can be resumed in the next day. For intensity IX area, the average time is more than 5 days, while the intensity X and above area, it will take even longer period because of the reconstruction. Further, in high-intensity areas, in addition to the time for the damaged equipments to be repaired and replaced, it will take longer time to wait for the repair of the lines.
