Evaluation of the Efficacy of Mud Injection to Repair Seismic Cracks on Adobe Structures via Full-Scale Shaking Table Tests

M. Blondet & J. Vargas-Neumann

Catholic University of Peru, Lima, Peru

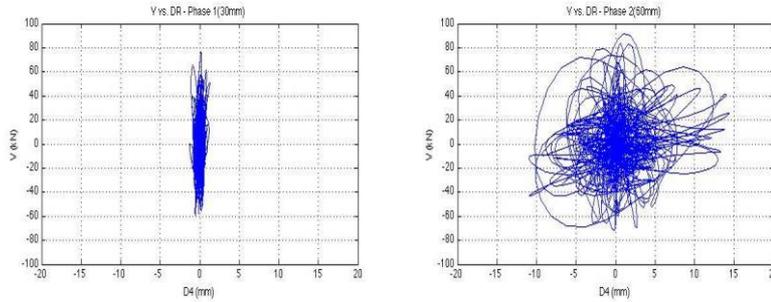
Figure 7. Base shear vs relative displacement response of the original structure

Figure 7 presents total base shear versus global displacement curves calculated for both testing phases. Base shear was computed subtracting the table inertia force from the actuator force. The global displacement is the displacement of the top of the back wall with respect to the table. During phase 1 the model remained essentially elastic, with a peak base shear of 75 kN (Fig. 7, left) and a lateral stiffness of about 60 kN/mm. During the second phase the model showed significant nonlinear response, consistent with the damage observed. The lateral strength of the module was estimated at 92 kN (Fig. 7, right).

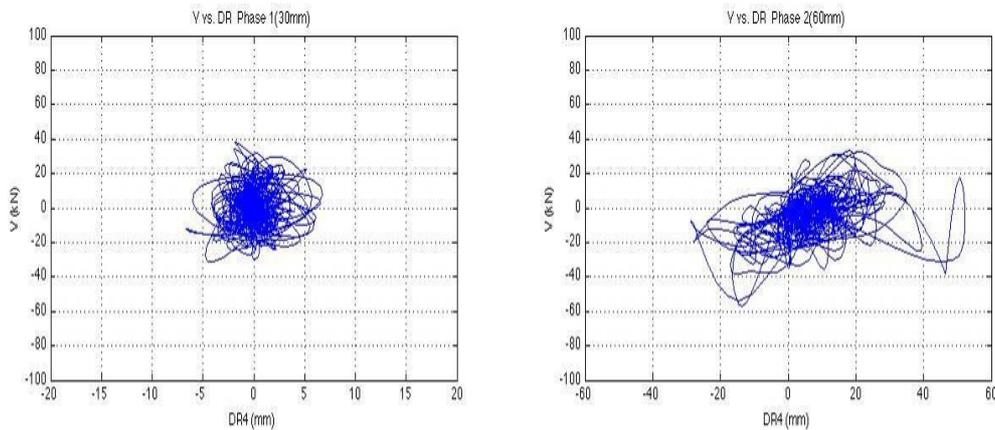
Figure 13. Base shear vs relative displacement response of the repaired structure

The base shear versus global displacement curves for both testing phases on the repaired model are shown in Fig. 13. These curves show that even during the low level phase 1 ($D = 30$ mm) the global response was nonlinear. The peak base shear was 38.4 kN, a much lower value than that of the original model (75 kN). During the second phase there was significant nonlinear response, consistent with the damage observed. The lateral strength of the module was estimated at 50 kN. This is about 54% of the strength shown by the original, undamaged structure.

These results show that the repair technique was not adequate to achieve a significant recovery of the initial stiffness and strength of the original structure. This could be due to the combination of several effects:

- The early detachment of the roof in the low level shaking ($D = 30 \text{ mm}$) probably caused the partial collapse of the back wall during the stronger shaking ($D = 60 \text{ mm}$).
- It seems possible that the interface between the material used to fill the cracks (mud or grout) and the existing adobe masonry was not sufficiently strong. Whereas during construction, the blocks are pressed on the mud mortar, when putting the filler material in the cracks, it is difficult to apply pressure. Thus, the bond between new and old material is not as strong as in the original masonry. Cracking due to drying shrinkage of the grout could also have occurred, preventing the development of good bond in the repaired areas.
