Study on the Mechanism of the Damaged Housing Lots during the 2011 Tohoku - Pacific Ocean Earthquake in Japan

S. Yasuda, K. Ishikawa, M. Watanabe & M. Yoshida

Keywords: slope failure, fill, embankment, housing lot

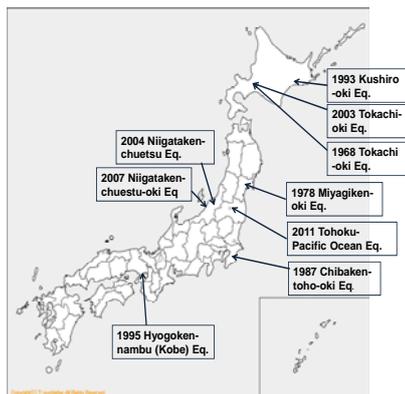
Figure 3 Earthquakes caused damage to housing lots after Tokachi-oki earthquake

Figure 3 shows earthquakes which caused damage to housing lots after 1968 Tokachi-oki earthquake. Recently almost all big earthquake has caused damage to housing lots because many housing lots have been developed gradually not only in big cities but also in medium dense populated cities. In 1978, several housing lots were damaged during the Miyagiken-oki earthquake in Sendai City. Of them severe slope failures occurred and many houses collapsed at Midorigaoka Ichi-chome housing lot as shown in Figure 4. In 1957 to 1958, this housing lot was constructed by filling a valley. During the

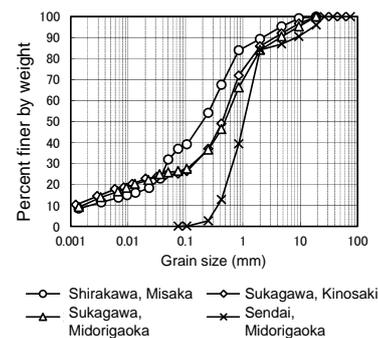
Figure 20 Grain-size distribution curves

The authors took soil samples and conducted several laboratory tests at four failed slopes in Miyagi and Fukushima prefectures to investigate soil properties. Table 1 and Figure 20 show summary of test results and grain-size distribution curves, respectively. Filled soils at three sites in Fukushima are silty sand with 25 to 37% of fines content on the other hand the soil in Sendai is clean sand with no fine. Degrees of compaction D_c tested at two sites are low as 72.4% and 86.8%. Undrained cyclic strength ratio R_L obtained by cyclic triaxial tests are 0.13 to 0.29. Relationships between degree of compaction and R_L are plotted in Figure 21 together with previous test data. R_L increases rapidly with D_c in the range of $D_c > 90\%$, despite R_L increases slightly with D_c in the range of $70\% < D_c < 90\%$. Therefore it can be said that the compaction with $D_c = 72.4$ or $D_c = 86.8\%$ must be not enough for stability of slopes if water level is high.
