# Seismic Strengthening of the Parliament Building of Republic of Macedonia: Necessity, Solution and Construction

**Z. Bozinovski, V. Shendova, G. Necevska Cvetnovska, R. Apostolska, E. Gjorgjievska & G. Jekic**

*Institute of Earthquake Engineering and Engineering Seismology, (IZIIS)  
"Ss. Cyril and Methodius" University, Skopje, Republic of Macedonia*

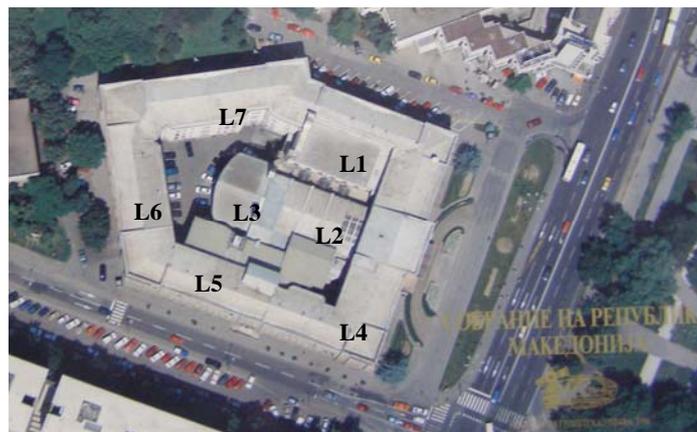
**Figure 3.1.** Individual structural units of the building (Units L1 – L7)

For the needs of further analysis, the structure has been divided into seven units in accordance with the defined expansion joints (Fig.3.1) from the aspect of the most unfavourable conditions for their individual functioning.

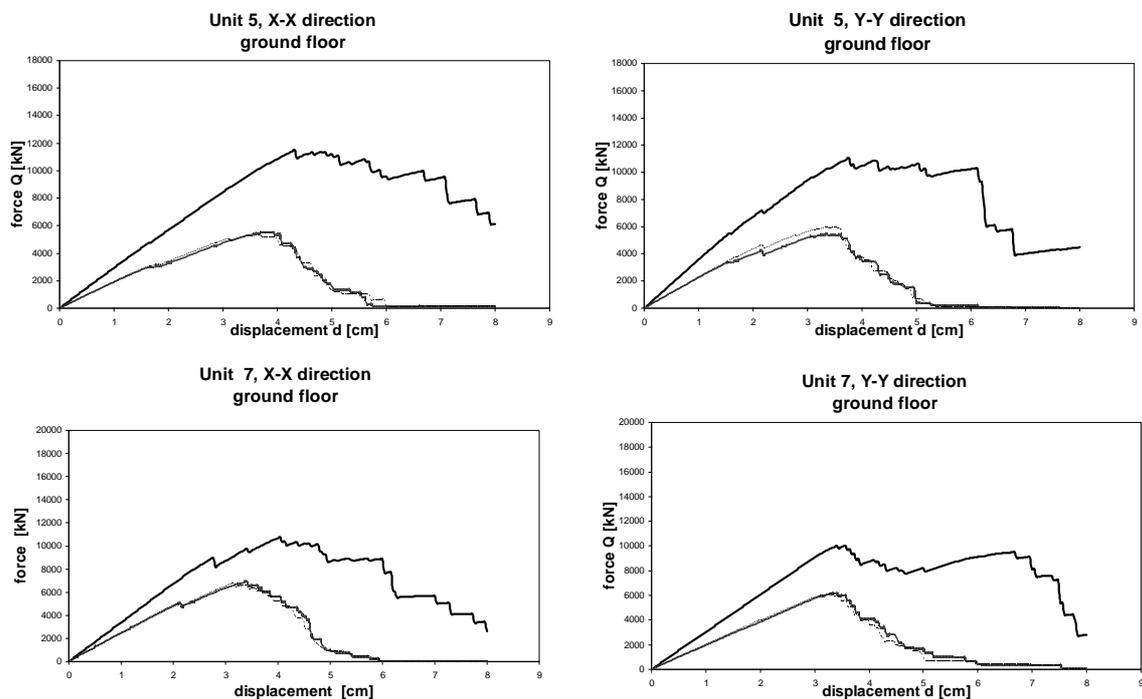
into the effect of the selected strengthening solution are shown on Fig. 4.2. The presented characteristic results obtained for the ground floor level per directions and units point to a considerable increase of both the bearing and deformability capacity of the system.

**Figure 4.2.** Comparative Q-d diagrams for characteristic units  
(--- existing state, — with additional storey, — strengthened structure)

A special parameter, which is very important for the behaviour and the stability of such type of structures during an earthquake is the capability of the structural elements to dissipate seismic energy by behaving in the nonlinear range. The presented comparative diagrams (Fig. 4.2) show that the capability for dissipation of seismic energy is considerably increased in the case of the strengthened structure compared with the existing structure and the structure with the built additional storey. The presented output results show that optimization of strength, stiffness and deformability capacity as well as capacity for dissipation of seismic energy has been done, which globally means a considerable increase of the stability of the structure under gravity and external seismic effects.
