# Fujinuma Dam Performance during 2011 Tohoku Earthquake, Japan and Failure Mechanism by FEM

## **SUMMARY:**

*Keywords: Dam, Fujinuma, Failure, Earthquake*

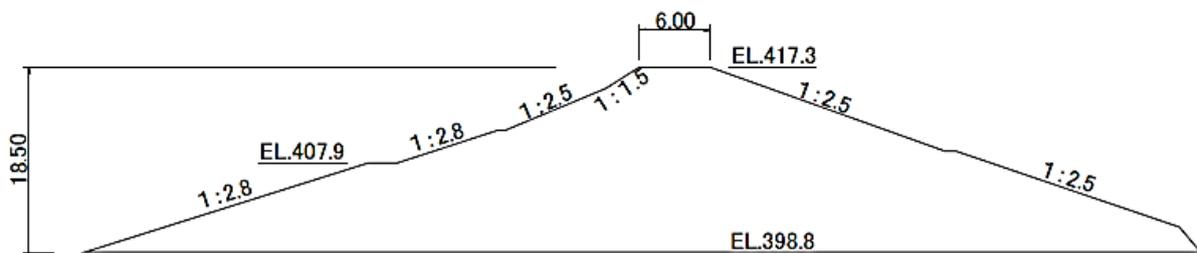
**Figure 5.** Cross Section of fujinuma dam

Fujinuma dam was Earth dam (Fig. 5) with 18.5 meters height and 133 meters crest length and reservoir volume equal to 1.5 million cubic meters. Width of dam crest was 6 meters. Upstream slope of dam was 2.5H: 1V and 2.8H: 1V and downstream slope was 2.5H: 1V. [JCOLD, 2011]

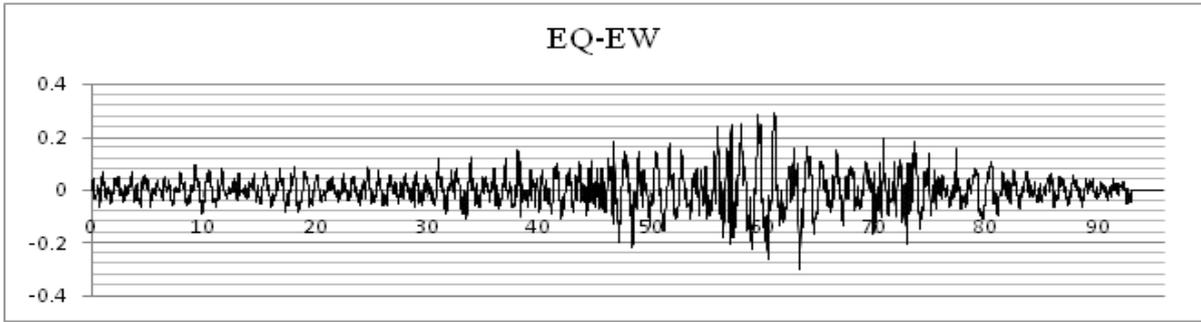
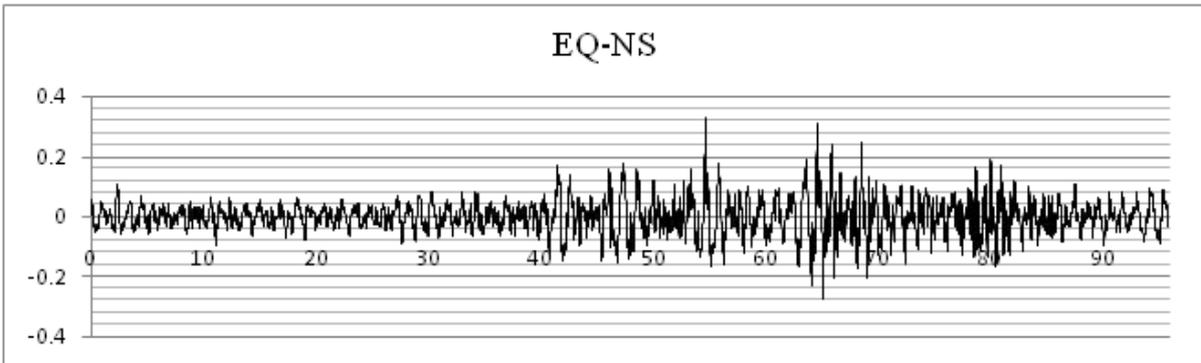
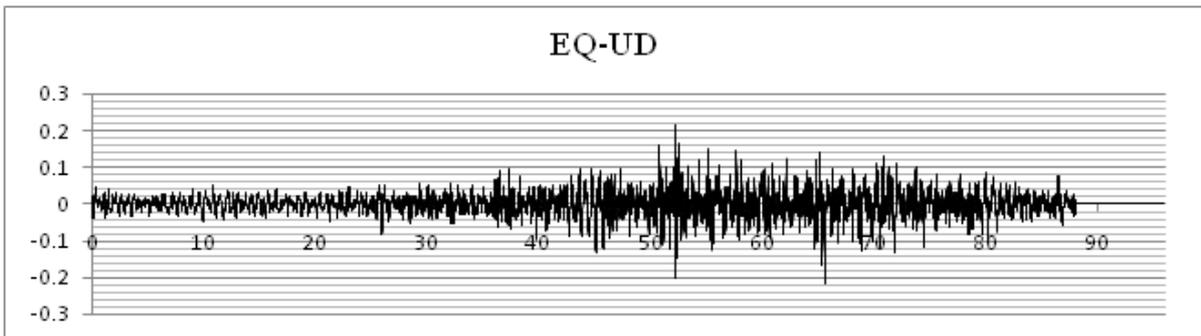
Time history of earthquake was taken from K-net Network. Naganuma station is the nearest location with 2.8 km distance to dam that records earthquake on 11 marches 2011. Maximum recorded acceleration equal to 0.315g and Earthquake has continued for 300 seconds that effective duration is equal to 96 seconds. Effective duration of earthquake is the time that has 95 percent of whole energy of earthquake (Fig.7, 8 and 9).

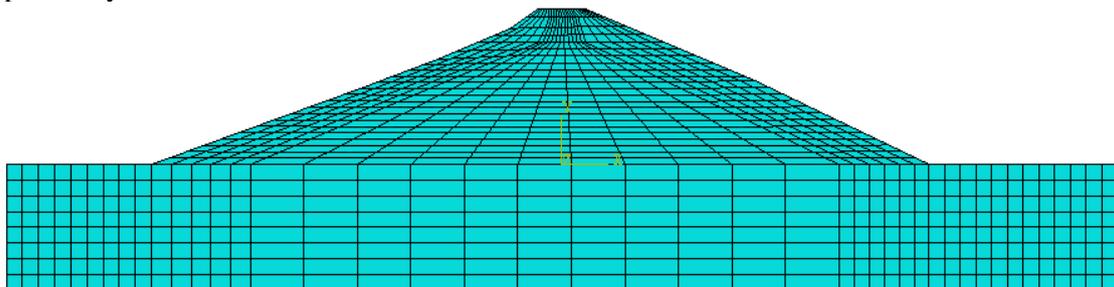
Figure 10. Dam mesh size and modelling.

Element size depends on dam size and relationship of seepage (Fig.10). This value is equal to 2 m in the general case considered. The results of dam in this condition are suitable and analysis of dam complete very well.

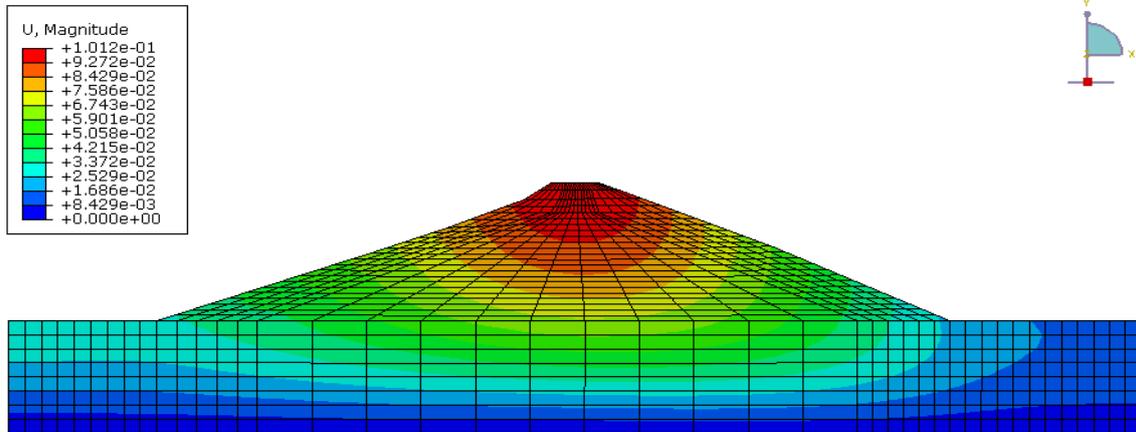
Figure 11. Displacements in t=0s of earthquake

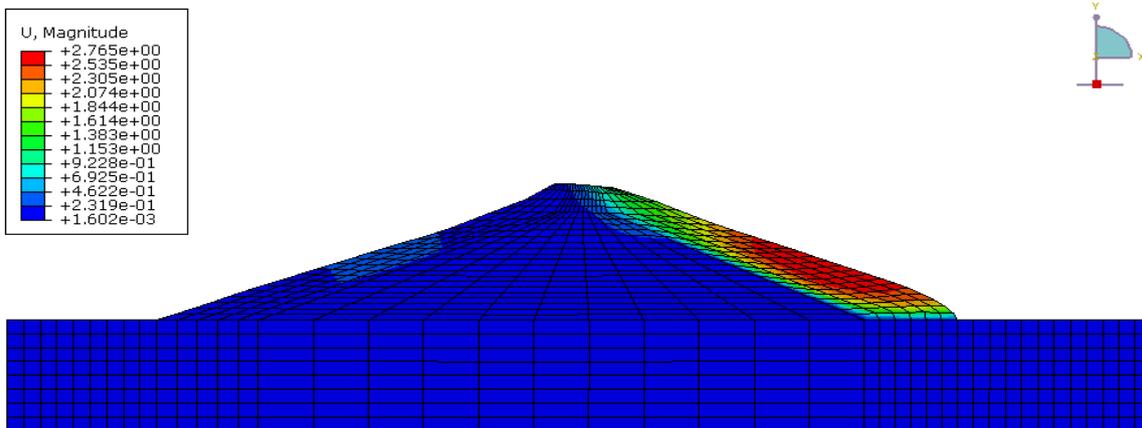
Figure 12. Displacements in t=30s of earthquake

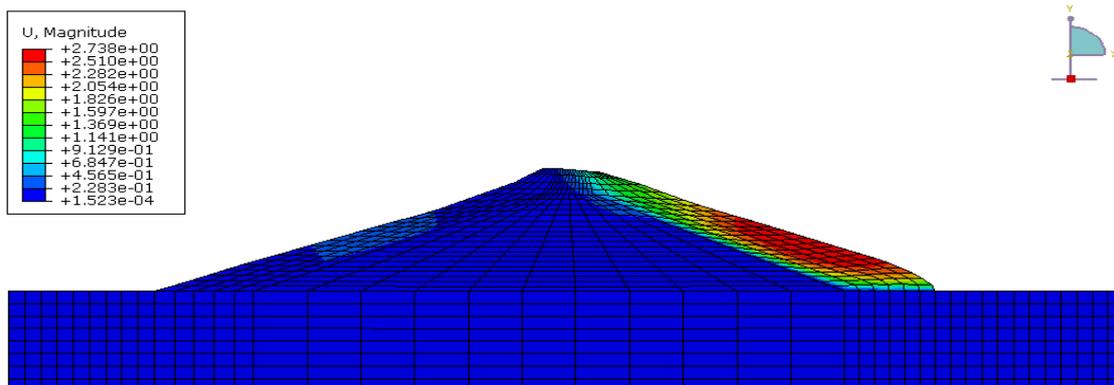
Figure 13. Displacements in t=60s of earthquake
