Performance of Port Facilities in Southern Chile during the February 27, Maule Earthquake

S. Brunet, J.C de la Llera

Pontificia Universidad Católica de Chile, Chile

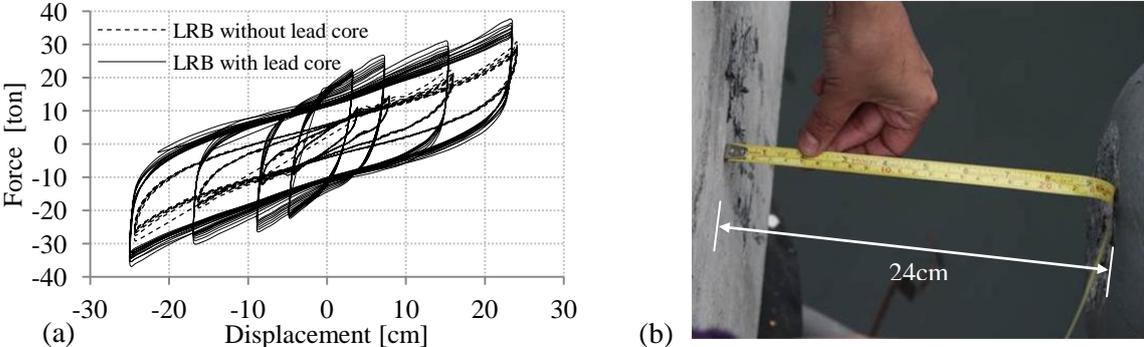
All seismic isolators were subjected to shear-compression tests to the design displacement $D_D=24.3$ cm, and 2 prototypes to a maximum displacement $D_M=29$ cm. Dynamic testing consisted in the application of 5 full cycles to lateral displacements equivalent to shear deformations $\gamma=\delta/H_R$: (i) $\gamma = 0.25$, (ii) $\gamma = 0.50$, (iii) $\gamma = 1.00$, and (iv) $\gamma = 1.5$. An axial load of 4.12 MN (420 tonf) was applied at all lateral displacements. This load corresponds to the average load for all isolators and the load combination: 1.2D+L+E. Shear forces, lateral stiffnesses, damping ratios, and shear moduli were obtained for all LRBs before and after the introduction of the lead core. A typical force-displacement hysteresis loop obtained for a LRB with and without the lead core is shown in Figure 3.4. Based on these parameters, the resulting isolated period of the pier for a design displacement D_D was $T_D=3.16$ s. Please note from the figure and table that the measured stiffnesses obtained for a typical LRB are slightly higher than the nominal stiffnesses of the vertical piles, and hence, isolators will be subjected to a higher shear force demand than vertical piles.

Figure 3.4. (a) Experimental force-displacement hysteresis loop; and (b) relative displacement measured between isolated berthing zone and non-isolated approach zone in South Coronel Pier

These results should be ideally compared with the ones derived from recorded ground motions in the past February 27, 2010, Maule event. Assuming that the available San Pedro record (Chile, 2010) is representative of the motions in the region (soft soil), the response history results for this record are presented in Table 3.1 just as a reference. The predicted lateral displacements of the CM of the pier for the San Pedro record were 17 cm in the longitudinal and 12.5 cm in the transversal direction. This displacement is less than the one predicted by the NCh2745 design spectrum, but it is consistent with the one observed at the isolation joint shown in Figure 3.4(b). This picture shows that there was pounding at the isolation joint between the isolated berthing zone and a drain pipe mounted on the non-isolated approach zone indicating that the relative displacement between the two structures was at least 24 cm in the longitudinal direction, which represents the sum of the displacements for the berthing and approach zones—the location where the picture was taken is shown in Figure 3.2. The maximum LRB displacement predicted by the model was 14.8 cm, which represents 61% of the design displacement D_D ; a shear force close to 255 kN (26 tonf) (70% of the design value), and apparent response periods of $T=1.96$ s and 1.97s for X- and Y-directions, respectively.
