# The August 23, 2011 Magnitude 5.8 Virginia Earthquake in the Eastern United States - An Engineering Perspective

## **SUMMARY:**

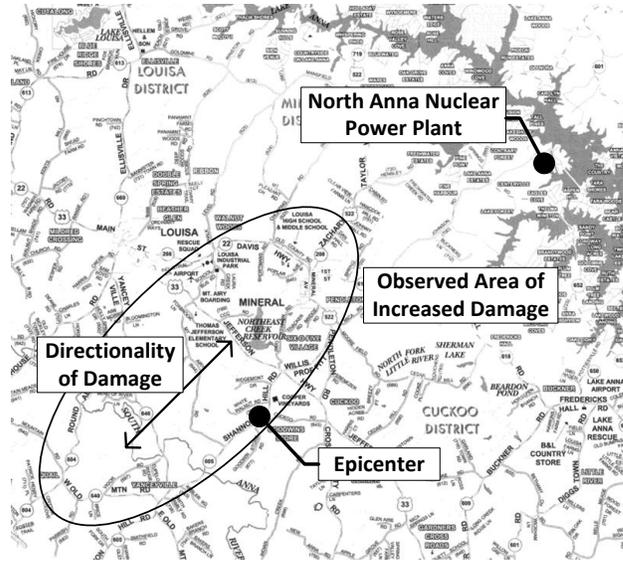
**Figure 3.1 Map of Epicentral Regions with Location of Increased Damage**

Since the epicentral region is a rural area, the building stock is mostly one to two story residences, and low rise commercial structures. As mentioned previously, there is a nuclear power plant nearby as shown in Figure 3.1 along with a map of Louisa County. The area around the epicenter with increased damage was oriented along a SW / NE line adjacent to the epicenter. A strong directionality was noted in the damage experienced in several buildings which seemed to correlate with this orientation. A similar band of larger seismic intensity is demonstrated in Figure 2.3b
