The Effects of Site and Soil Conditions To the Earthquake Damage: Oct, 23 2011 Van-Tabanlı Earthquake ($M_w=7.2$)

SUMMARY:

Keywords: Earthquake damage, local site conditions, strong motion data

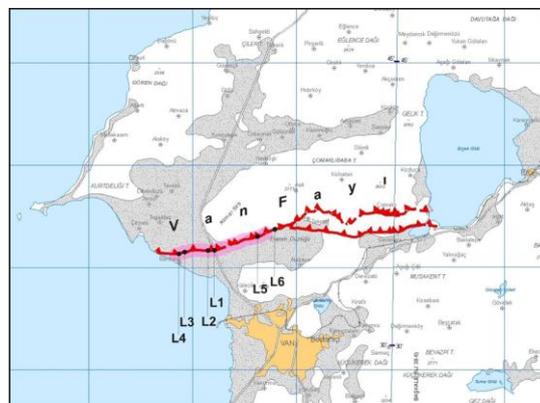
A thrust fault in north of Van was reactivated by a 7.2 earthquake on October 23, 2011. This fault is called Van Fault by Akyuz *et al.* (2011) and Emre *et al.* (2011) extending between Lake Van in west and Lake Ercek in east and it was not mapped in previous studies (Figure 2). The total length of the fault is about 27km in land, but it probably continues both further west and east beneath Lake Van and Lake Ercek, respectively. The northern side is uplifting along the nearly E-W-trending fault line (Figure 3). The October 23rd, 2011 Van earthquake involved surface faulting between Lake Van in west and Lake Ercek in east. Surface rupture was mapped by different teams in the field. According to Akyuz *et al.* (2011), the rupture extends for a distance of about 4km in north of Bardakçı Village. However, Emre *et al.* (2011) mapped about 10km long surface rupture for the October 23, 2011 Van earthquake (Figure 2.3). The northern block uplifted up to 10cm along the surface rupture. Compressional deformation structures observed in the field (Figure 3) along the rupture zone indicates thrust faulting. Akyuz *et al.* (2011) states that the surface rupture occurred during the October 23, 2011 earthquake follows a pre-existing morphological scarp which was probably produced by historical earthquakes.

Figure 3. Surface rupture map of the October 23, 2011 Van earthquake (Emre *et al.* 2011) (pink line is the surface rupture)

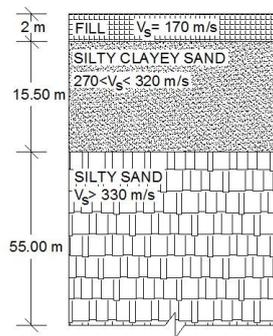
Figure 9. Idealized soil profile in Ercis

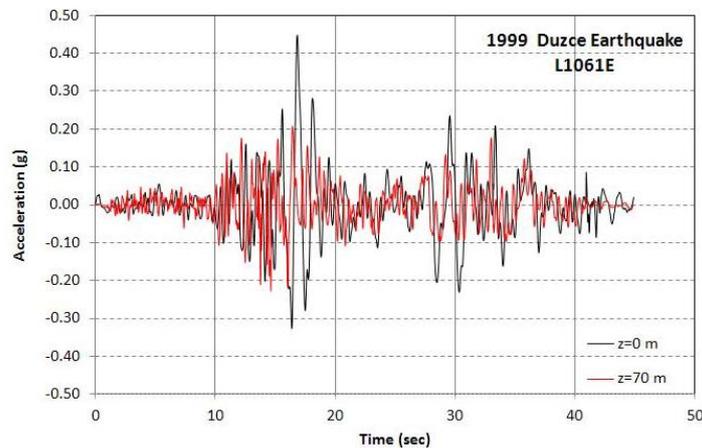
Site amplification plays a major role on damage distribution during earthquakes. Some typical soil layers (unconsolidated soils) can amplify earthquake ground motions resulting in damage to structures far from the epicenter of the earthquake. A site response analysis was performed with a typical site profile near Ercis to recognize if soil amplification took place during the earthquake. An idealized soil profile based on 21 borehole results in Ercis was taken out (Figure 9). Duzce ($M_w=7.1$) earthquake ground motion records (recorded at site class B) have been used as bedrock motion at engineering bedrock level ($z=70m$ for this site). The motions at the surface ($z=0$) for Duzce, 1999 is determined after site response analyses by using SHAKE2000, and the motions corresponding to Duzce Earthquake, 1999 are given in Figure 10. The peak ground accelerations at the surface increased between 59-96% with respect to the bedrock motion.

Figure 10. Time histories at surface ($z=0$) and $z=70$ m depth obtained from site response analysis at idealized soil profile in Van region with using Duzce earthquake ground motion record in E-W direction

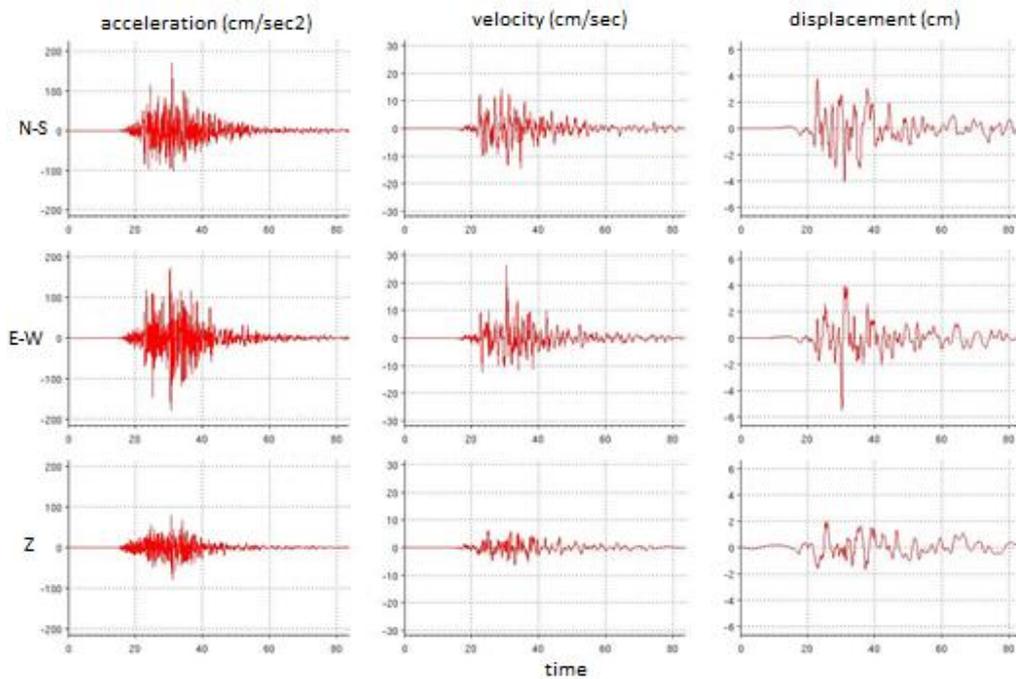
Figure 13. Acceleration, velocity and displacement time histories of the recordings of $M_w=7.2$ earthquake at the Van- Muradiye station

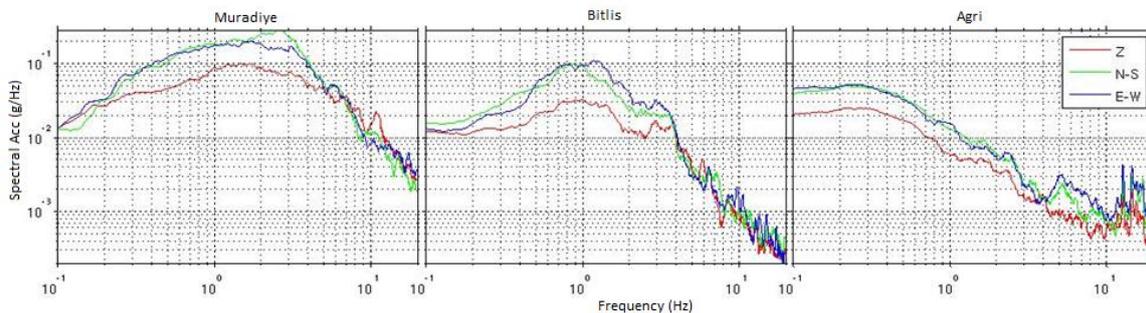
Figure 14. The acceleration amplitude spectra of the strong motion recordings at Muradiye, Bitlis and Agri stations

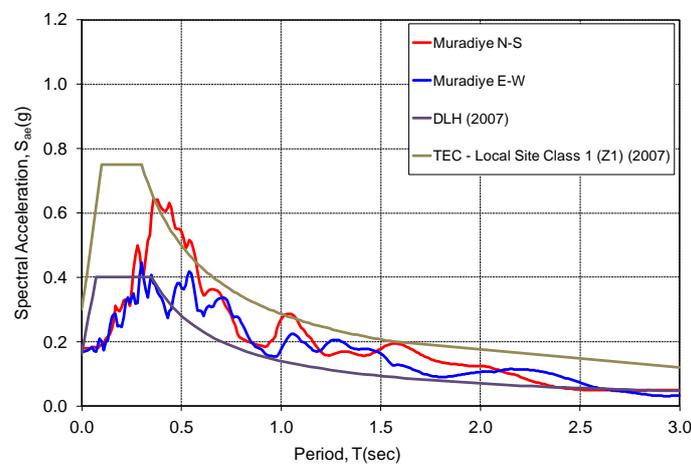
The strong motion recordings of the main shock are provided by the National Strong Ground Motion Network operated by the Earthquake Department of the Disaster and Emergency Management Presidency (<http://www.deprem.gov.tr>). Three of the stations are located within 150 km of the epicenter of the main shock; Muradiye, Bitlis and Agri. Figure 12 shows the acceleration, velocity and displacement time histories of the ground motion recorded at Muradiye Station during the October 23, 2011 Van-Tabanlı earthquake. Figure 13 shows the acceleration spectra of the ground motion recorded at Muradiye, Bitlis and Agri Stations during the October 23, 2011 Van-Tabanlı earthquake. It can be seen that the ground shaking observed was low with peak accelerations not exceeding 0.2g in both horizontal directions, vertical accelerations below 0.1g, and the duration of strong ground motion in the order of 20 seconds. Peak ground accelerations of 0.18g, 0.101g and 0.018g are recorded at Muradiye Station (46 km away from the epicenter), Bitlis station (116 km away from the epicenter) and Agri station, respectively. Response spectra of the earthquake ground motions recorded during the October 23, 2011 Van-Tabanlı earthquake are given in Figure 14. Design response spectra corresponding to 10% probability of exceedance in 50 years with respect to Turkish Earthquake Code (TEC, 2007) and Turkish Seismic Code for Shore Structures (DLH, 2007) are also included in Figure 15. As can be seen from Figure 15, the design response spectrum as given by DLH (2007) falls below the response spectrum of the earthquake ground motion recorded at Muradiye station, whereas TEC

(2007) spectrum fits quite well to this spectrum for the October 23, 2011 Van-Tabanlı earthquake.

Figure 15. Response spectra of Van-Tabanlı earthquake of October 23, 2011
