PERFORMANCE OF STEEL STRUCTURES DURING THE FEBRUARY 27, 2010, CHILE EARTHQUAKE

R. Herrera & J. F. Beltran

Universidad de Chile, Santiago, Chile

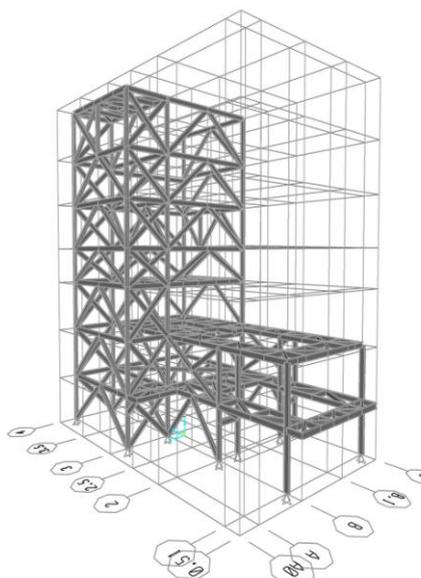
Figure 9: Industrial mill building.

The mill building was not directly affected by the earthquake, because it is located in the north part of the country, but it is a structure representative of the industrial buildings designed in Chile and can, therefore, give an insight on the causes of the performance achieved by these structures. The building’s lateral load resisting systems are concentrically braced frames, as shown in Fig. 9. It has a

height of approximately 21.5 m with a larger floor area in the lower two stories, which are 3.25 m high each. The material is steel ASTM A36 and beams and columns are built up I shapes, while braces are either built up I shapes or XL shapes (starred angles). The dimensions of the structural members are shown in Table 5.1. More details on this structure can be found in Astica (2012).
