Regions Of Liquefaction Damage In Kaiapoi Following The Canterbury Earthquakes And Their Correlation With Former River Channels

L.M. Wotherspoon, M.J. Pender & R.P. Orense

The University of Auckland, Auckland, New Zealand

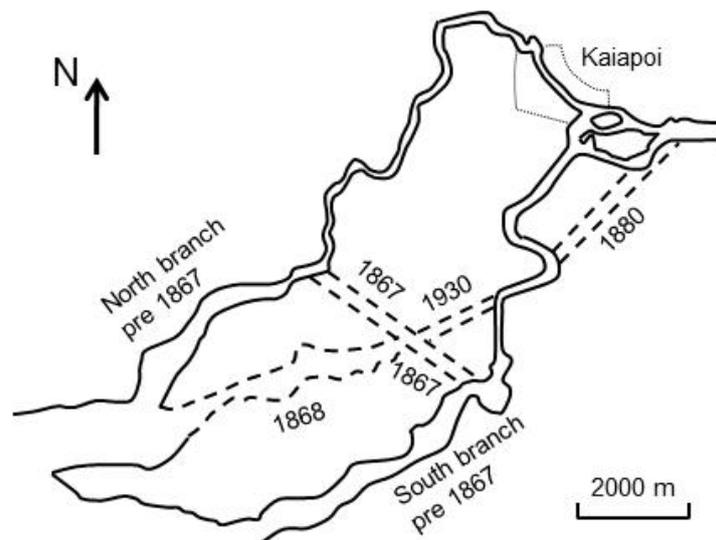
At the time of the first settlement of Kaiapoi, the Waimakariri River had two branches shown by the solid lines indicating the pre 1867 river channels in Figure 2. The north branch (which would later be renamed the Kaiapoi River) ran through the centre of the town (the dotted line in Figure 2 indicates the outline of present day Kaiapoi), while the south branch passed to the south and along the eastern edge of the town. The two branches split to the south west of Kaiapoi, and rejoined to the east of the town, forming Kaiapoi Island where the southern part of town was located. Throughout the 1860s, the main flow of the river passed along the north branch and through the middle of Kaiapoi (Ward & Reeves 1865, Wood 1993).

branch in 1867 shown in Figure 2. Soon after this, to combat the flooding of the town and island, local residents carved out a new channel in 1868 from the north branch to the 1867 channel as indicated in Figure 2. This choked off the north branch and shifted the flow of the river to this new channel and the south branch (Logan 2008). Downstream, the entire flow of the Waimakariri was carried by the remaining south branch channel.

In 1897-1880, the course of the river shifted away from the eastern edge of Kaiapoi along the channel shown in Figure 2. This meant that the entire flow of the Waimakariri was no longer passing along the edge of the town, and this reduced down to a small stream. The network of channels to the east of the town reduced down to a single channel further east of the town, with the now minor flow from the north branch connecting up to this main channel in this area.

By 1923 the north branch has been totally blocked off from the Waimakariri by stopbanks and only drained the surrounding swampland. At this time the vast majority of the flow was through the channel created in 1867 and 1868 up to its point of confluence with the south branch. In response to flooding, a major river improvement scheme was implemented to improve the channel and stopbank system (Logan 2008). The cut in 1930 shown in Figure 2 was excavated, straightening the river to its current course (following channels indicated by 1868, 1930 and 1880). Further improvements to the stopbank network were made in the 1960's, with the capacity of the system increasing in a stepwise manner up to the present.

Figure 2. Waimakariri River modifications since European settlement

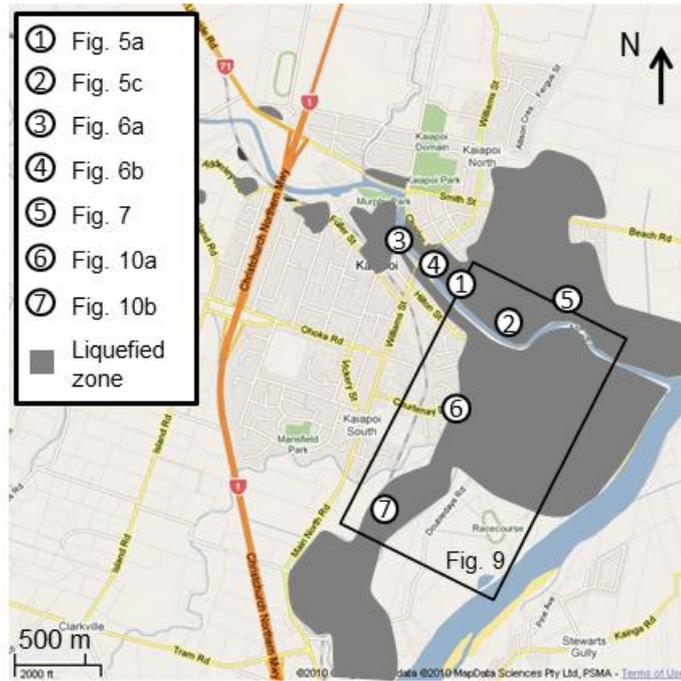
Figure 4. Location of key areas of liquefaction-induced damage outlined in following figures

Examples of the damage to structures along this area of reclaimed land are presented in Figure 6, the locations of which are indicated in Figure 4. The Mandeville footbridge, a wooden bridge spanning the Kaiapoi River built in 1874 and abutting an old reclaimed rubbish dump area, suffered severe buckling damage as a result of the compressive forces from lateral spreading of both riverbanks. The Kaiapoi Visitors centre, directly adjacent to the north bank of the Kaiapoi River, back-rotated approximately 5° away from the river as a result of lateral spreading.
