Seismic Monitoring of Reinforced Concrete Buildings Following the Mw 8.8 Feb 27th, 2010 Offshore Maule Earthquake in Chile

Following the February 27, 2010 Mw 8.8 earthquake impacting central Chile, a team of U.S. researchers, professionals, and local collaborators instrumented several reinforced concrete buildings in Santiago, Chile, to measure aftershock response data. The selected buildings, designed according to ACI 318-95, represent typical construction, e.g. moderate to high rise office buildings with large office space and inner core shear walls and mid-rise residential shear wall buildings. Instrumentation consisted mainly of accelerometers as well as some displacement transducers with data recorded using digitizers. Several aftershocks were captured over a period of one month. Data collected were processed and system identification algorithms were used to determine modeling parameters (e.g. building periods, acceleration amplification, inter-story drifts). Investigations included analyses to assess building rocking and torsion, and assessment of diaphragm in-plane rigidity. An overview of the instrumented buildings, recorded data, and analytical results will be presented,

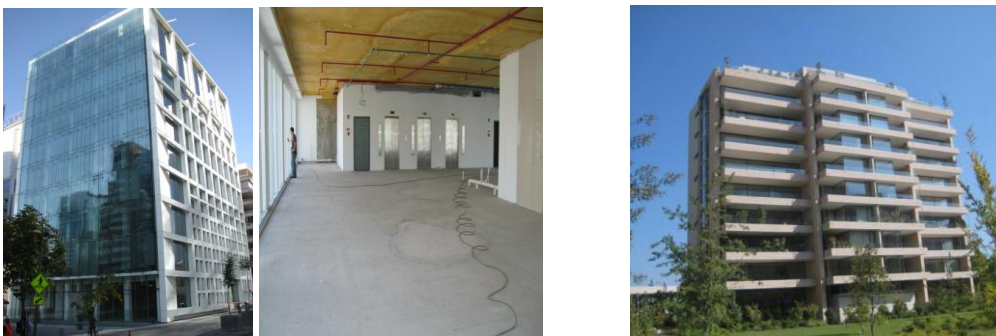
The second building, referred to hereafter as “*Building B*”, was located in a newly developed residential district of Santiago in the north east of the city (Independencia) and represents a 10-story reinforced concrete shear wall building with one level of underground parking. At the time of instrumentation only floor 2 and 9 were unoccupied and chosen for instrumentation. The building suffered structural damage at the underground parking level which consisted mainly of concrete cracking and rebar buckling at the column and wall – ceiling slab connections. Damage on the ground level included column buckling in 2 structural columns supporting the second floor, and moderate cracks along interior and exterior shear walls. Smaller shear cracks were also observed in floors 2-10, mostly occurring in exterior walls when windows were present in the walls on the floors below. Figure 2.1c shows an outside view of *Building B* and Figure 2.2 a-d presents photographs of some structural damage observed in *Building B*.

Figure 2.1 a,b&c: Photographs of instrumented *Building A* (2 left photographs) & *B* (right) in Santiago
