THE EARTHQUAKE OF 28 JULY 1957 IN MEXICO CITY
by Emilio Rosenblueth*

Introduction

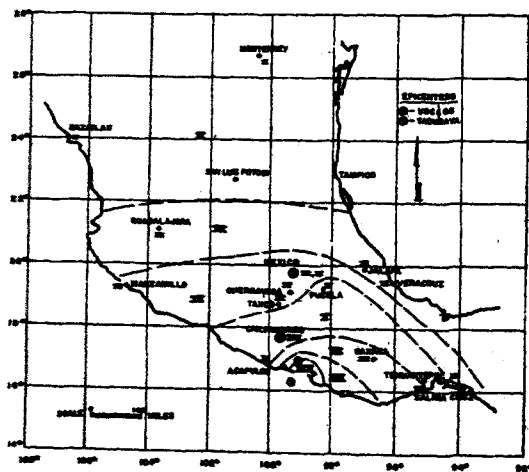
FIG. 2 ISOSEISMAL MAP, MEXICO EARTHQUAKE OF JULY 28, 1957. MODIFIED MERCALLI INTENSITY SCALE, 1931 (After Duke and Leeds)

The time in Mexico City was 2:40:51 a.m.⁽³⁾ Tacubaya reports the epicenter at 16°21'N, 99°13'W, 358 km south of the city (Fig. 2).⁽²⁾ The underwater fault in question belongs to the Middle American Trench and may be regarded as a continuation of the San Andreas fault.⁽⁴⁾

Curves in Figs. 2 and 3 are based on witness accounts, appraisal of damage, and, in Fig. 3, on horizontal accelerations computed from the dimensions of brick fence walls that collapsed.⁽⁶⁾ The method for computing horizontal accelerations is debatable but practically all the walls had the same height and thickness in compliance with Federal District regulations. This makes the procedure appropriate for comparative purposes.

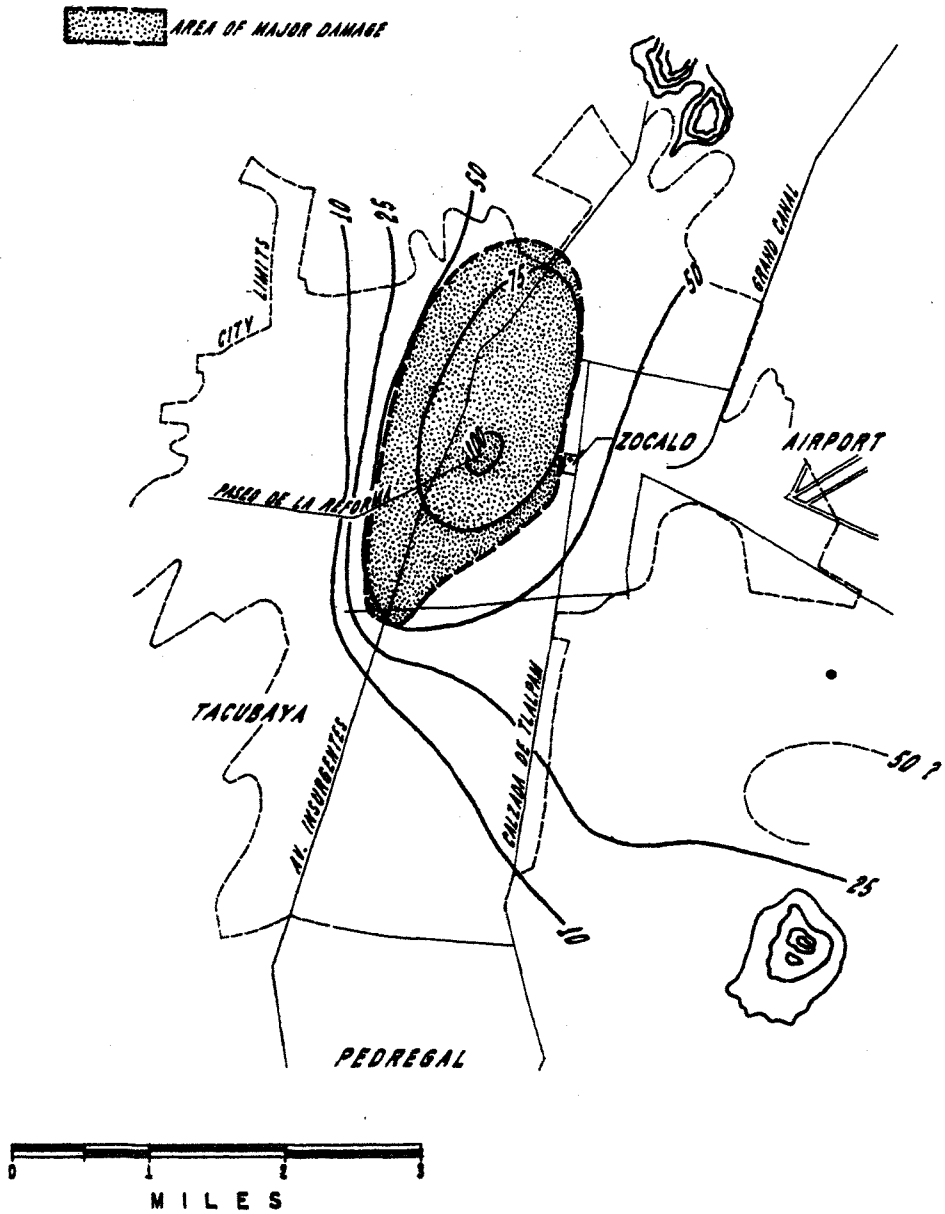
FIG. 3.- ISOSEISMAL MAP, MEXICO CITY, EARTHQUAKE OF JULY 28, 1957. ACCELERATIONS IN CENTIMETERS PER SECOND PER SECOND COMPUTED FROM DAMAGE OBSERVATIONS. (AFTER MERINO Y CORDONADO)

A similar phenomenon is noticeable in Mexico City itself (Fig. 3). J. Merino y Coronado⁽⁶⁾ has remarked that curves of maximum intensity coincide roughly with those of maximum rate of settlement of one foot per year in response to extensive pumping of underground water;⁽⁸⁾ zones subsiding at a faster rate were associated with softer ground (higher water content) and denser population. Precisely the same factors led to greater earthquake damage.

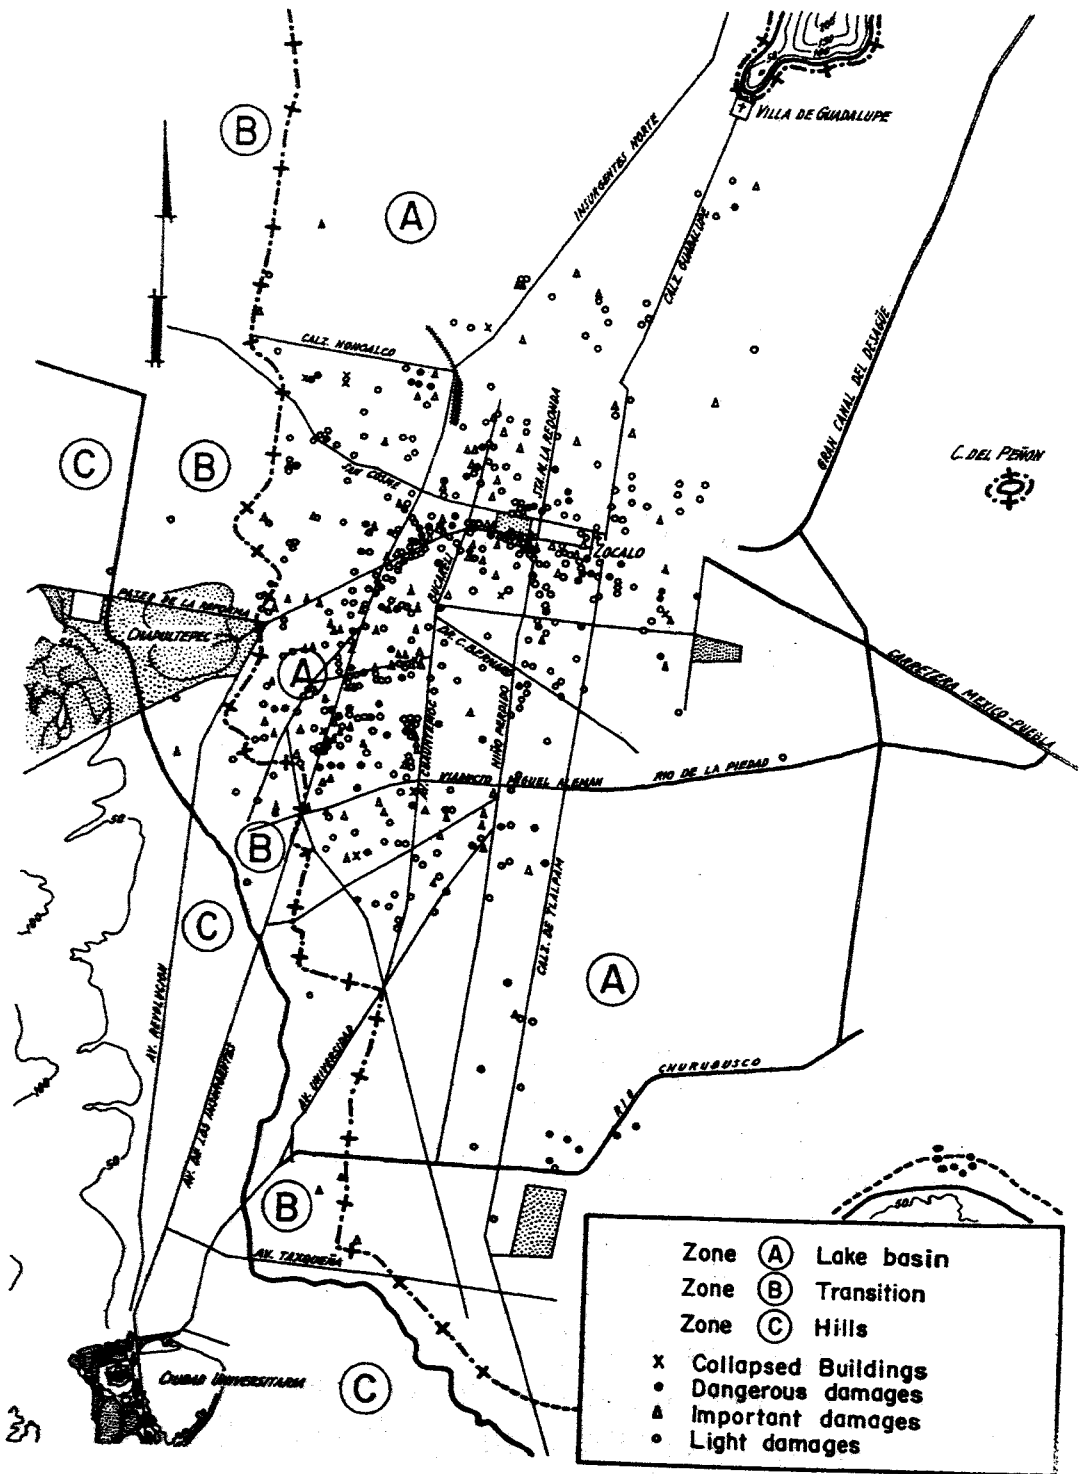
Fig. 4. MEXICO CITY'S ZONE CLASSIFICATION ATTENDING TO THE MECHANICAL CHARACTERISTICS OF THE SUBSOIL, AND DISTRIBUTION OF THE DAMAGES CAUSED BY THE EARTHQUAKE OF 28 JULY (After Marsal)

Before enumerating damages in Mexico City one should describe subsoil conditions. Zones of the Valley of Mexico are well defined in terms of subsoil conditions. The following description as well as Figs. 4 and 5 were taken from Ref. 10. The figures are slightly modified in the light of more recent information.⁽⁸⁾

With basis on information from over 400 borings, there are three distinct zones (Figs. 4 and 5). Essentially the same division was proposed as early as 1953:⁽¹²⁾
