AN ANALYSIS OF DAMAGE TO HANSHIN ELEVATED EXPRESSWAY DURING 1995 KOBE EARTHQUAKE

Satoko ABE, Yozo FUJINO, Masato ABE

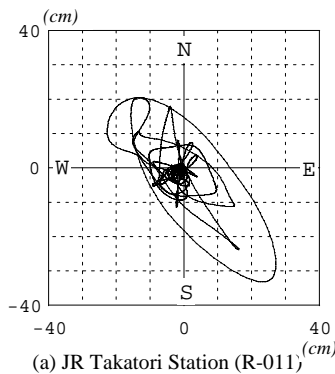
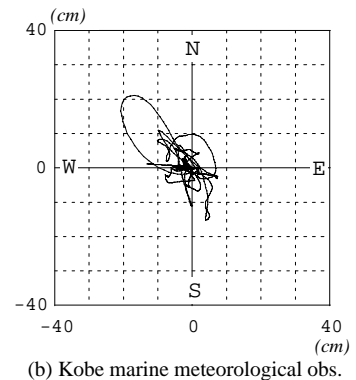
Figure9: Direction of Ground motion

Fig8 shows the direction of the residual inclination of the RC single piers from P50 to P300, while Fig.9 shows the orbit of the horizontal ground motion measured. It is clear that the dominant direction of the residual inclination is similar to the dominant direction of the ground motion.
