GEOTECHNICAL ISSUES OF THE JUNE 27, 1998 ADANA-CEYHAN EARTHQUAKE

Korhan ADALIER¹ And Ogun AYDINGUN²

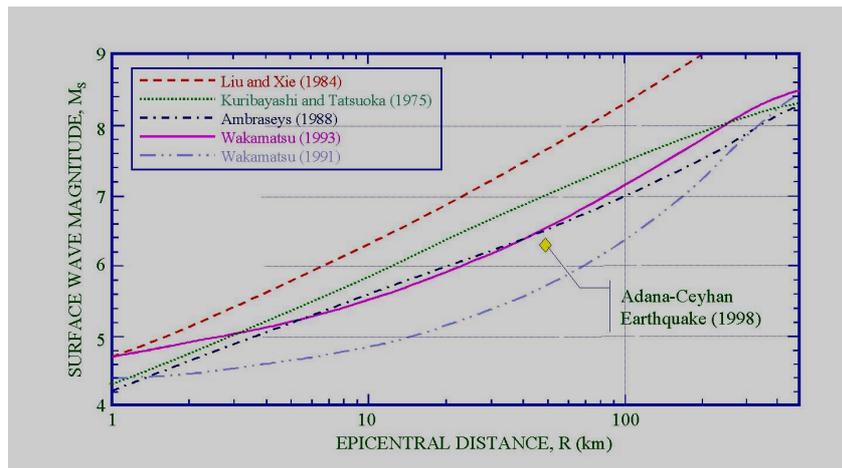
Numerous rock-falls and landslides were reported in the nearby Cebelinur-Misis Mountains. No fault related surface fracturing was observed in the field, probably due to the rather soft and deep alluvial soil layer covering the area and the depth of the fault plane. Almost all of the significant geological deformations were associated with soil liquefaction. Most of the liquefaction related subsidence, lateral spreading, slope failures, and sand boils happened in the low lying areas of the epicentral region along the Ceyhan river (concentrated mainly within a zone of less than 1 km from the river banks). Liquefaction was observed as far as 50 km from the epicenter at the Buyuk Almagolu district. Based on the distribution of liquefaction during past earthquakes, several researchers have proposed upper bound relationships for farthest epicentral distance to a liquefied site versus the earthquake magnitude (Figure 4). It is clearly seen that, during the Adana-Ceyhan earthquake of June 27, 1997, liquefaction occurred far from the threshold predicted by all except Wakamatsu (1991). This further indicates the very high liquefaction susceptibility of the river sedimented young alluvial sands in the region.

Figure 4: Epicentral distance to farthest liquefied sites predicted by different researchers and the Adana-Ceyhan case.
