DAMAGE TO A PILE FOUNDATION DUE TO LIQUEFIED GROUND MOTION

Shin'ichiro MORI¹, Atsunori NUMATA² And Baoqi GUAN³

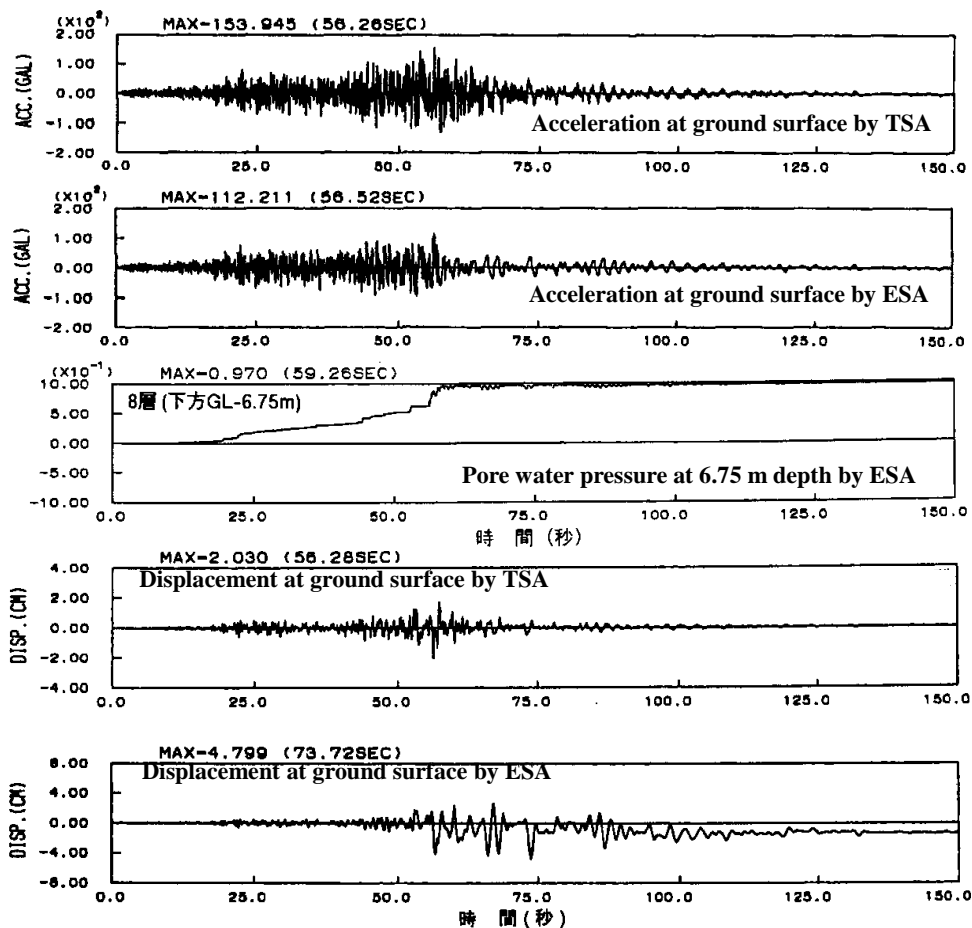
Fig. 9 Time histories of acceleration and displacement responses at ground surface both by effective stress analysis (ESA) and total stress analysis (TSA), and the time history of excessive pore water pressure in a depth of 6.75 m by ESA

The time histories of acceleration and displacement responses at ground surface both with effective stress analysis (ESA) and total stress analysis (TSA), and the time history of excessive pore water pressure in a depth of 6.75 m by ESA are shown in Fig. 9. Difference between ESA and

TSA before 45 seconds is observed to be very small. On the contrary, after 53 seconds, the amplitude of acceleration decreases and the higher components of displacement diminish in the results of ESA compared with those of TSA. Furthermore, after 56 seconds when excessive pore pressure reaches the maximum of 97 %, it can be clearly seen and understood that the amplitude of acceleration suddenly decreases and that of displacement suddenly increases. In addition, south-directed residual displacement at ground surface can be seen.

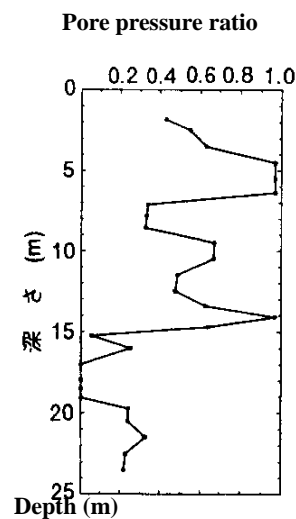
Fig. 10 Distribution of pore water pressure ratio along depth

The profile of excessive pore water pressure ratio is shown in Fig. 10. This figure explains that complete liquefaction was spread along the depth of 4 to 6 m in reclaimed silt layer and the pore pressure in the upper part of As1 layer and in a part of As2 layer reached a considerable level.
