# Seismic studies of the San Francisco-Oakland Bay bridge

A. Astaneh-Asl University of California at Berkeley, Calif., USA

ABSTRACT: During the October 17, 1989 Loma Prieta earthquake, the San Francisco-Oakland Bay bridge sustained some damage and was closed for a month. Following the earthquake, a comprehensive research project has been underway at the University of California at Berkeley to study seismic behavior of the bridge and formulate retrofit seismological, geotechnical and structural aspects. By developing realistic models of the bridge and subjecting the models to realistic ground motions, seismic deficiencies are being identified. This paper summarizes the progress of this study.

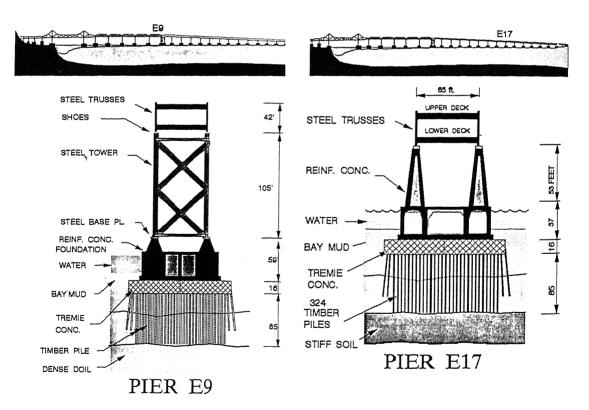
Figure 3. Typical Structures of the East Bay crossing

supported on steel columns with the exception of Pier E17 which is a hollow reinforced concrete pedestal as shown in Figure 3. During the earthquake, apparently these six spans had moved together in the east-west direction about 13 cm. causing the concrete pedestals at Pier E17 to rock about their base. The rocking caused some damage to the concrete at the base of the pedestals.

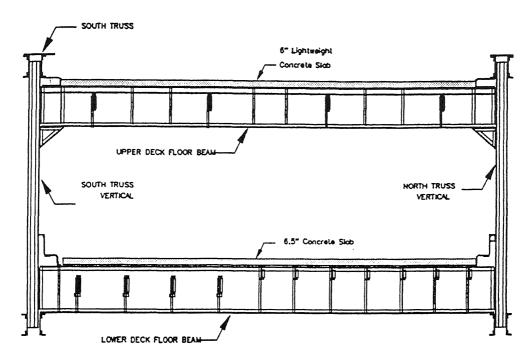
Figure 4. Typical cross section of the bridge

As shown in Figure 4, the concrete deck of the Bridge is supported on longitudinal stringers which in turn are supported by double angle connections to the web of floor plate girders. Investigation of behavior of deck system indicated that the double angle connections can experience considerable yielding due to axial push-pull when bridge moves in longitudinal direction. To study cyclic behavior of these connections comprehensive experimental and analytical studies are underway. A total of 14 test of full scale connections have been tested under simulated cyclic loading.
