Analysis of the collapsed Armenian precast concrete frame buildings

Loring A. Wyllie, Jr

H.J. Degenkolb Associates, Engineers, San Francisco, Calif., USA

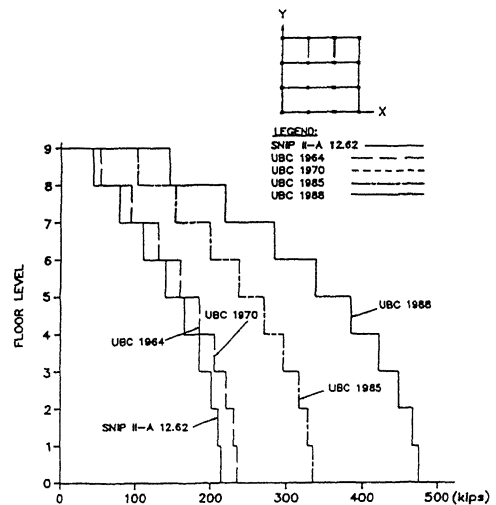
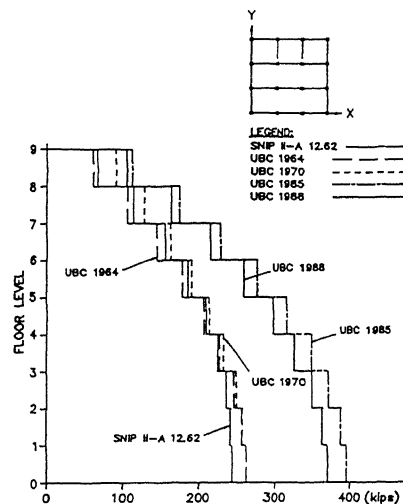
Figure 2 Seismic Shear for Various Design Codes

a. Seismic design shears in X-direction or moment frame direction.

b. Seismic design shear in Y-direction or shear wall direction

The analysis indicated that the design of the buildings did comply with the Soviet SNiP 62 code. Figure 2 shows the story shears for the square building configuration for the various codes studied. It is very interesting to note how close the Soviet code parallels the UBC of the United States at that time. However, it should be pointed out that the story shears calculated by the Soviet code contain a 1.4 factor which the author believes to be similar to a load factor in United States codes. The UBC story shears shown in the figure are unfactored shears.
