# Correlation between recorded building data and non-structural damage during the Loma Prieta earthquake of October 17, 1989 – Selected case studies

S.S.Rihal

California Polytechnic State University, San Luis Obispo, Calif., USA

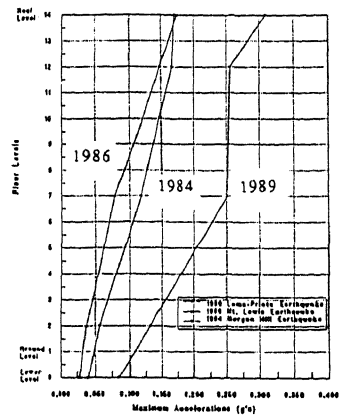
Figure 6

- Thresholds of response motions that produce non-structural component damage.  
At the 7th floor level peak recorded acceleration was 0.257g and peak recorded displacement was 10.12 inches in the E-W direction. Significant non-structural component damage occurred at this floor level, especially during the 1989 Loma Prieta earthquake.  
The number of cycles of recorded floor accelerations ( $\geq 0.05g$ ):  
Non-structural components @ 7th floor level experienced 35 cycles of floor accelerations with amplitudes  $\geq 0.05g$ . This may be one significant reason for the extensive nonstructural damage observed during the 1989 Loma Prieta earthquake.

CSMIP PROJECT Santa Clara County Building Case Study Maximum Recorded Accelerations vs. Floor Levels SW Corner of Building in East-West Direction

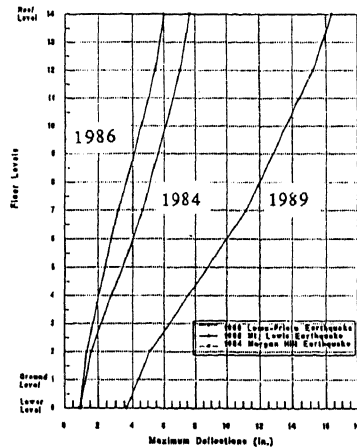
Figure 7

CSMIP PROJECT Santa Clara County Building Case Study Maximum Recorded Deflections vs. Floor Levels SW Corner of Building in E-W Direction

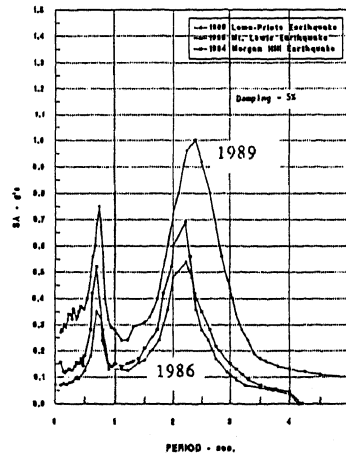
Figure 8

In an attempt to further determine threshold levels of non-structural damage, recorded floor acceleration response spectra for the 7th floor and 12th floor (in E-W and N-S directions) were superimposed as shown in Figure 8. It is suggested that if the fundamental dynamic properties, e.g., period etc., of the non-structural components can be estimated, then the responses of non-structural components to floor response spectra could be evaluated and correlated with observed non-structural component damage.

CSMIP PROJECT Santa Clara County Building - Case Study Earthquake Response Spectra - 7th Floor, E-W Direction CSMIP Chan No. 13
