## EFFECTIVENESS OF THE GROUND IMPROVEMENT ON LIQUEFACTION OBSERVED DURING THE HYOGOKEN- NAMBU EARTHQUAKE

S. Yasuda<sup>1)</sup>, K. Ishihara<sup>2)</sup>, K. Harada<sup>3)</sup> and N. Shinkawa<sup>3)</sup>

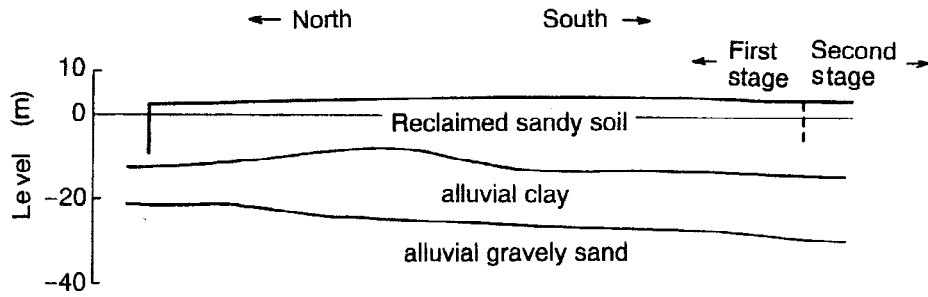
Fig.3 Simplified typical subsoil cross-section at Port Island

The depth to seabed was 10-15m before reclamation at the sites of the two islands. The seabed was comprised of an alluvial clay layer with a thickness of 10m to 20m. Figure 3 shows a simplified typical subsoil cross-section for Port Island. As shown in this figure, the reclaimed sandy soil was 15m to 20m thick. The reclaimed sandy soil was loose and the alluvial clay beneath it was very soft. Therefore, the consolidation of

the soft clay had to be accelerated and the loose sandy soil had to be strengthened in zones where heavy or important structures were to be constructed. For these purposes the subsoil in some zones was improved by installing sand drains and preloading. In addition, some zones were compacted with sand compaction piles or rod (vibro) compaction. The purpose of the soil improvement, therefore, was not the mitigation of liquefaction during earthquakes. Only one zone where a tram depot was to be built in Rokko Island, was compacted by sand compaction method to prevent the occurrence of liquefaction (Nakajima et.al., 1992).

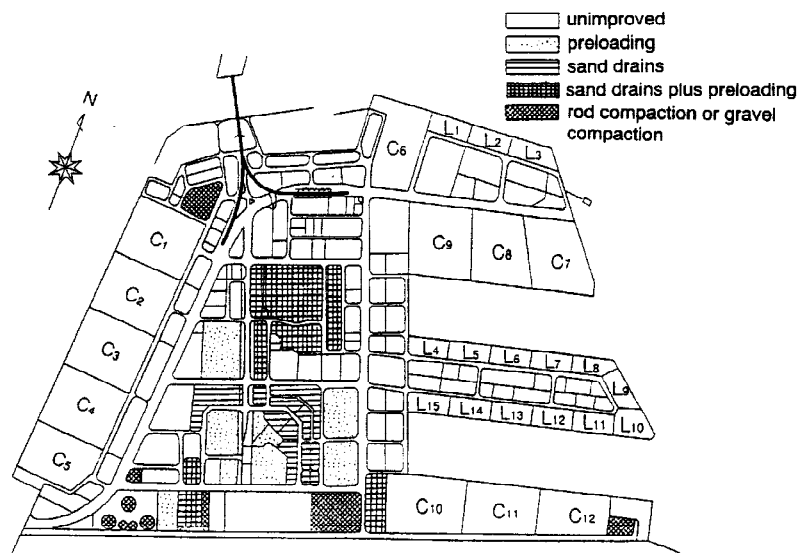
Fig.4 Improvement zones in Port Island

Figures 4 and 5 show the zones of soil improvement in both in Port and Rokko Islands. The central areas, which are used as residential areas, were improved by installing sand drains, preloading and a combination of the two methods. High-rise apartments and office buildings are constructed in these areas. The ground for an amusement park, tanks, some structures and a tram depot were improved using sand compaction piles or rod (vibro) compaction. Most of this soil improvement work was advanced to the bottom of the alluvial soft clay.

Figures 10 and 11 show the zones where sand and water were ejected, judging from aerial-photographs taken one to four days after the 1995 Hyogoken-Nambu Earthquake (Association for the Development of Earthquake Prediction, 1995). By comparing Figures 4 and 5 which show the improved zones, it was determined that no sand and water were ejected in the zones treated with sand compaction piles, rod (vibro) compaction, sand drains plus preloading and sand drains. Sand and water were ejected at a few locations in the zone treated by preloading only.

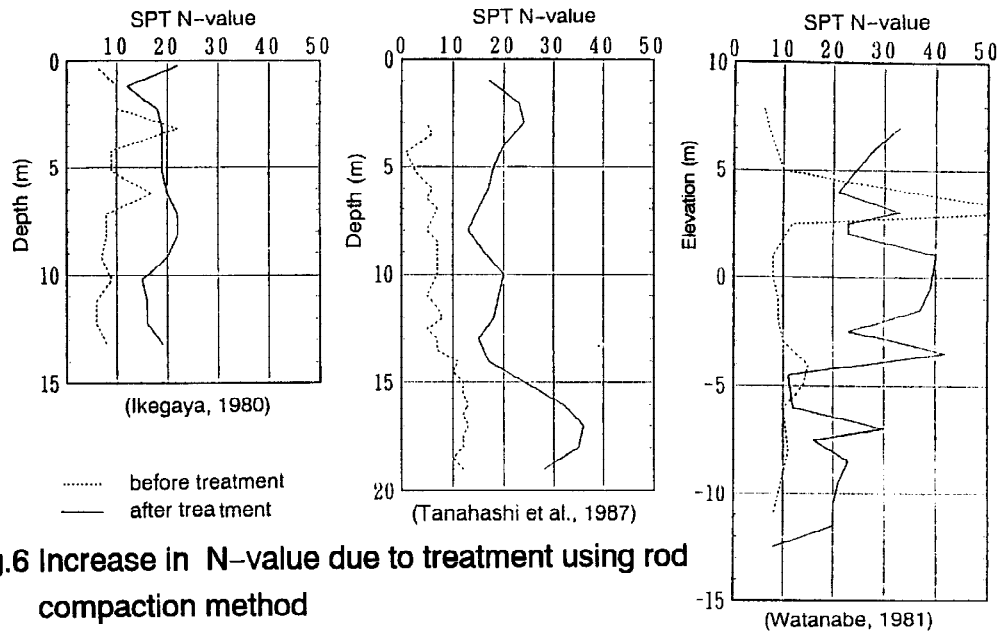
**Fig.6 Increase in N-value due to treatment using rod compaction method**

The authors collected data on soil borings made before and after the soil improvement. Figures 6 to 8 show a comparison of N-values in SPT of reclaimed sandy soils before and after treatment by rod (vibro) compaction, sand drains plus preloading and sand drains, respectively. Broken lines and solid lines show the N-values in SPT before and after the treatment at the same site, respectively. As shown in these figures, N-values in SPT increased after the soil was improved. Ground water was encountered usually 4m to 6m below the ground surface on both islands. The N-values in SPT of uncompacted soils below the ground water table were mostly 10 or less. Figure 9 compares N-values in SPT in untreated zones with those in zones treated with sand drains and sand compaction piles, including other published data (Nakajima et al., 1992). Based on Fig.6 to Fig.8, the N-values in SPT of soil treated and untreated subsoils are summarized in Table 1. N-
