## A CASE STUDY ON THE COLLAPSE OF A 7-STORY SRC-BUILDING DUE TO THE 1995 HYOGOKEN-NANBU EARTHQUAKE

T. NAGAO, H. TAKAHASHI, K. NISHIKAWA and M. ARAI

A 7-story SRC building collapsed at the 4th story due to the 1995 Hyogoken-nanbu earthquake. A case study was performed using elasto-plastic dynamic response analyses in order to estimate why and how this type of failure has occurred. It can be said that it was the worst earthquake for this building in terms of spectrum shapes, input directions or intensity levels.

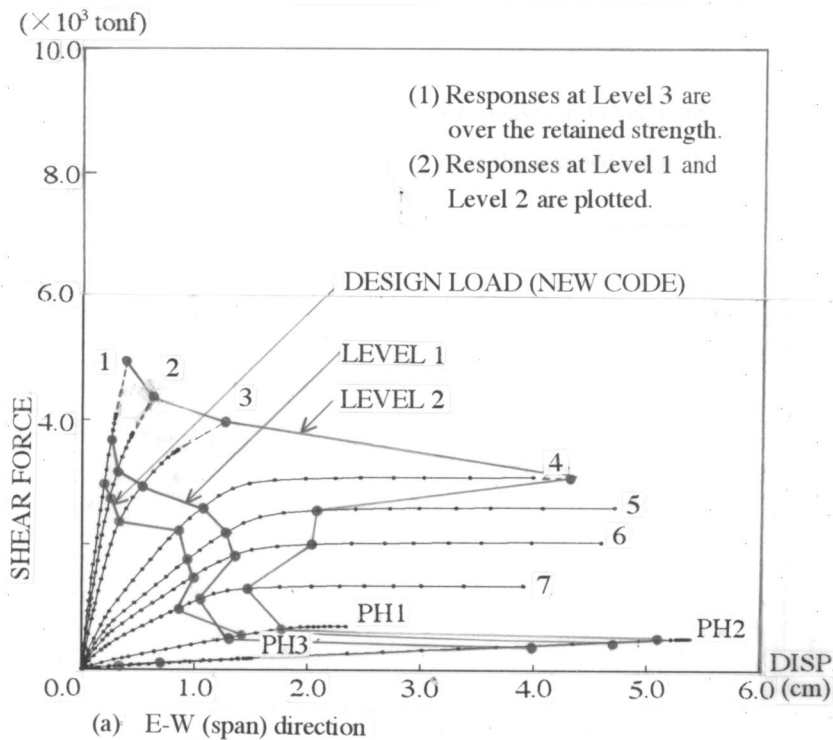
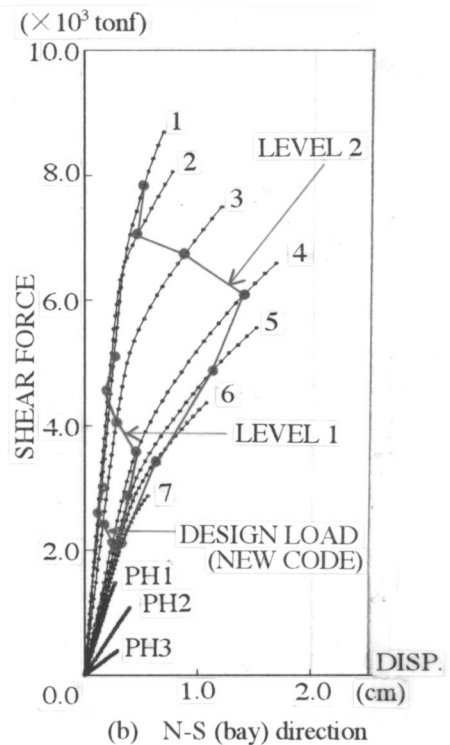
Fig. 6 Relationship of story-shear force to inter-story displacement

These are shown in fig.6(a) and (b) for the E-W and N-S directions, respectively. The ultimate strength can be retained 2.86 times (it was determined at the 4th to 6th stories, therefore, more can be retained under the 3rd stories) of the design seismic load level in the E-W direction and 6.09 times in the N-S Direction. The stiffness and strength under the 3rd stories are larger comparing to the 4th to 7th stories, in both directions. The stiffness reduction rate from the 3rd to 4th story are so large as 54% (E-W) and 63% (N-S).

As shown in fig.6 and fig.10, the story-shear force responses are over the ultimate strength of the structure in level 3. The structure might be able to resist elastically for level 1 in spite of being over the design load. The 4th story will lose the restoring force at level 2 in the E-W direction (fig.6(a)).

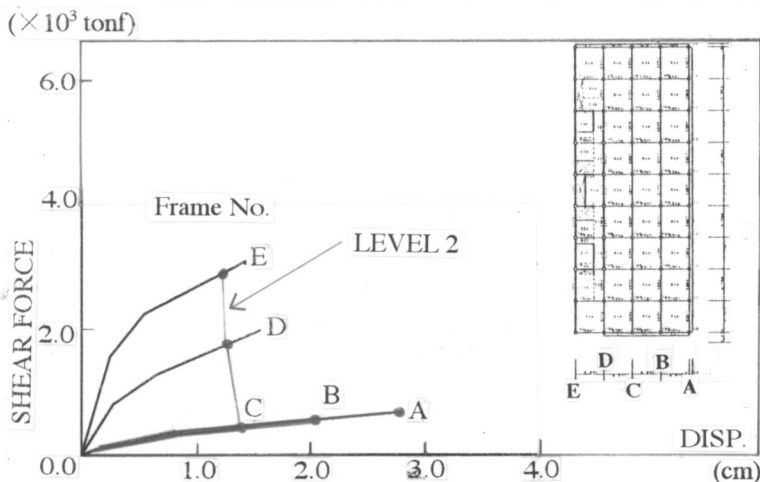
Fig. 7 Relationship of story-shear force to inter-story displacement separated in 5 plane frames

Strength and stiffness are larger in the N-S direction, because of the larger shear force capacity of walls. Figure 7 shows the story-shear force to drift relationship of the 4th story (N-S direction) separated in five plane frames (A,B and C are open frames, D and E are frames with shear walls), 64% of the horizontal load is sustained by walls.

The maximum drift responses at level 2 are separately plotted for five plane frames (fig.7). Responses are concentrated to the east side open frame (A frame) due to the torsion.

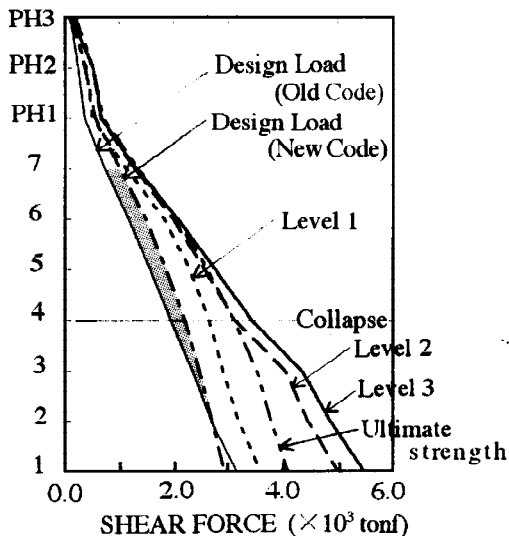
Fig. 10 Maximum story-shear force response (E-W direction) (design loads are plotted)

(1) As shown in fig.10, the equivalent static loading distribution recommended in the old code was underestimated around middle to upper stories.

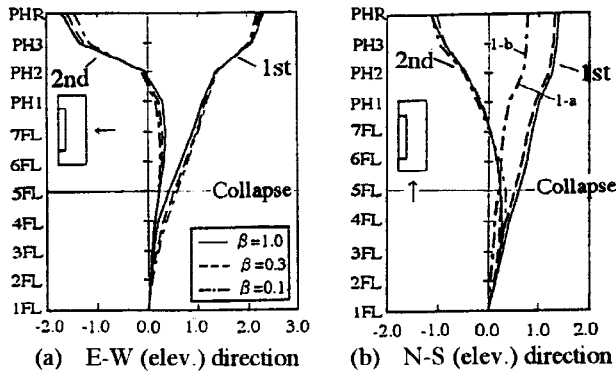
(a) E-W (elev.) direction (b) N-S (elev.) direction  
(c) E-W (plan) direction (d) N-S (plan) direction  
Fig. 9 Natural mode of vibration

In fig.9(a), the 1st and 2nd modes of the E-W direction shows that a whipping phenomenon will occur at the penthouse structure, therefore the column axial force in the west side will increase according to the overturning moment response. A coupled mode of drift and torsion occurs when stimulating to the N-S direction (fig.9(d)), thus the responses will concentrate to the east side open frames.

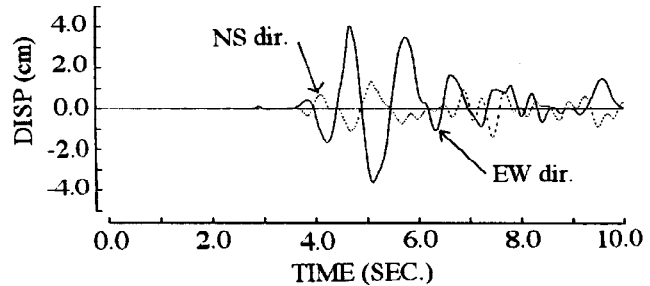
Fig. 12 Time history of the 4th story drift (at Level 2, time=0~10sec)

The maximum inter-story displacement responses concentrate at 4th and 5th stories especially in the E-W direction, as shown in fig.11. One and a half cycles of drift with more than 1/100 inter-story displacement angle occur at level 2 in the E-W direction, as shown in fig.12, which will be over the deformation capacity of the SRC column with less ductile composition.
