## BEHAVIOR OF LARGE STEEL BEAM-COLUMN CONNECTIONS

Egor P. POPOV and Marcial BLONDET

### ABSTRACT

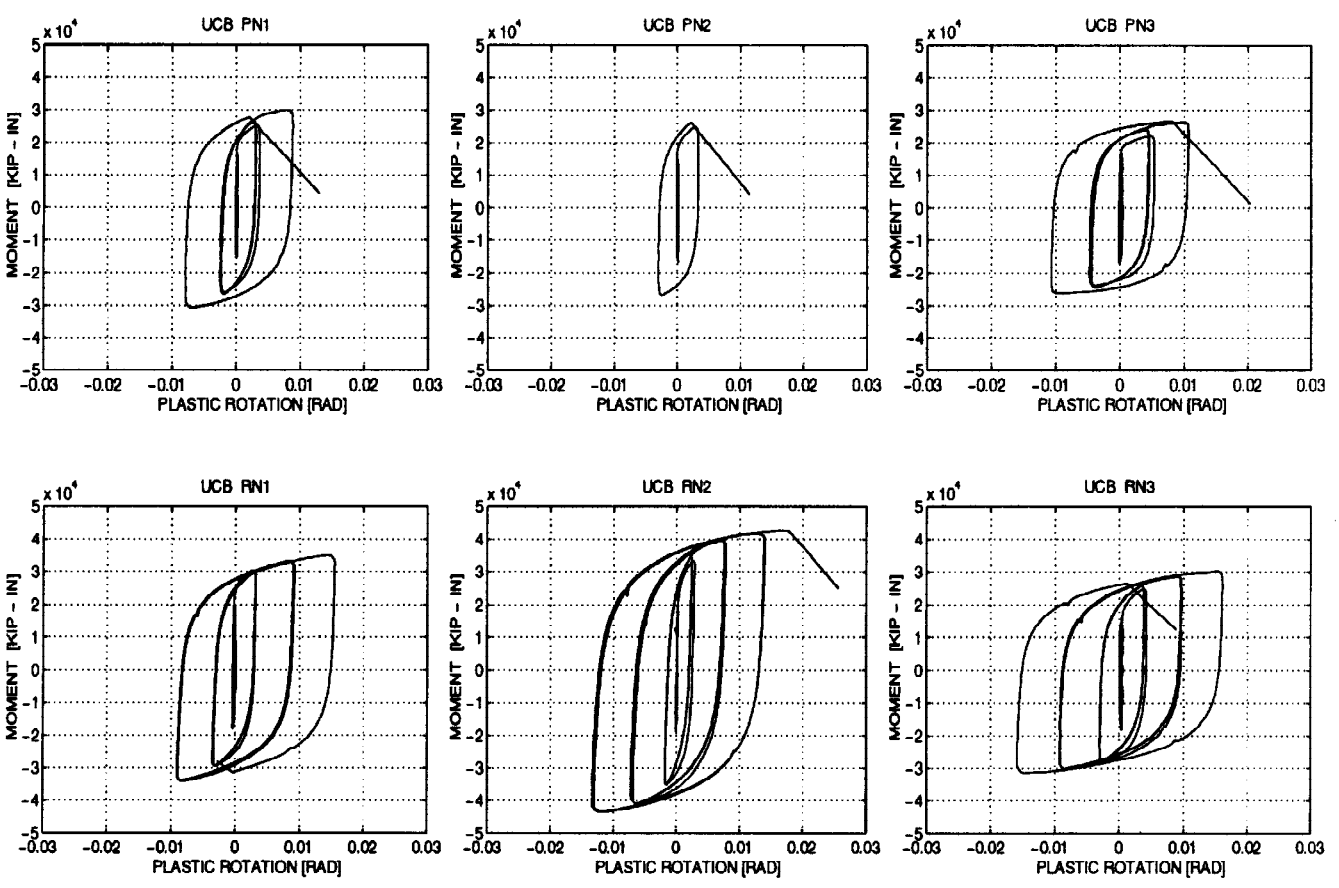
**Fig. 8. Moment @ Column Face vs. Plastic Rotation**

The hysteretic response of the specimens can be visualized in Figs. 7 and 8, which provide force versus beam end displacement plots and moment at column face versus plastic rotation plots, respectively. The response of the repaired specimens is shown in the second row.
