TESTING OF DAMAGED STEEL MOMENT CONNECTIONS

ABSTRACT

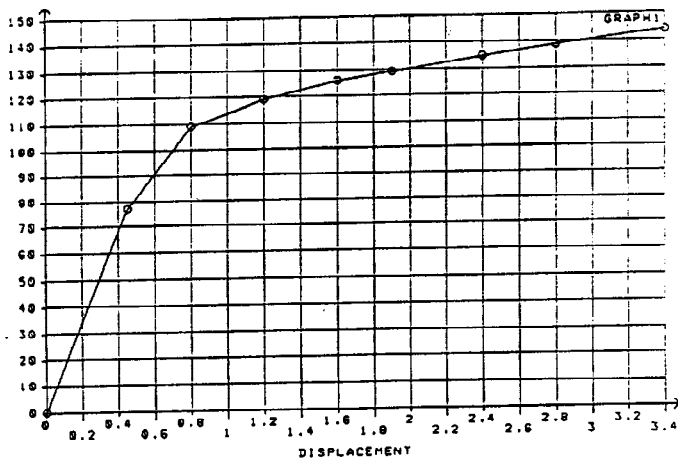
Fig. 3. FEM, Force vs. Disp.

A typical finite element model for a standard connection with continuity plates has 1604 nodes and 967 plate elements. Calculations were done on a Hewlett Packard LM 5/60 computer with a 60 MHz pentium processor using the COSMOS/M program. The load at the end of the beam is plotted versus the calculated beam tip displacement in Fig. 3. For this model, a beam tip force of 130 kips is required to reach a two inch deflection which is representative of 3% rotation. Contours of Von Mises' stress at maximum tip displacement are shown in Fig. 4. The high stress region extends to the beam centerline with the peak stress reaching 55.9 ksi, indicative of a plastic hinge. It can also be seen that the panel zone is a region of high stress suggesting that deformation of the panel zone may be significant for these specimens.

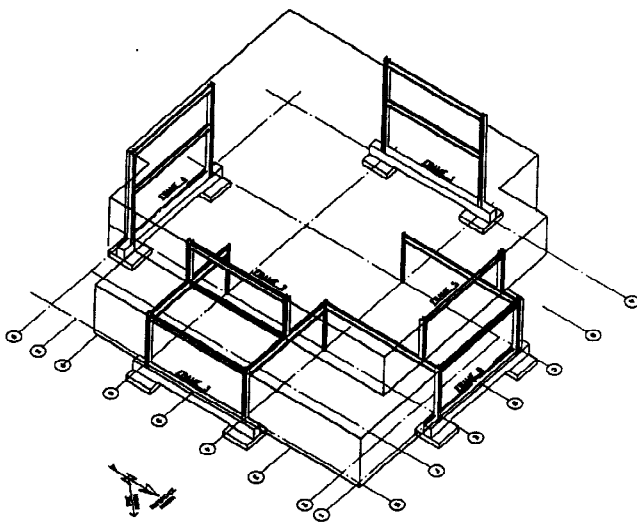
Fig. 5. Lateral Force Framing

Demolition of the building began in December, 1994. The four moment connections at the second floor level were obtained from the moment frames on the west and south sides of the building, Fig. 5. The columns were flame cut five feet above and below the beam flanges and the beam was flame cut eight feet from the column face. These "rough cut" specimens were transported to a local fabricator for cleanup and addition of end plates. The dimensions of the finished test specimen are given in Fig. 6. All columns are W14x132. Two specimens (#3 and #4) use W24x76 beams and two specimens (#1 and #2) use W27x96 beams. The steel was specified as A36, however, tests on coupon samples taken from the specimens indicate the yield stress is approximately 47.5 ksi.
